The Use of Geofibers and Synthetic Fluids Kwigillingok Airport

Prepared for the Alaska Department of Transportation

By: Rodney Collins and Billy Connor

February 2011

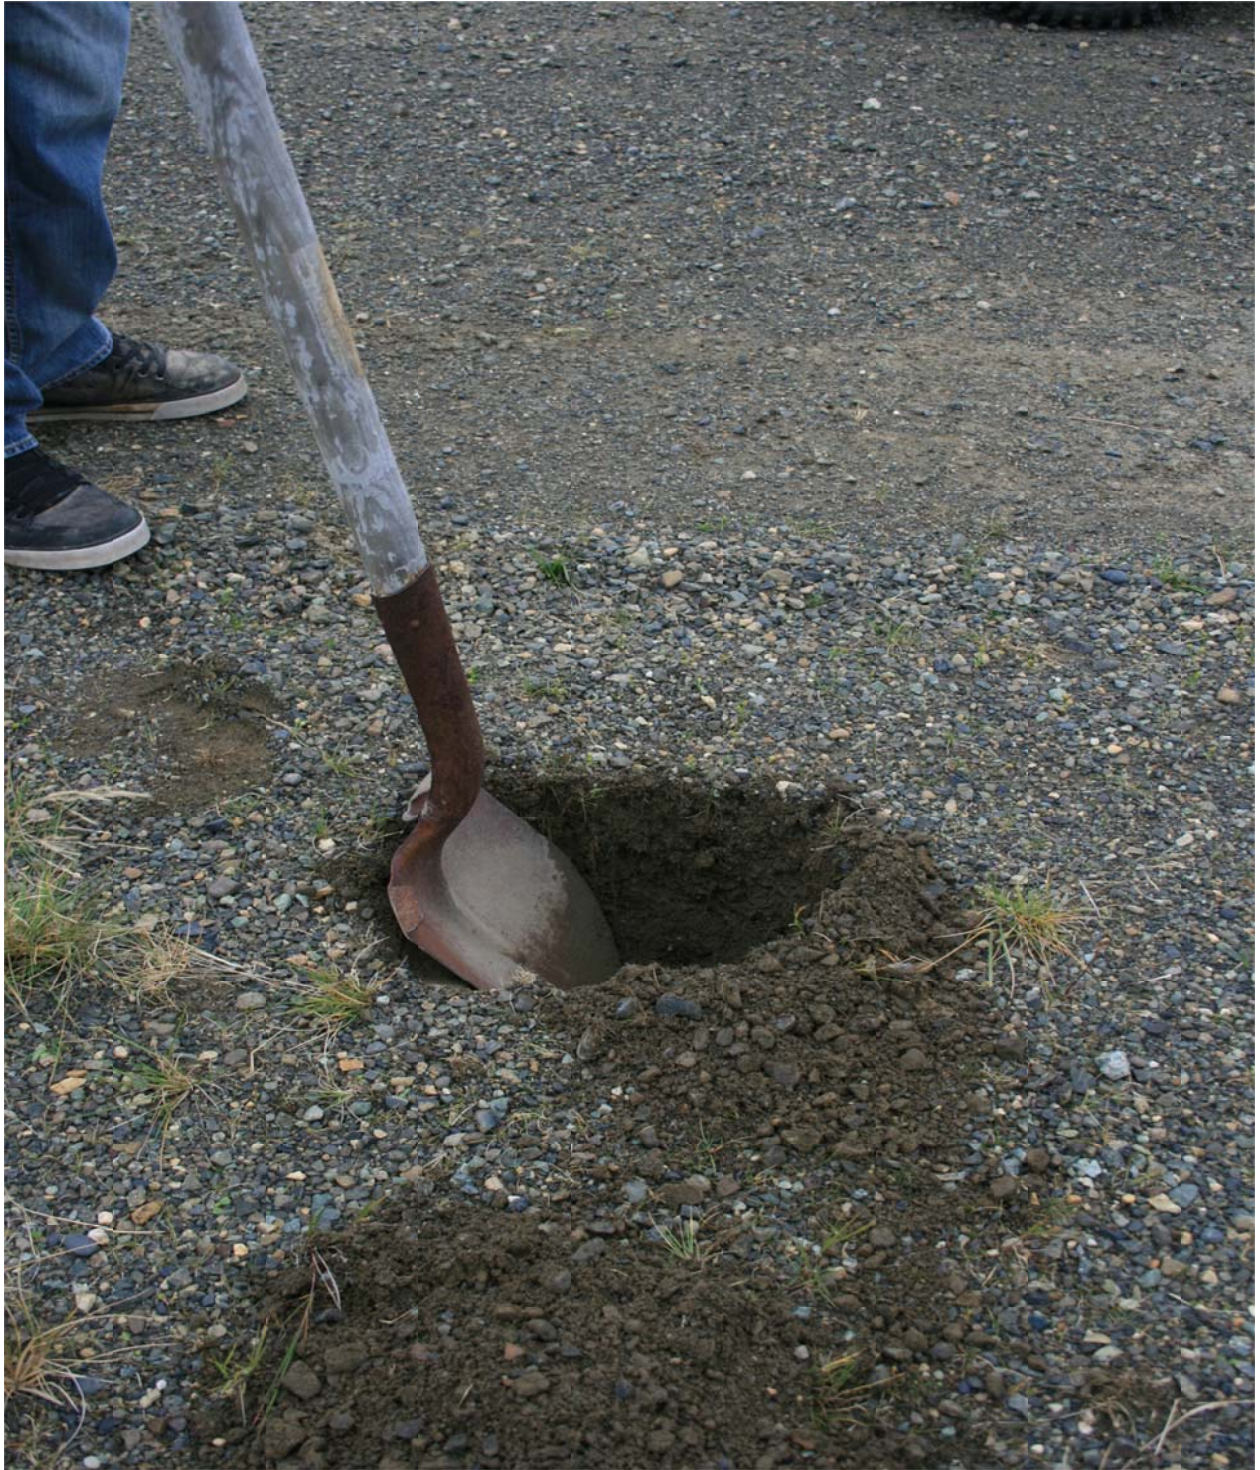
The depth of the gravel on the runway surface was checked on the northern and southern sections of runway, also on the sides of the runway. The depth of gravel at both the north and south ends of the runway was approximately eight inches; no further digging could be done after this depth was reached because it was heavily compacted and only a spade shovel was used, the image showing where the hole was dug is shown as [Fig.3](#). One hole was dug on the side of the runway to find the depth of gravel throughout the runway; this showed the gravel to be nearly one inch thick on the side of the runway which is shown in [Fig.4](#). It is apparent that the many years of grading had resulted in the variable thickness of the gravel surface. However, it is not clear whether this is due to differential settlement. Unfortunately, we did not have the equipment to determine this.

Figure 4: Hole on side of the runway showing a shallow depth of gravel
