# Memo

Project: Dalton Highway H&H MP 0-9 (#025-5-1-055, P1)

Subject: **General Project Recommendations**

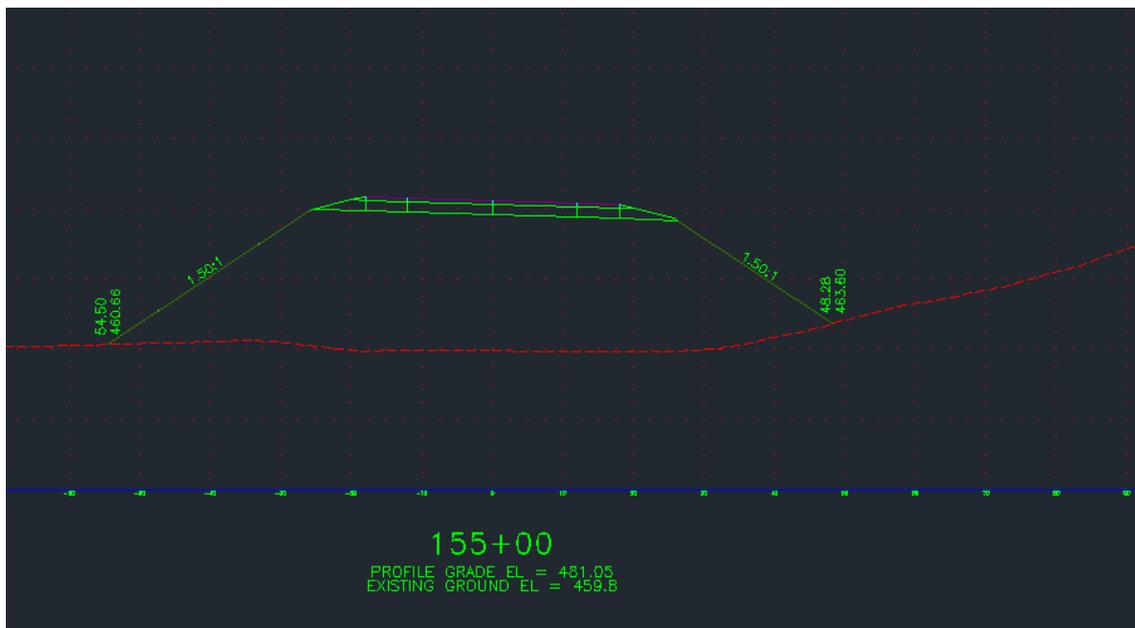
Where the existing ground slope is flat on the south side of the road prism, such as in Figure 1 below for the section at 155+00, there exists potential for aufeis development, especially where cross drainage structures may be required for local drainage. The location in this figure also corresponds to the low point of the north side ditch along this section of the O5 alignment, where cross drainage structures would typically be located. Options for mitigation of aufeis formation include insulated subdrains below any culverts, thaw pipes in the culverts, and minimizing winter flow at the cross drainage structures.

Figure 1 Representative road prism section along O5 alignment

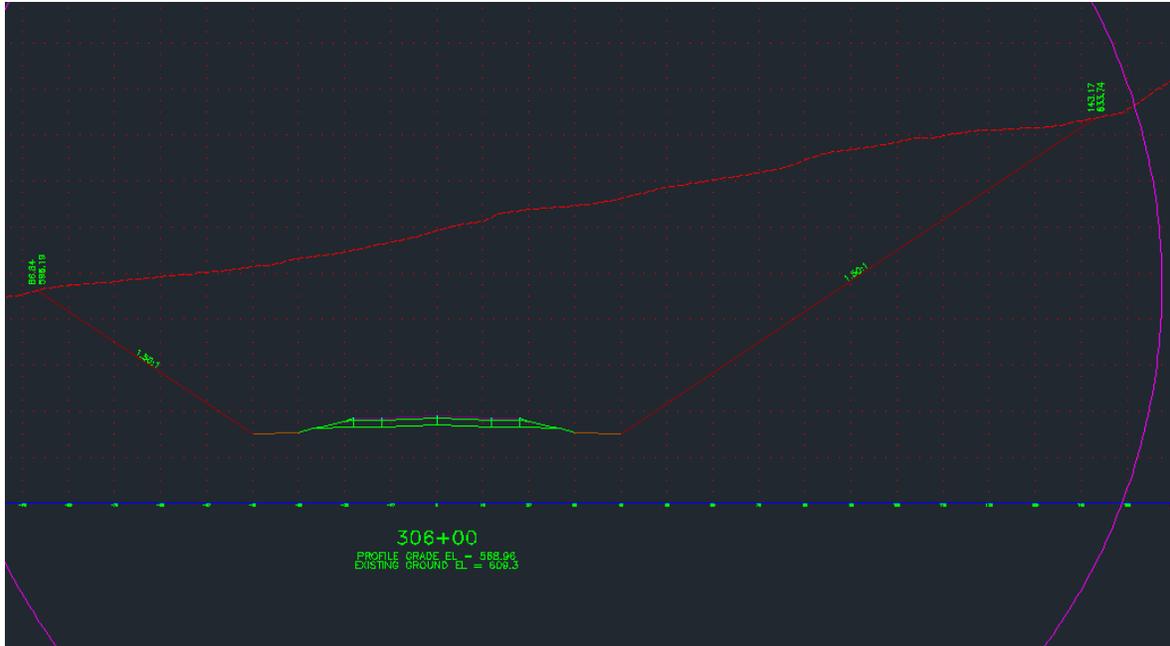
In addition to the ditch treatments for protection from local scour, there are a few areas where the road prism will be cut into the hillslope and additional measures should be considered. For example, Figure 2 shows the road prism at station 306+00 where both sides show a significant cut (entrenched road section). The width of the ditches should be sufficient to catch rock or soil slides in the case of cut slope failures. Sections with significant entrenchment may also result in snow drifting, particularly in the ditches.

**Figure 2 STA 306+00 Significant Entrenchment Section**

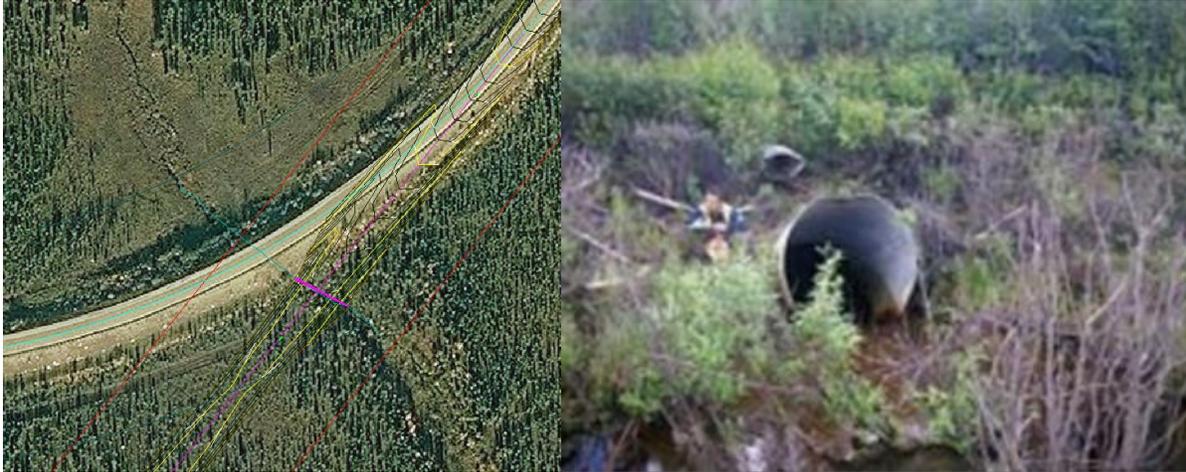
The existing Rosebud Creek culvert is plagued by afeis with thick accumulations developing at both the upstream and downstream sides. The crossing consists of 30 feet of cover over a 60 inch CMP with a slight skew angle (approximately 10 degrees as shown in Figure 3) with a 24 inch CMP located directly above it as shown in Figure 4. The roadway has settled adjacent to the culvert crossing most likely due to permafrost thawing. Both culverts have damage at their inlet and outlet. The first and last 6 feet of the 60 inch culvert has been disconnected at the inlet and outlet and the remaining end sections are both bent upwards (Figures 3 and 4). The inlet is slightly perched and the outlet has a scour hole. The damage is likely due to buoyancy forces from ice. The 24 inch culvert above has a slightly squashed inlet. Figure 5 shows the afeis conditions at the inlet and outlet on March 21, 2016. Afeis fills the channel and floodplains both upstream and downstream of the Elliott Highway at this location.

**Figure 3 (Left) Aerial View of Rosebud Creek; (Right) Rosebud Creek Inlet**

For the first option, the new alignment will not be as high (not as much cover) for the extended culvert and the existing culvert would need to be repaired or replaced. Aufeis would continue to be a problem at both the inlet and outlet of an extended culvert. It is recommended that during the construction of the new alignment, the existing Rosebud culvert should be replaced with an equivalent or larger culvert that extends through the proposed embankment. In addition, the 24 inch overflow culvert should be replaced with a minimum 36 inch culvert during the repair and construction of the Rosebud crossing. Thaw systems should be constructed through both culverts.

The second option of removal of the existing embankment would provide an opportunity to remove the existing the culvert crossing (inlet and outlet damage), provide for some mitigation credits by remediation of the upstream channel, and construct a new shorter 60 inch or greater culvert, a new shorter 36 inch aufeis overflow culvert, and thaw pipe systems.

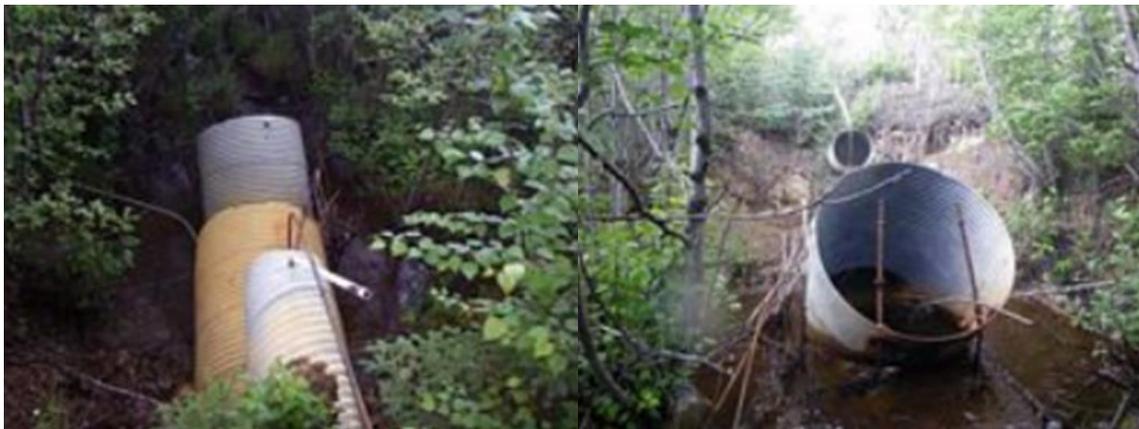
**Figure 4 (Left) Rosebud Creek Outlet from above; (Right) Rosebud Creek Culvert Outlet from downstream**

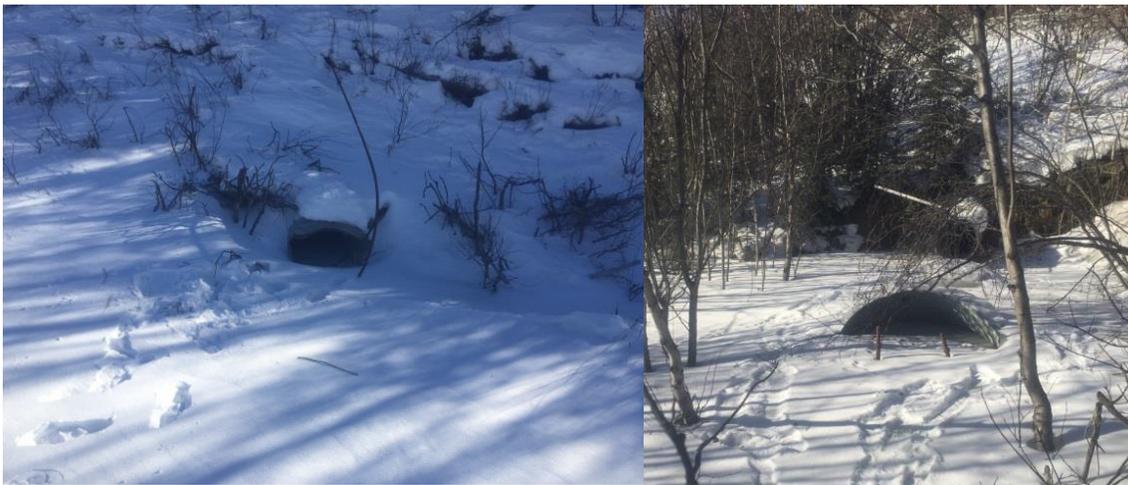
**Figure 5 (Left) Rosebud Overflow Culvert Inlet; (Right) Rosebud Overflow Culvert Outlet**

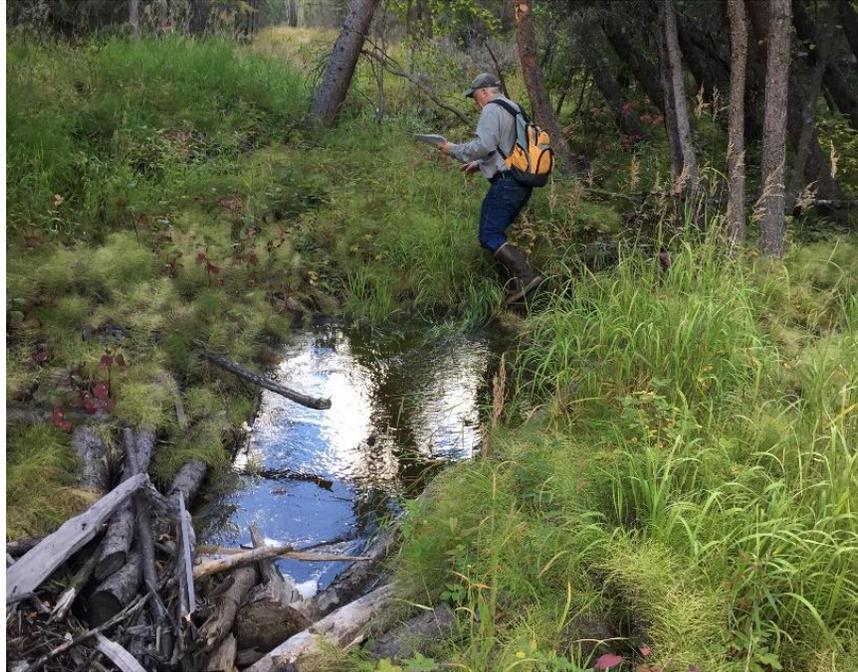
The proposed alignment crosses the West Fork of Tolovana Tributary #1 approximately 8,000 ft. southwest of the existing highway crossing at STA 205+00. The highway-creek crossing is close to the confluence of the Tolovana and the Tributary and is generally in the floodplain valley of the Tolovana. The West Fork Tolovana Tributary #1 meanders in and out of the proposed alignment downstream of the crossing from STA 192+00 to 205+00. At the crossing location (205+00), the tributary conditions on August 17, 2016 were approximately 6 to 10 feet wide, 1 foot deep, an approximate flow velocity of 0.75 fps, a gravel-sand creek substrate, and crossing the alignment at a significant skew. These conditions can be seen in Figure 6.

**Figure 6 West Fork Tolovana Tributary #1 Alignment Crossing**

Because the Tolovana Tributary #1 crossing intersects and then meanders back and forth across the O5 alignment, there is a range of locations to place the crossing. It is recommended that the culvert crossing be southeast of the RS2477 Trail intersection with the O5 alignment (approx. STA 205+00). With this alternative the highway embankment would help protect the trail from erosion and flooding. Because of the creek and highway alignment orientation, the crossing will need standard culvert inlet and outlet erosion protection and some additional riprap embankment protection upstream and downstream to help guide the creek towards and out of the culvert crossing. The extents of the additional embankment riprap protection will be determined during the design of the crossing. There may be a need to provide channel improvements downstream of the crossing to direct the flow away from the highway embankment and toward the West Fork of the Tolovana River.

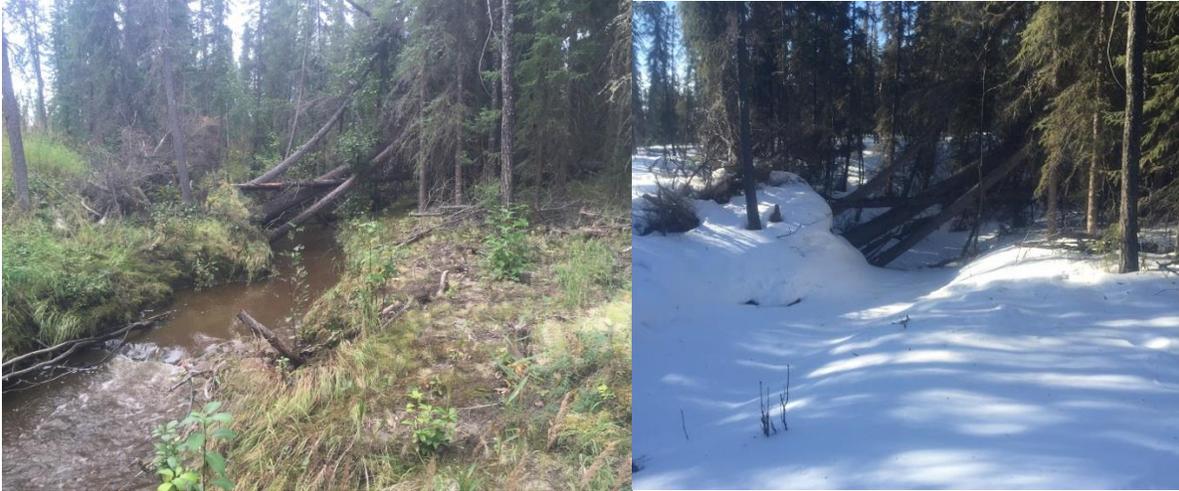
Lost Creek Tributary #2 has been identified by ADF&G as potential fish habitat. The channel is well defined and slightly incised (3-4 feet from top of bank to the ice surface and OHW), has a confined floodplain, and is a step-pool stream containing some larger rocks and large woody debris. The crossing should be well suited to a large open bottom arch pipe or buried culvert with stream simulation to maintain bed conditions while providing adequate flood capacity. The stream crossing is approximately 45 degrees skew to the road alignment. The skew increases culvert length and constructions costs; however, changing the highway alignment to reduce the skew and culvert crossing costs may increase road construction costs and contradict road design guidance. Therefore, it is recommended that the highway alignment be maintained as proposed. Figure 7 depicts the crossing location in summer and winter conditions.

**Figure 7 (Left) Lost Creek Tributary #2 August 18, 2016; (Right) Lost Creek Tributary #2 March 21, 2016**

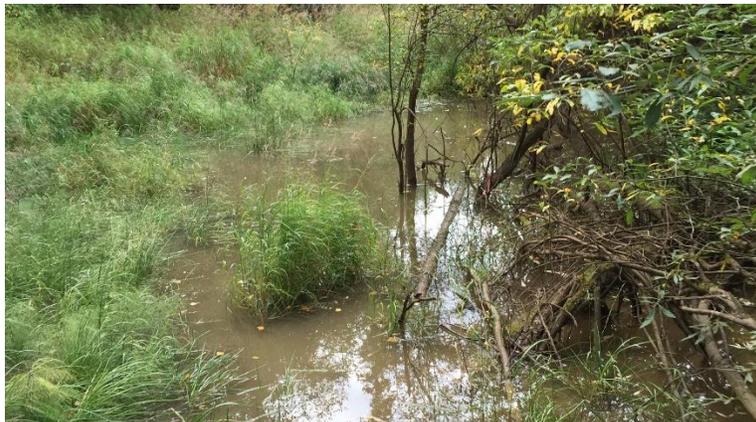
At MP 8.0 there are no highway alignment changes proposed, but some road rehabilitation work will be performed. At this particular crossing there is a small drainage basin with a cross drainage culvert under approximately 30 feet of cover. The culvert is not conveying the local drainage as indicated by the large pool at the inlet, and no perceivable flow from the outlet (Figures 8 and 9). It is assumed that the water is draining through the embankment via percolation and groundwater. The cause of the blockage could either be sediment and debris blocking flow, or a pipe collapse. Inspection looking up the culvert outlet did not verify either of these conditions.

**Figure 8 Culvert at MP 8.0 Inlet**

It is recommended that the inlet pool be drained to allow for more adequate investigation. If the pipe has not collapsed the construction contractor could clear the debris, repair the culvert if needed, and reinstate drainage conveyance. If the pipe has collapsed, ADOT&PF should explore replacing the pipe using trenchless excavation approaches to avoid a significant earthwork costs and temporary highway closure. Ultimately a feasibility and cost study comparing open trench excavation and trenchless excavation would determine the appropriate method for replacing a structurally failed culvert. The current size of the culvert would provide adequate capacity if not blocked. Since it is less than 48 inches, it will not be addressed in the H&H design.

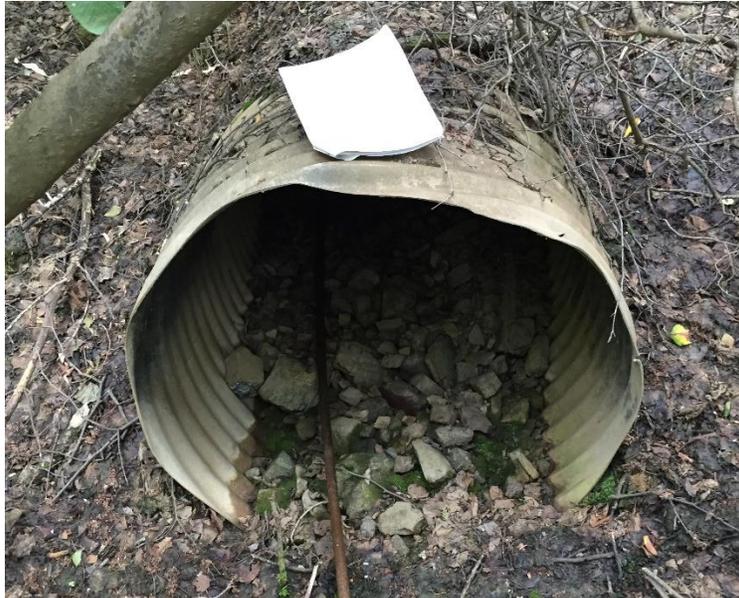
**Figure 9 Culvert at MP 8.0 Outlet**

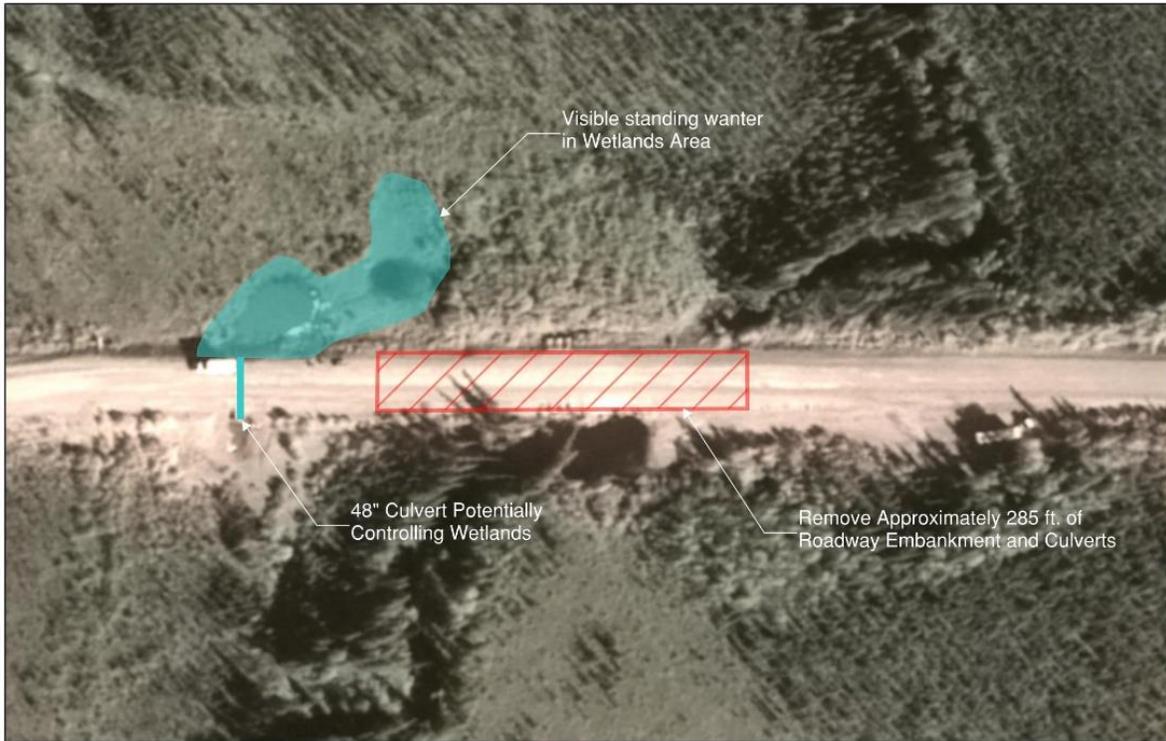
The existing Dalton Highway alignment culvert crossing at Lost Creek at MP 5.7 is shown in Figure 10. This section has a considerable amount of fill and crosses Lost Creek at a large skew angle. The existing crossing includes a single 60 inch CMP culvert which follows the historic creek bed plus a battery of culverts to provide flow capacity during floods. The flood capacity culverts from east to west include three 72 inch CMP culverts, two 48 inch CMP culverts, and two 36 inch CMP culverts. Figure 11 shows the view looking to the NW at the Lost Creek crossing. The large spruce trees on either side indicate the location of the historic channel. Removal of the Lost Creek culverts and adjacent roadway embankment represent an opportunity to earn mitigation credit for restoration of the historic creek bed and adjacent floodplain. Based on the summer field visit it is recommended that 285 ft. of road embankment and culverts can be removed to restore some of natural floodplain (seen in the hatched area in Figure 10). To the northwest of this area are the two 48 inch CMP culverts, one of which appears to be acting as an elevation control structure for an upstream wetlands area. A pool at

the outlet of this 48 inch culvert may serve as a water supply point (roadway maintenance) for future operations. The existing water supply point at the outlet of the 60 inch CMP would most likely be lost due to removal of this culvert and access to east side of Lost Creek.

**Figure 10 Proposed Road and Culvert Removal at Existing Lost Creek Crossing**

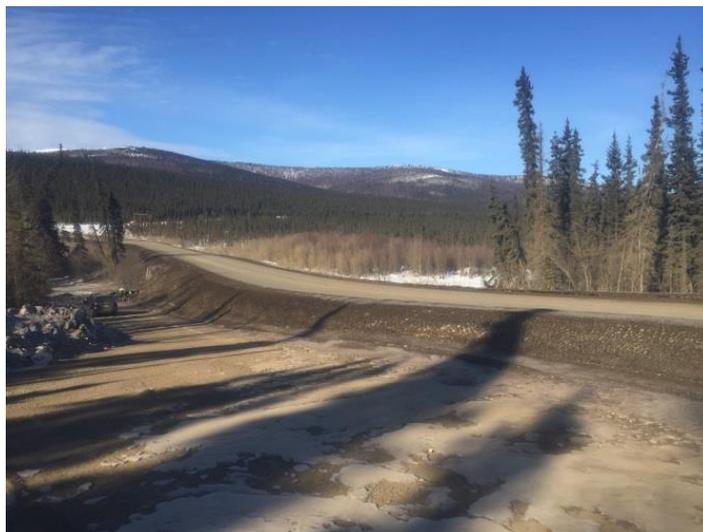
**Figure 11 Looking NW toward Lost Creek**
