CADD	ECC	GEOLOGIC HAZARD SUMMARY ARRANGED BY 2012 SEIS STATIONING LYNN CANAL HIGHWAY PHASE 2 2012 SEIS ALIGNMENT HAZARD REVISIONS		
	DATE	9/10/12			
	CHECK	RGD			
	FILE No.	GEO_HAZ_SUMM.PPT			
PROJECT No.	113-95756	DATE	9/24/12	HDR / 2012 SEIS JUNEAU ACCESS / AK	G-2
		REV	1

TITLE
GEOLOGIC HAZARD SUMMARY
ARRANGED BY 2012 SEIS STATIONING
 LYNN CANAL HIGHWAY PHASE 2
 2012 SEIS ALIGNMENT HAZARD REVISIONS

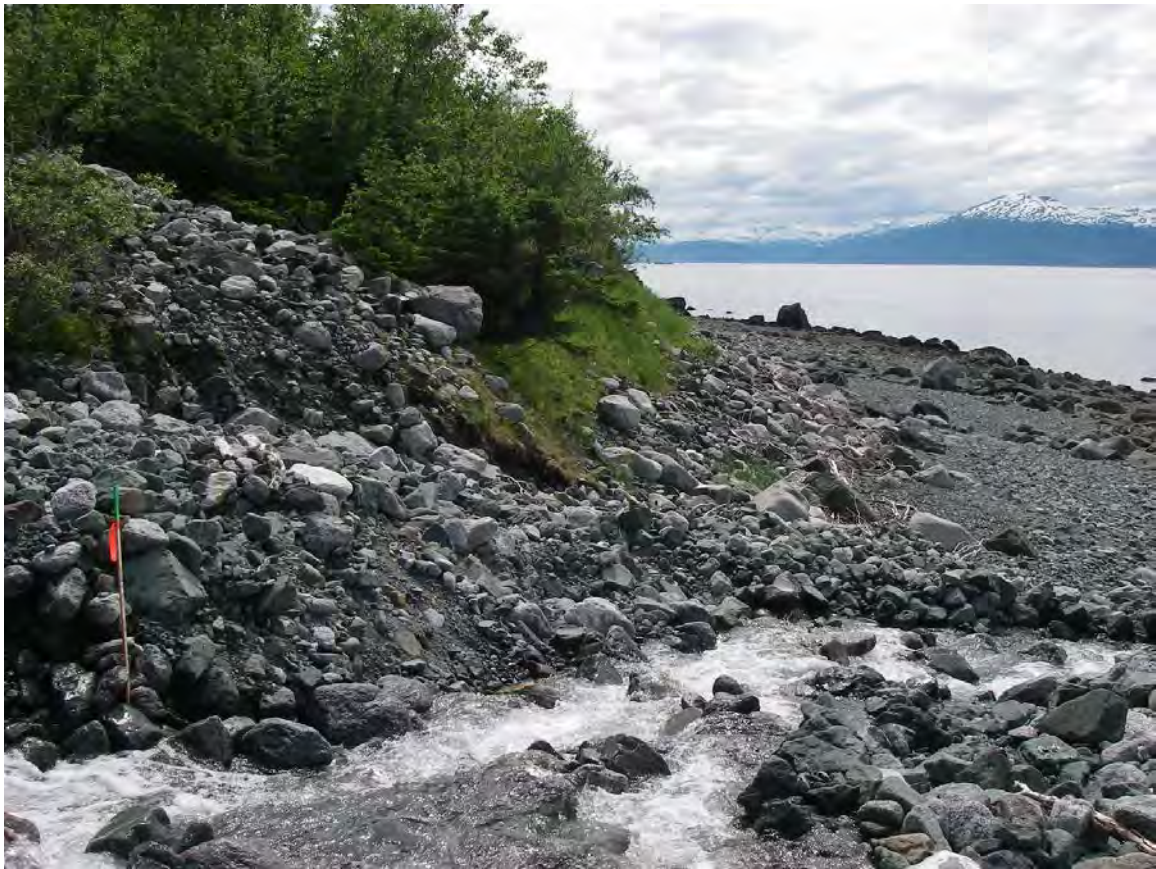
Hazard ID #:	DF01
Hazard Type:	debris_flow
HIN:	225
Rating:	A
2012 SEIS Alignment Location:	1495
Frequency (yrs):	1-5
Predictability:	moderate
Material Volume (CY):	100-1000
Clast Size (ft):	1-2
Source Elev. (ft):	>1000
Centerline Slope:	fan
Alignment Location:	deposition_zone
Impact Alignment:	yes
Alignment Exposure (ft):	500+
Vegetation:	denuded
Deciduous Trees:	yes
2012 SEIS Alignment South Margin:	1492+00
2012 SEIS Alignment North Margin:	1498+00
Photo #:	4098, 4099, 5146

DF01. View south/down alignment at debris flow deposition zone at beach. Survey lath represents previous IRP 2006 alignment.

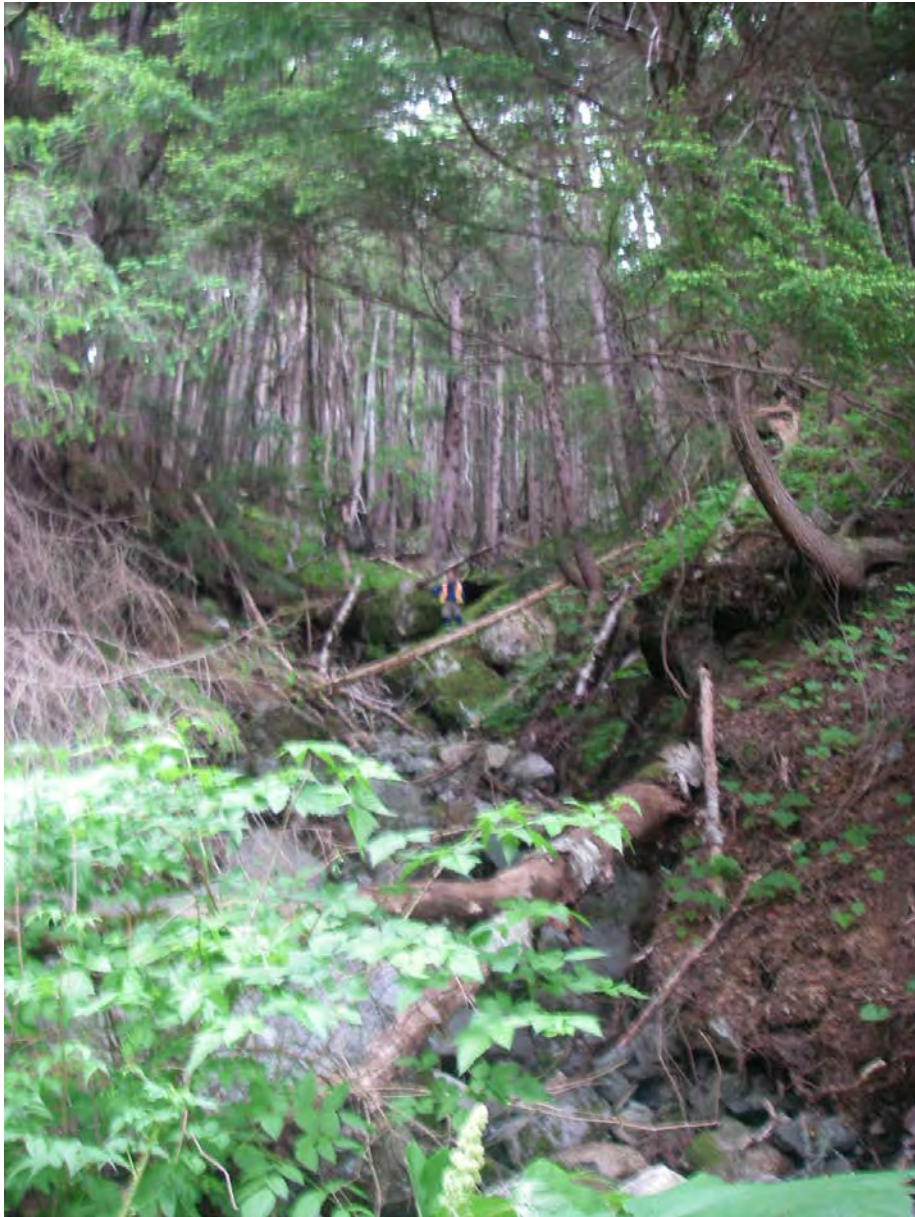
Hazard ID #:	DF02
Hazard Type:	debris_flow
HIN:	129
Rating:	A
2012 SEIS Alignment Location:	1514
Frequency (yrs):	1-5
Predictability:	moderate
Material Volume (CY):	<10
Clast Size (ft):	0-1
Source Elev. (ft):	2000-3000
Centerline Slope:	fan
Alignment Location:	deposition_zone
Impact Alignment:	yes
Alignment Exposure (ft):	50-200
Vegetation:	disturbed
Deciduous Trees:	yes
2012 SEIS Alignment South Margin:	1514+00
2012 SEIS Alignment North Margin:	1514+70
Photo #:	1515, 2036, 5865

DF02. View east/upslope up debris flow channel incised into overburden.

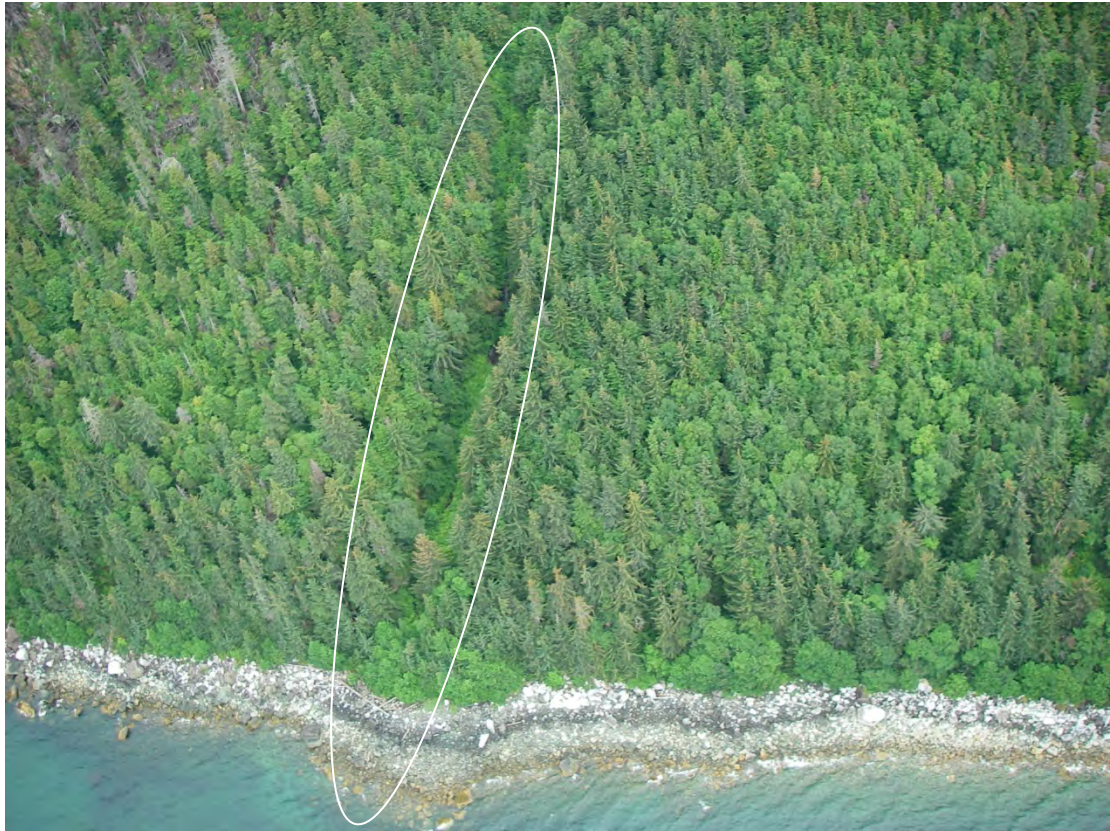
Hazard ID #:	DF03
Hazard Type:	debris_flow
HIN:	183
Rating:	A
2012 SEIS Alignment Location:	1517
Frequency (yrs):	0-1
Predictability:	moderate
Material Volume (CY):	<10
Clast Size (ft):	0-1
Source Elev. (ft):	2000-3000
Centerline Slope:	fan
Alignment Location:	deposition_zone
Impact Alignment:	yes
Alignment Exposure (ft):	50-200
Vegetation:	disturbed
Deciduous Trees:	yes
2012 SEIS Alignment South Margin:	1516+70
2012 SEIS Alignment North Margin:	1517+70
Photo #:	3893, 5148, 5865, 6256

DF03. View east/upslope at debris flow channel, deposition zone, and fan.

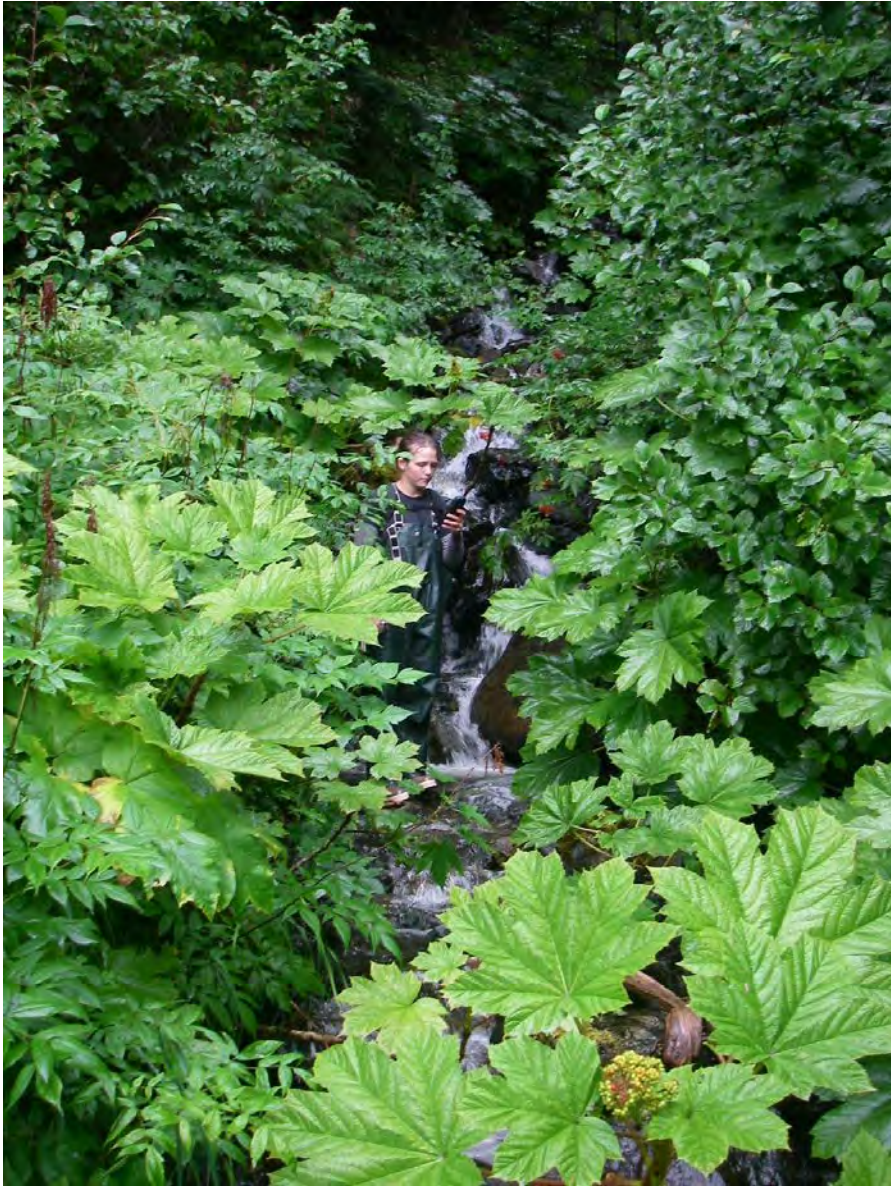
DF03. View east/upslope up debris flow channel.

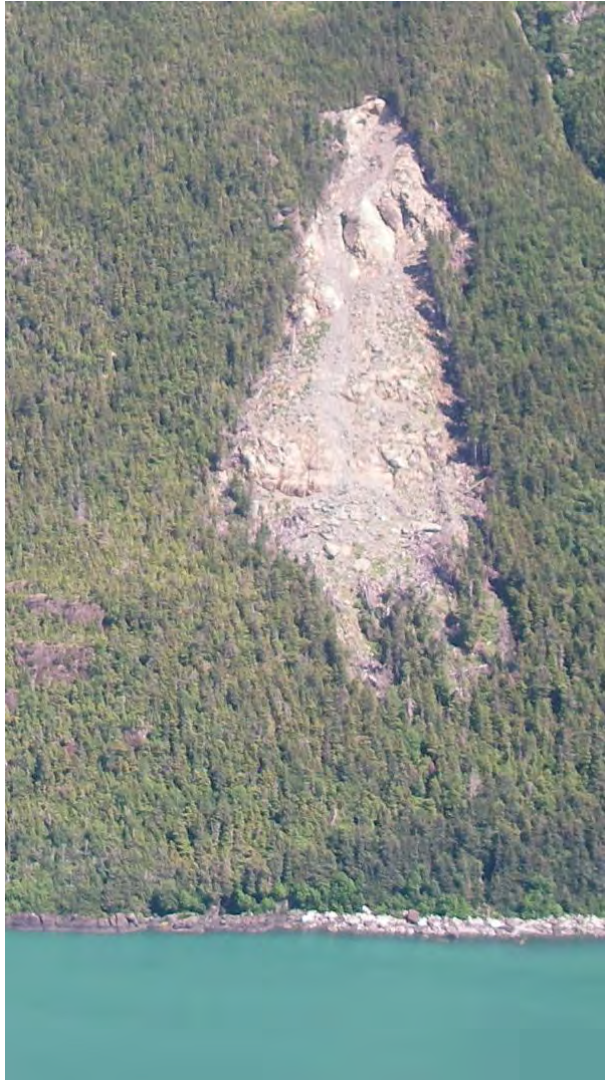
RS01. View east/upslope at 2001 rockslide and avalanche path.

Hazard ID #:	RS01
Hazard Type:	rock_slide
HIN:	219
Rating:	A
2012 SEIS Alignment Location:	1522
Frequency (yrs):	unknown(>25?)
Predictability:	unpredictable
Material Volume (CY):	100-1000
Clast Size (ft):	4+
Source Elev. (ft):	>1000
Centerline Slope:	open_bedrock_slope
Alignment Location:	deposition_zone
Impact Alignment:	no
Alignment Exposure (ft):	200-500
Vegetation:	denuded
Deciduous Trees:	no
2012 SEIS Alignment South Margin:	1520+70
2012 SEIS Alignment North Margin:	1524+00
Photo #:	4123, 4124, 4126, 5148, 5865

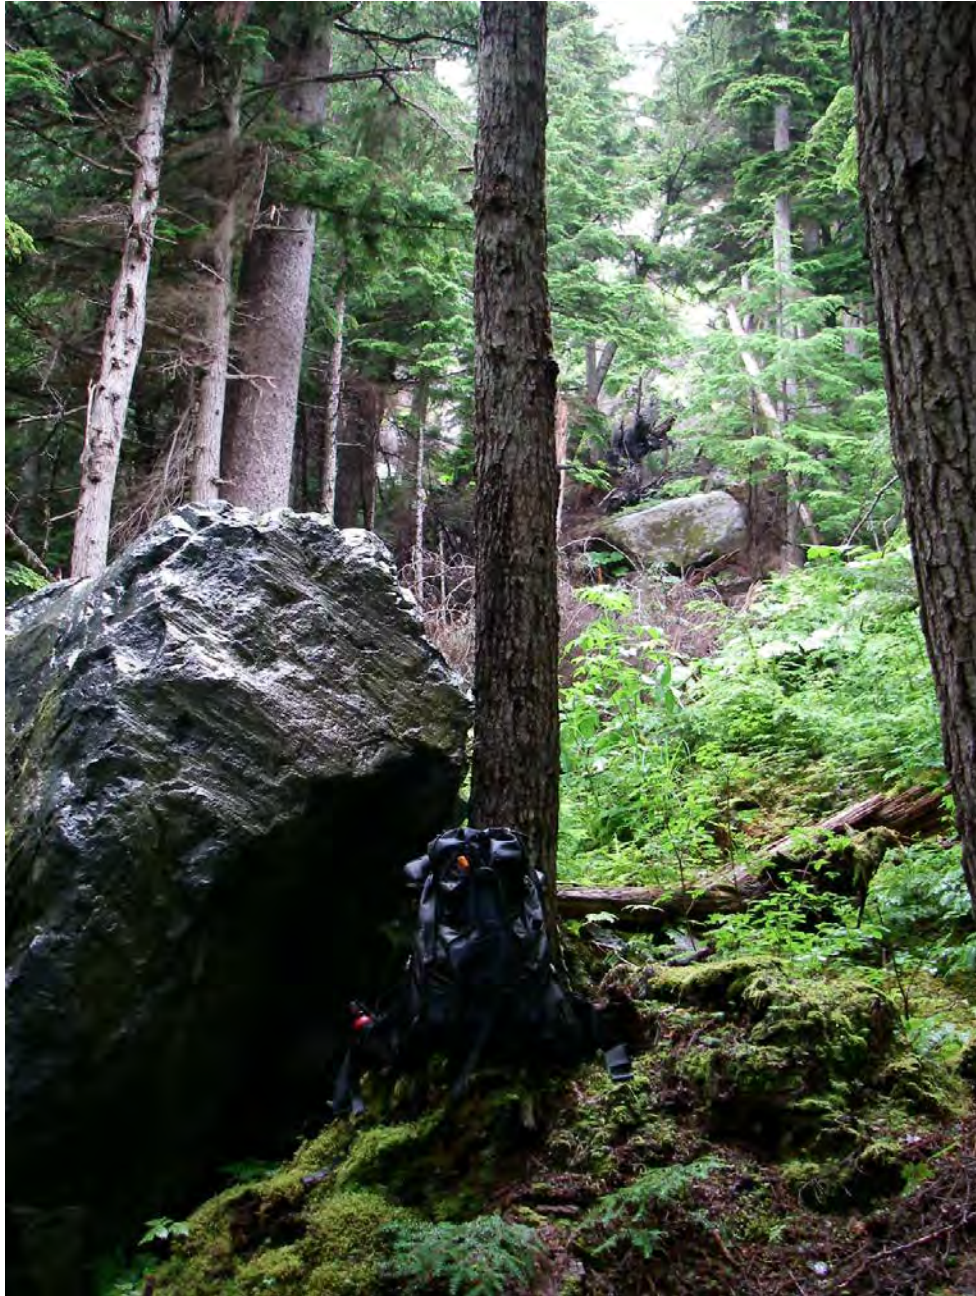
RS01. View east/upslope of fresh rockslide mega-boulder at southwest (downslope and down alignment) corner of rockslide and avalanche path.

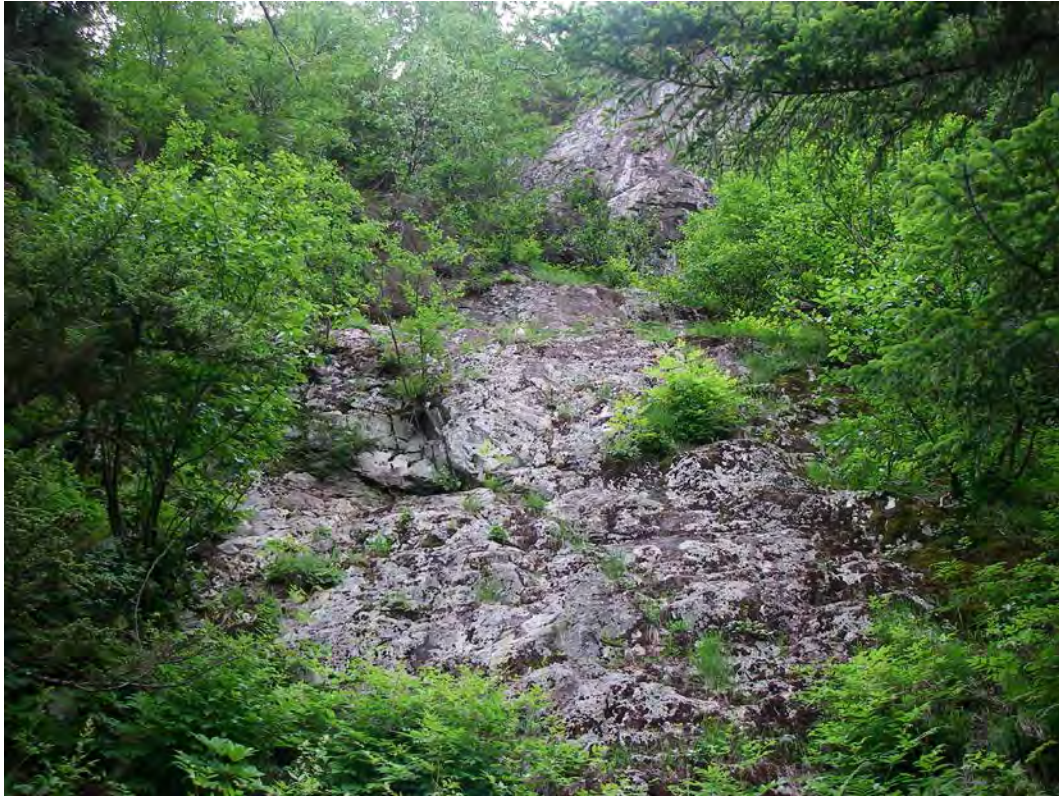
Hazard ID #:	RF01
Hazard Type:	rockfall
HIN:	147
Rating:	C
2012 SEIS Alignment Location:	1550
Frequency (yrs):	1-5
Predictability:	unpredictable
Material Volume (CY):	<10
Clast Size (ft):	3-4
Source Elev. (ft):	100-500
Centerline Slope:	open_soil_slope
Alignment Location:	below_deposition_zone
Impact Alignment:	no
Alignment Exposure (ft):	200-500
Vegetation:	disturbed
Deciduous Trees:	yes
2012 SEIS Alignment South Margin:	1548+00
2012 SEIS Alignment North Margin:	1553+00
Photo #:	4212, 4214, 5148

RF01. Basalt cliff that is the origin of rockfall hazard.

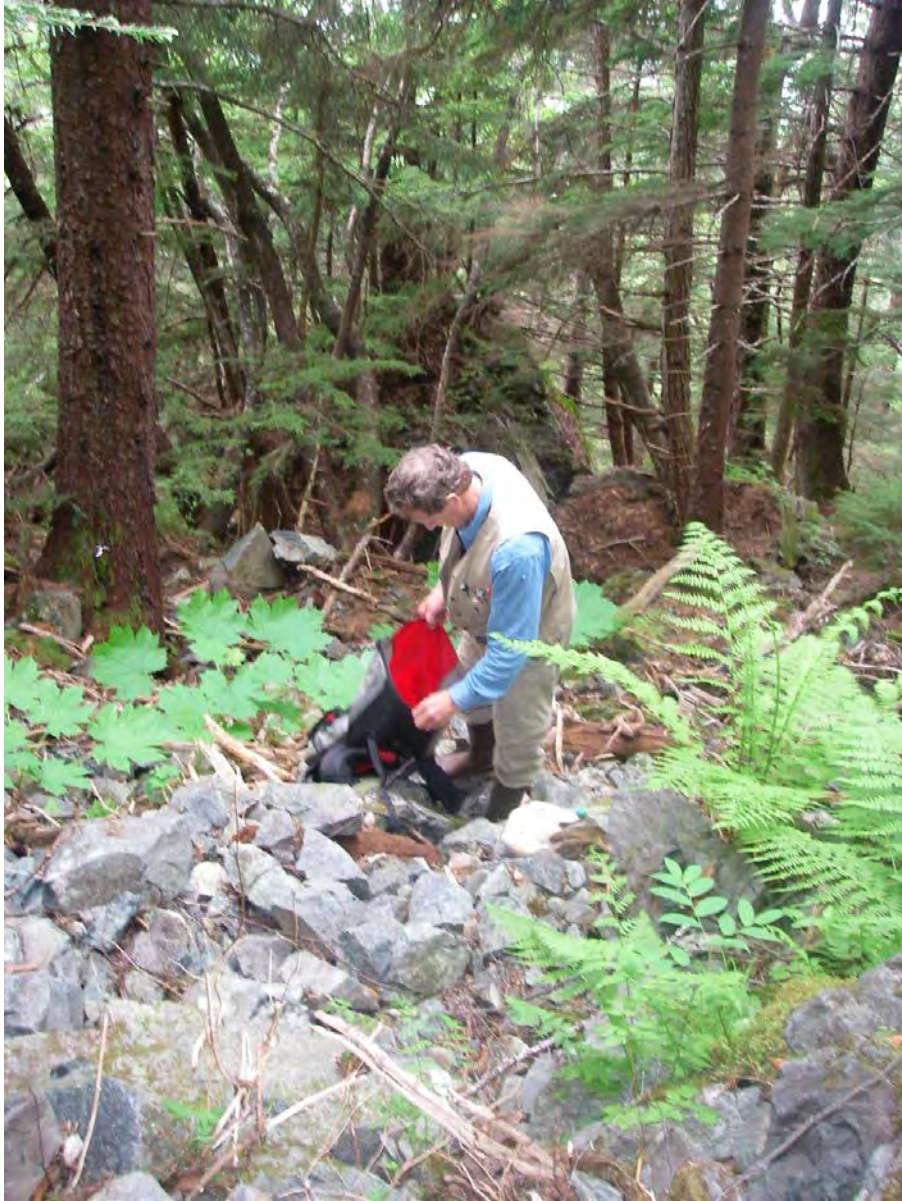
Hazard ID #:	RF02
Hazard Type:	rockfall
HIN:	111
Rating:	C
2012 SEIS Alignment Location:	1550
Frequency (yrs):	5-25
Predictability:	unpredictable
Material Volume (CY):	<10
Clast Size (ft):	0-1
Source Elev. (ft):	100-500
Centerline Slope:	open_soil_slope
Alignment Location:	below_deposition_zone
Impact Alignment:	no
Alignment Exposure (ft):	50-200
Vegetation:	disturbed
Deciduous Trees:	yes
2012 SEIS Alignment South Margin:	1547+40
2012 SEIS Alignment North Margin:	1552+70
Photo #:	3049, 5149

RF02. View west/downslope at rockfall deposition.

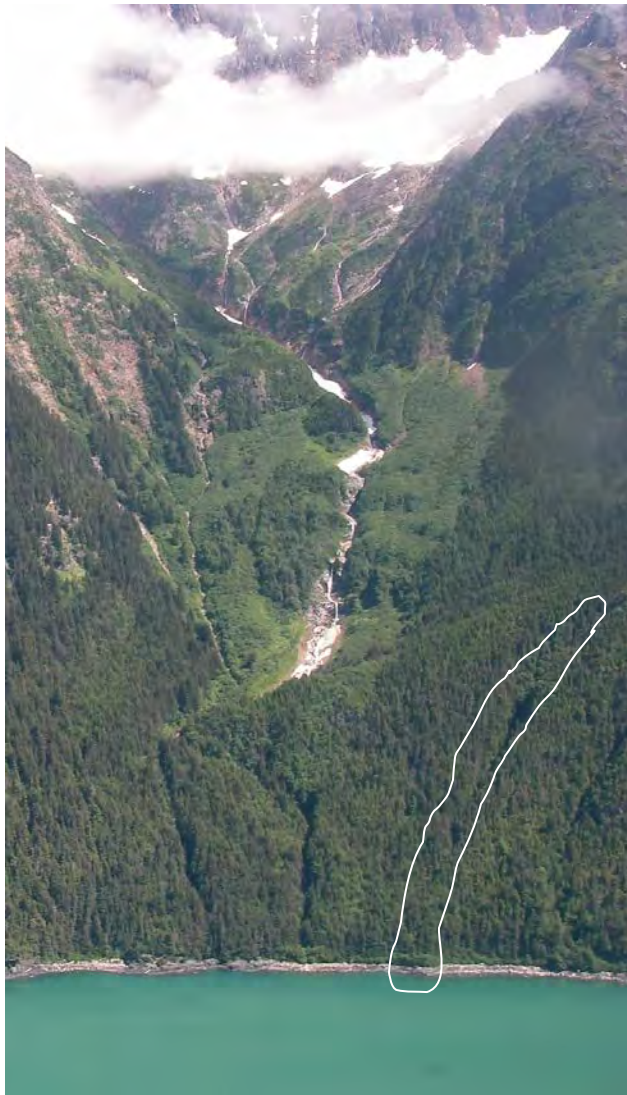
DF04. View east/upslope at debris flow channel, incision visible as gully.

Hazard ID #:	DF04
Hazard Type:	debris_flow
HIN:	117
Rating:	B
2012 SEIS Alignment Location:	1670
Frequency (yrs):	5-25
Predictability:	moderate
Material Volume (CY):	10-100
Clast Size (ft):	0-1
Source Elev. (ft):	1000-2000
Centerline Slope:	fan
Alignment Location:	deposition_zone
Impact Alignment:	yes
Alignment Exposure (ft):	50-200
Vegetation:	disturbed
Deciduous Trees:	yes
2012 SEIS Alignment South Margin:	1669+40
2012 SEIS Alignment North Margin:	1671+10
Photo #:	3875

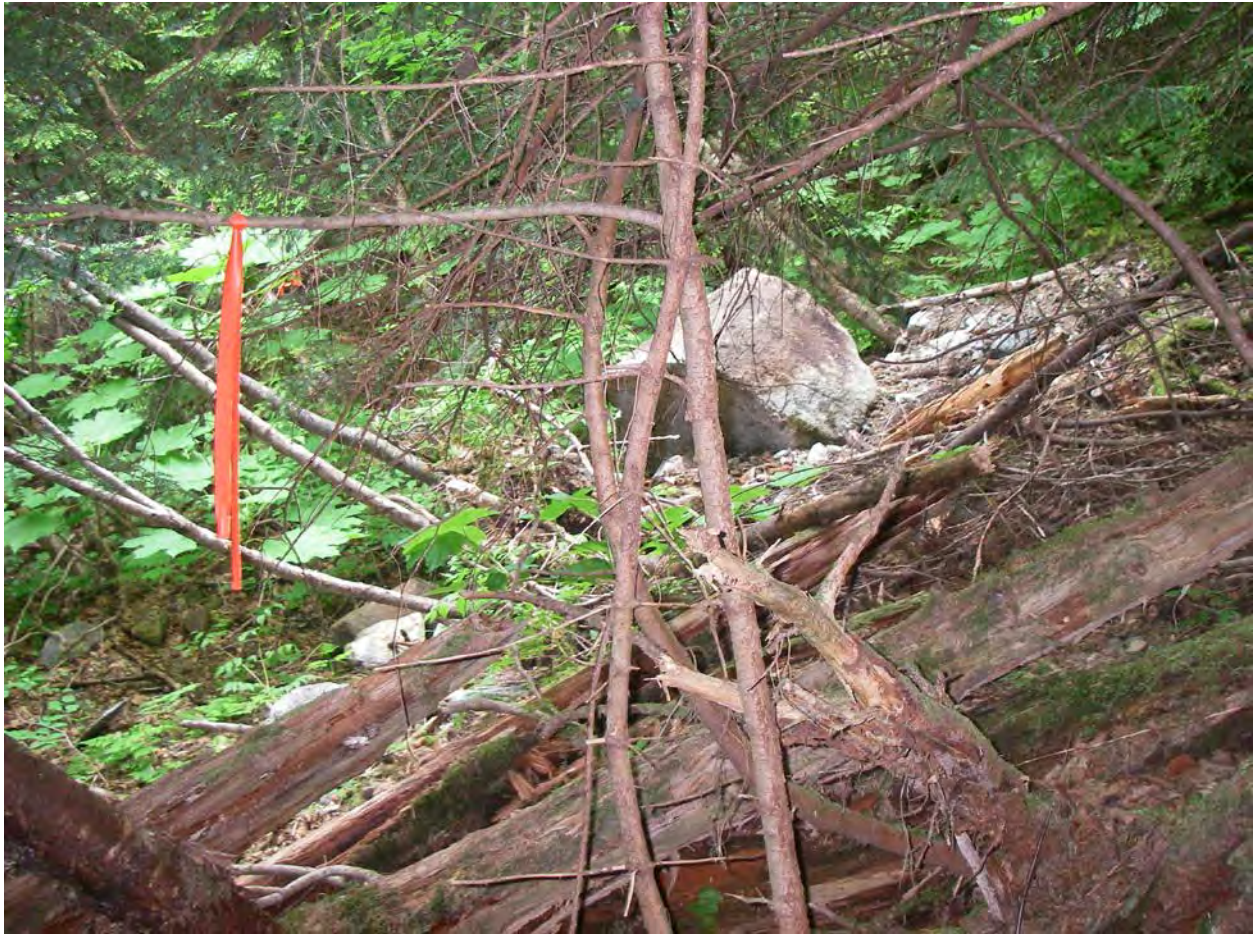
DF04. Debris flow deposit.

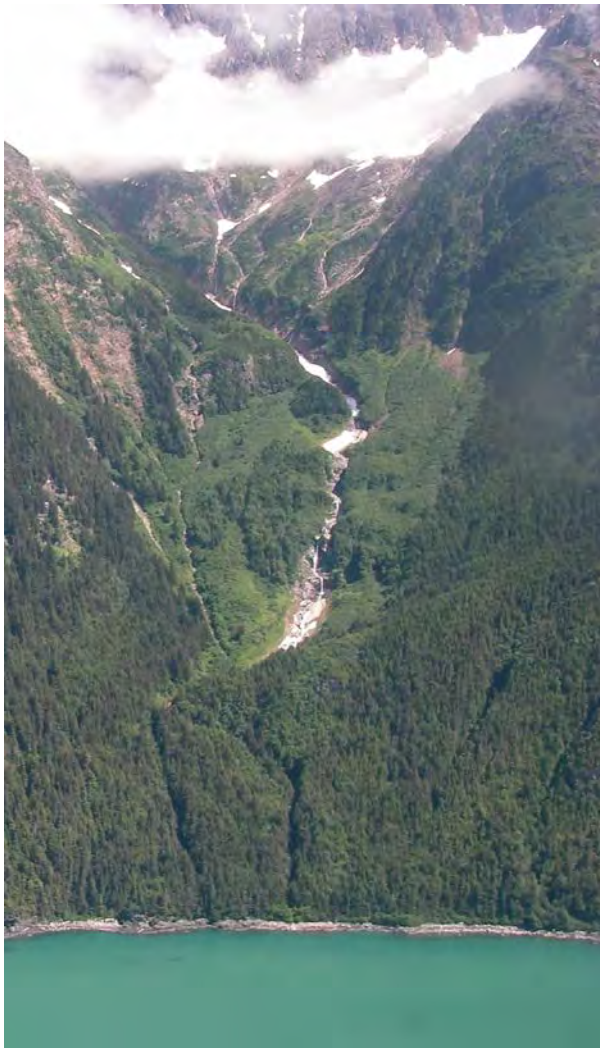
DF05. Debris flow channel visible as incised gully through trees in lower part of photo, left of center.

Hazard ID #:	DF05
Hazard Type:	debris_flow
HIN:	129
Rating:	A
2012 SEIS Alignment Location:	1675
Frequency (yrs):	1-5
Predictability:	high
Material Volume (CY):	10-100
Clast Size (ft):	0-1
Source Elev. (ft):	1000-2000
Centerline Slope:	single_channel
Alignment Location:	deposition_zone
Impact Alignment:	yes
Alignment Exposure (ft):	50-200
Vegetation:	denuded
Deciduous Trees:	no
2012 SEIS Alignment South Margin:	1674+20
2012 SEIS Alignment North Margin:	1675+40
Photo #:	6203, 6204

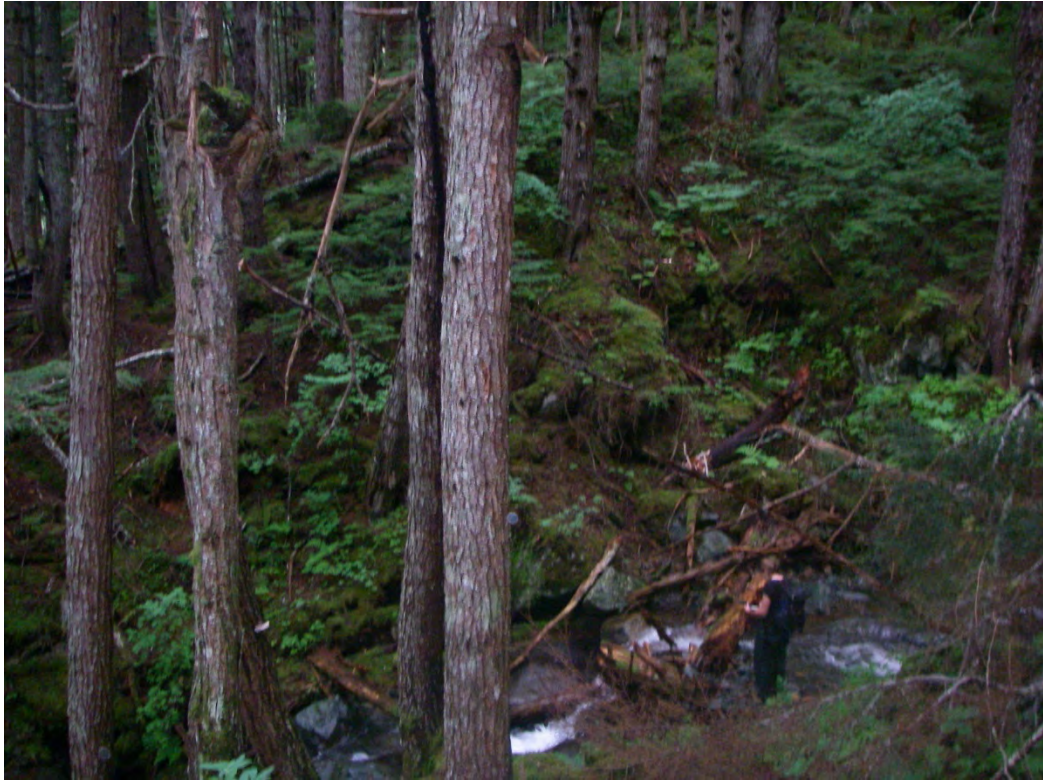
DF05. View north/up alignment along debris flow incision and levee.

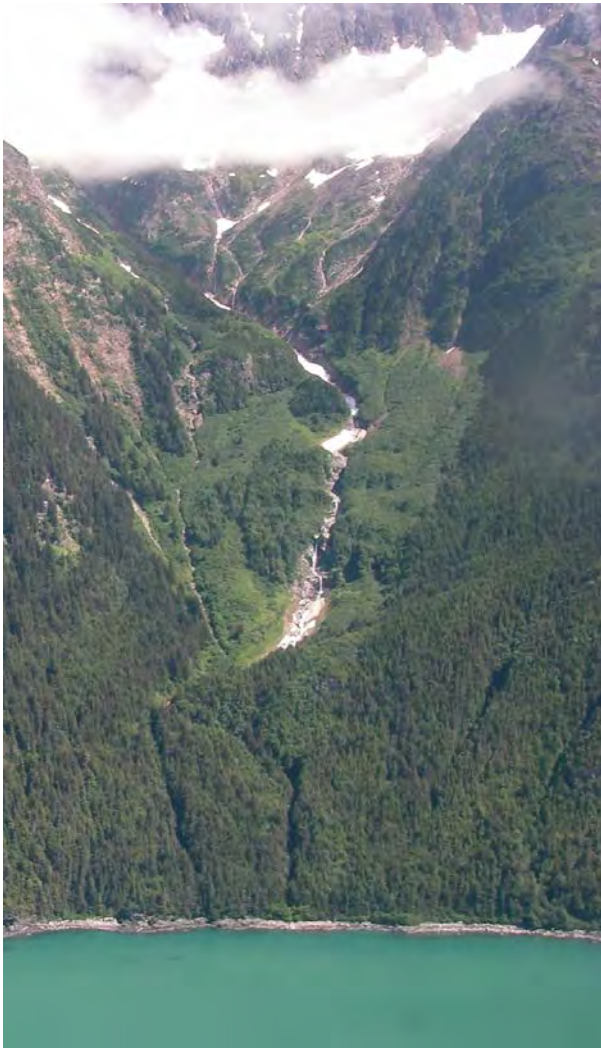
DF06. View east/upslope at debris flow channel and avalanche path.

Hazard ID #:	DF06
Hazard Type:	debris_flow
HIN:	183
Rating:	A
2012 SEIS Alignment Location:	1678
Frequency (yrs):	0-1
Predictability:	high
Material Volume (CY):	10-100
Clast Size (ft):	0-1
Source Elev. (ft):	2000-3000
Centerline Slope:	fan
Alignment Location:	deposition_zone
Impact Alignment:	yes
Alignment Exposure (ft):	50-200
Vegetation:	disturbed
Deciduous Trees:	yes
2012 SEIS Alignment South Margin:	1677+60
2012 SEIS Alignment North Margin:	1678+80
Photo #:	3876

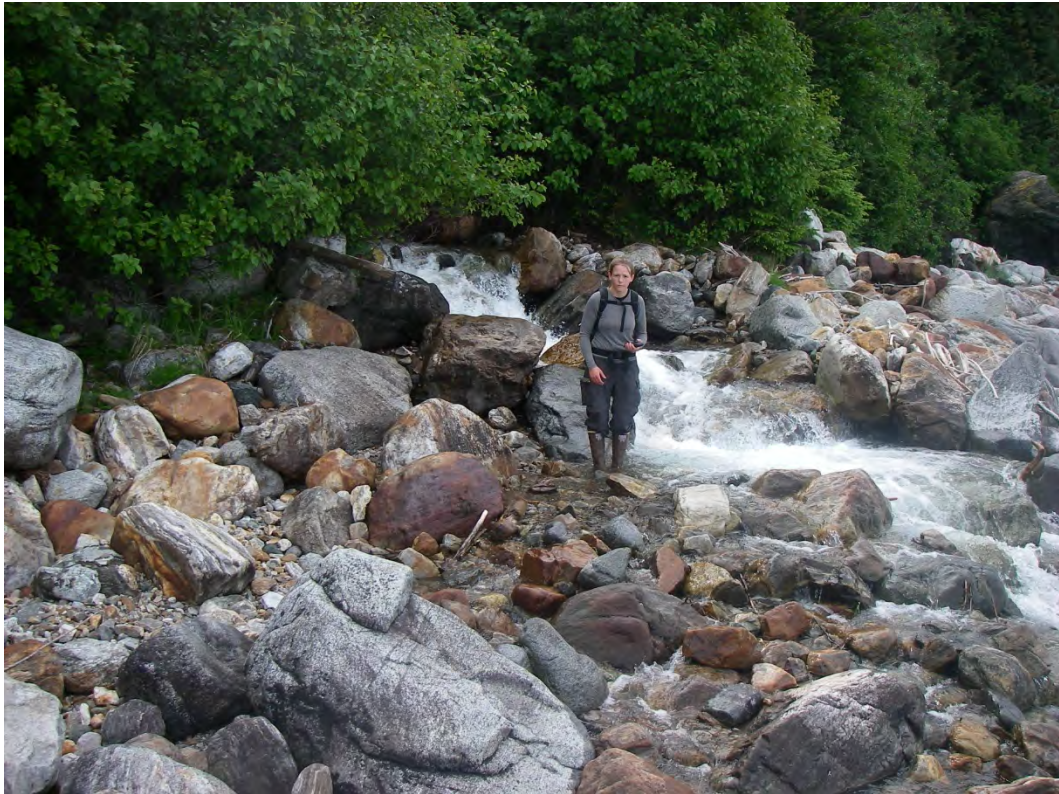
DF06. View southeast (upslope and down alignment) across debris flow deposition zone at tide line.

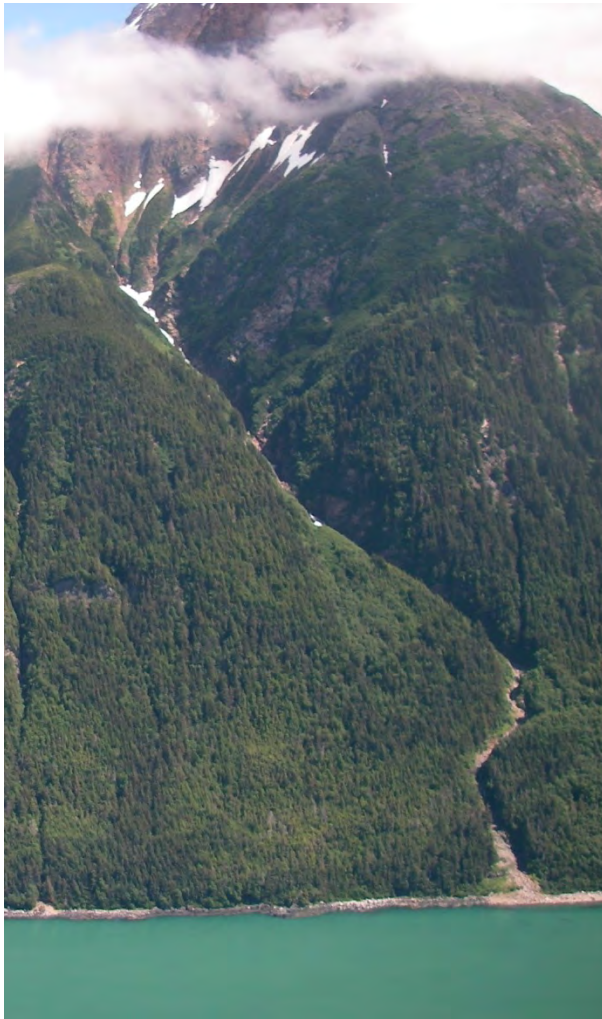
DF07. View east/upslope of debris flow channel and avalanche path.

Hazard ID #:	DF07
Hazard Type:	debris_flow
HIN:	153
Rating:	A
2012 SEIS Alignment Location:	1704
Frequency (yrs):	1-5
Predictability:	moderate
Material Volume (CY):	100-1000
Clast Size (ft):	1-2
Source Elev. (ft):	>1000
Centerline Slope:	multi_channel
Alignment Location:	deposition_zone
Impact Alignment:	yes
Alignment Exposure (ft):	50-200
Vegetation:	denuded
Deciduous Trees:	yes
2012 SEIS Alignment South Margin:	1703+30
2012 SEIS Alignment North Margin:	1704+40
Photo #:	4366, 5155

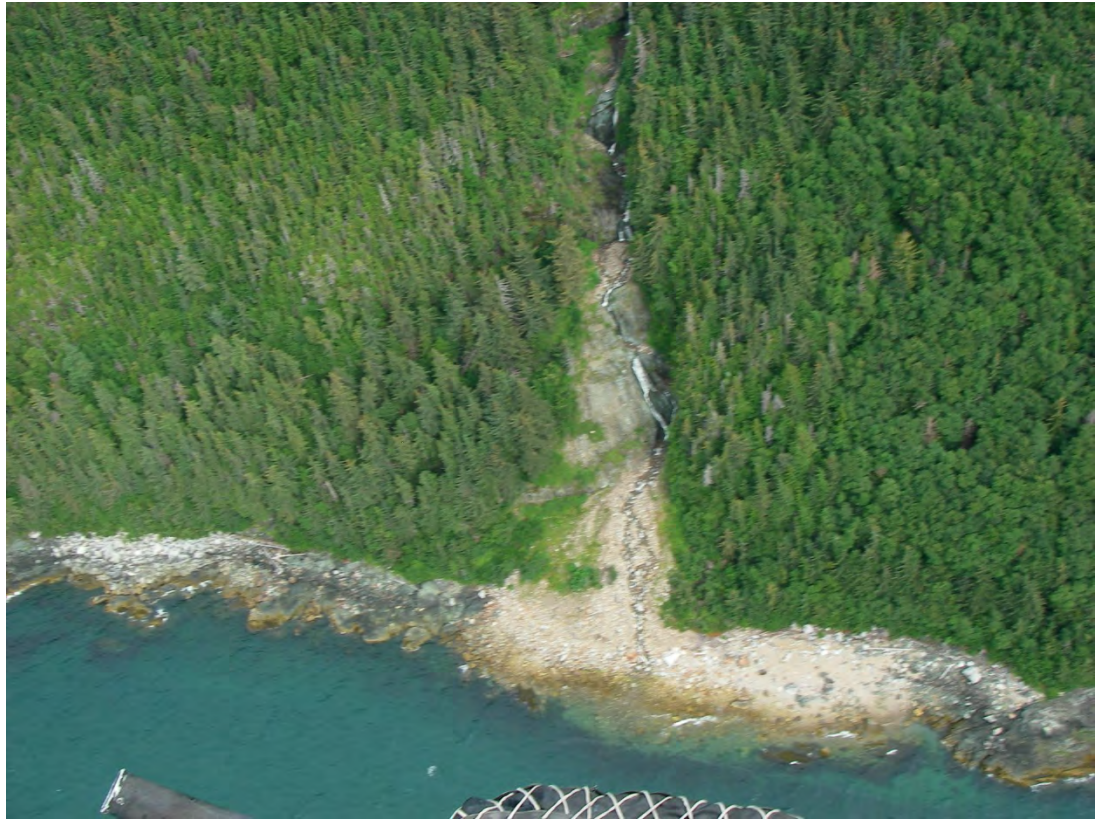
DF07. Path and terminus of debris flow channel.

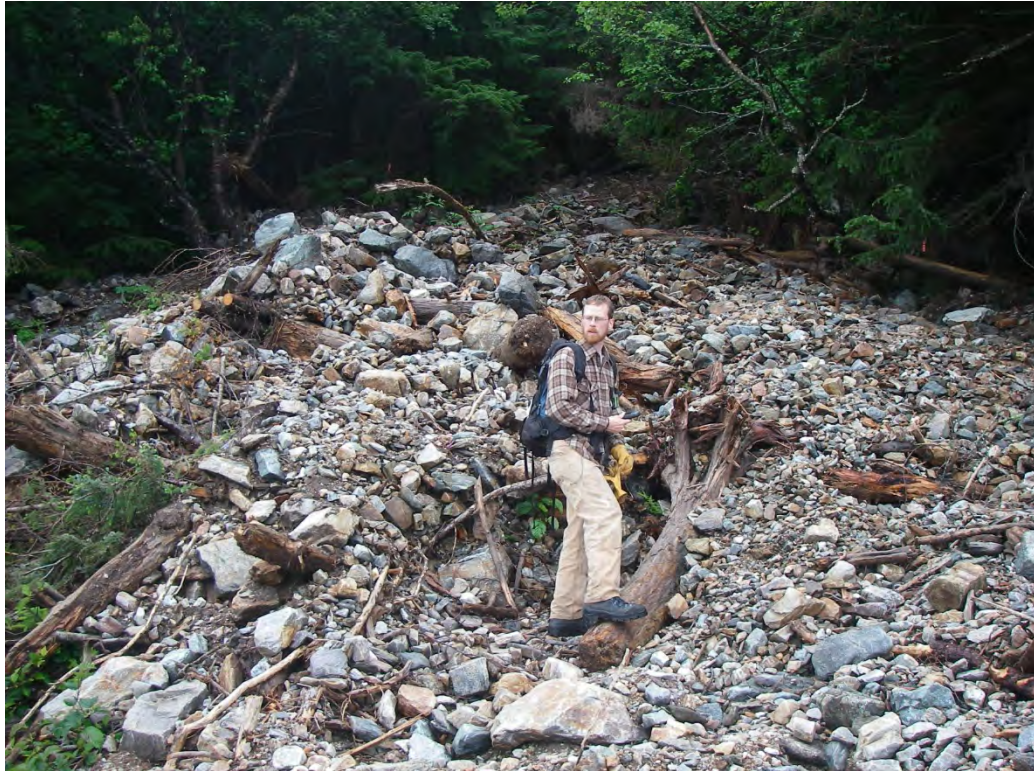
Hazard ID #:	DF08
Hazard Type:	debris_flow
HIN:	129
Rating:	A
2012 SEIS Alignment Location:	1721
Frequency (yrs):	1-5
Predictability:	high
Material Volume (CY):	10-100
Clast Size (ft):	1-2
Source Elev. (ft):	>1000
Centerline Slope:	fan
Alignment Location:	deposition_zone
Impact Alignment:	yes
Alignment Exposure (ft):	50-200
Vegetation:	denuded
Deciduous Trees:	yes
2012 SEIS Alignment South Margin:	1720+30
2012 SEIS Alignment North Margin:	1721+30
Photo #:	1126, 5156

DF08. Debris flow deposition fan and avalanche path.

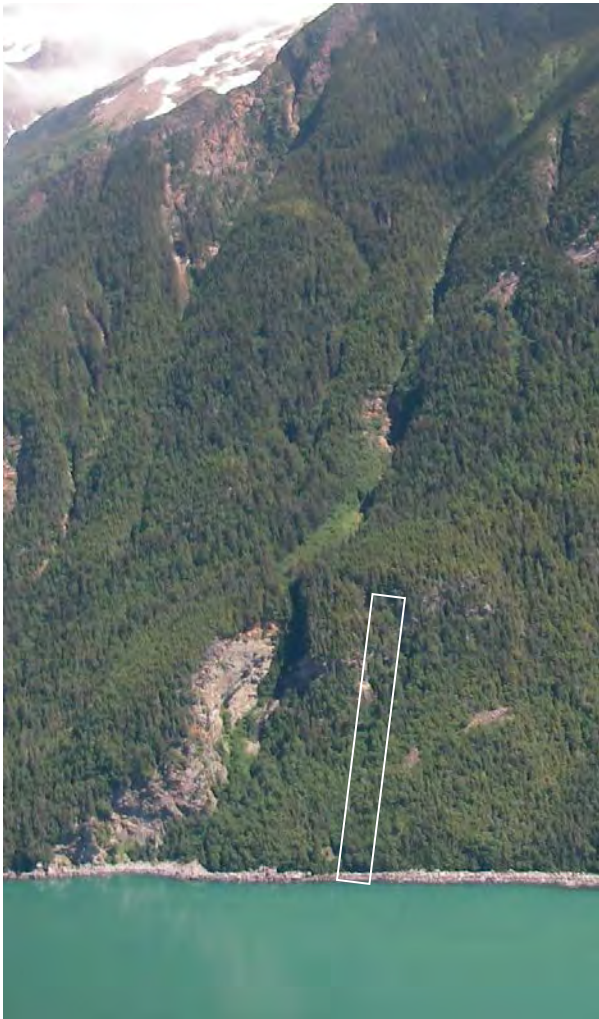
RF06. View east/upslope at rockfall area.

Hazard ID #:	RF06
Hazard Type:	rockfall
HIN:	201
Rating:	A
2012 SEIS Alignment Location:	1731
Frequency (yrs):	0-1
Predictability:	unpredictable
Material Volume (CY):	<10
Clast Size (ft):	3-4
Source Elev. (ft):	500-1000
Centerline Slope:	open_bedrock_slope
Alignment Location:	deposition_zone
Impact Alignment:	yes
Alignment Exposure (ft):	50-200
Vegetation:	disturbed
Deciduous Trees:	yes
2012 SEIS Alignment South Margin:	1730+20
2012 SEIS Alignment North Margin:	1731+10
Photo #:	4674, 6206

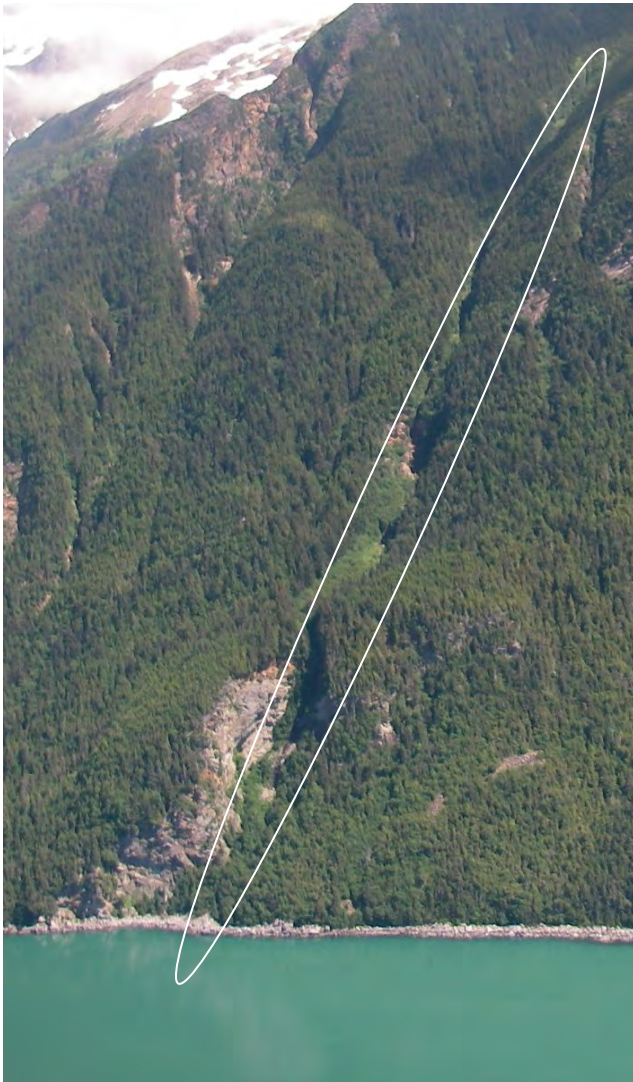
DF09. View east/upslope at debris flow channel and avalanche path.

Hazard ID #:	DF09
Hazard Type:	debris_flow
HIN:	153
Rating:	A
2012 SEIS Alignment Location:	1734
Frequency (yrs):	unknown (1-5?)
Predictability:	low
Material Volume (CY):	10-100
Clast Size (ft):	1-2
Source Elev. (ft):	>1000
Centerline Slope:	single_channel
Alignment Location:	path
Impact Alignment:	yes
Alignment Exposure (ft):	50-200
Vegetation:	disturbed
Deciduous Trees:	yes
2012 SEIS Alignment South Margin:	1732+90
2012 SEIS Alignment North Margin:	1734+90
Photo #:	3307

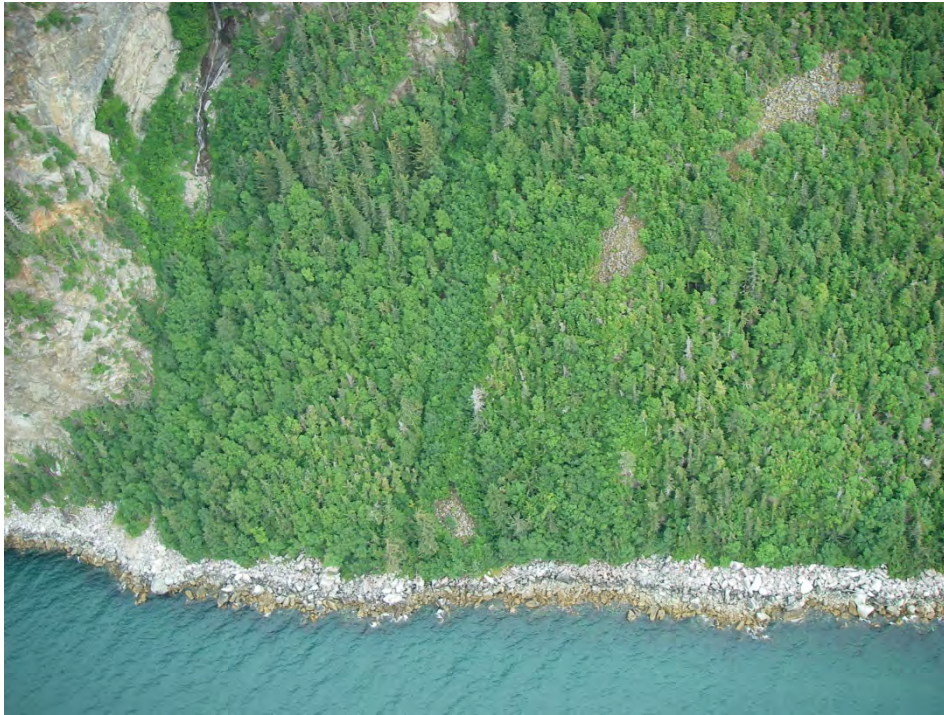
DF09. View east/upslope at debris flow path and avalanche path through dense deciduous trees.

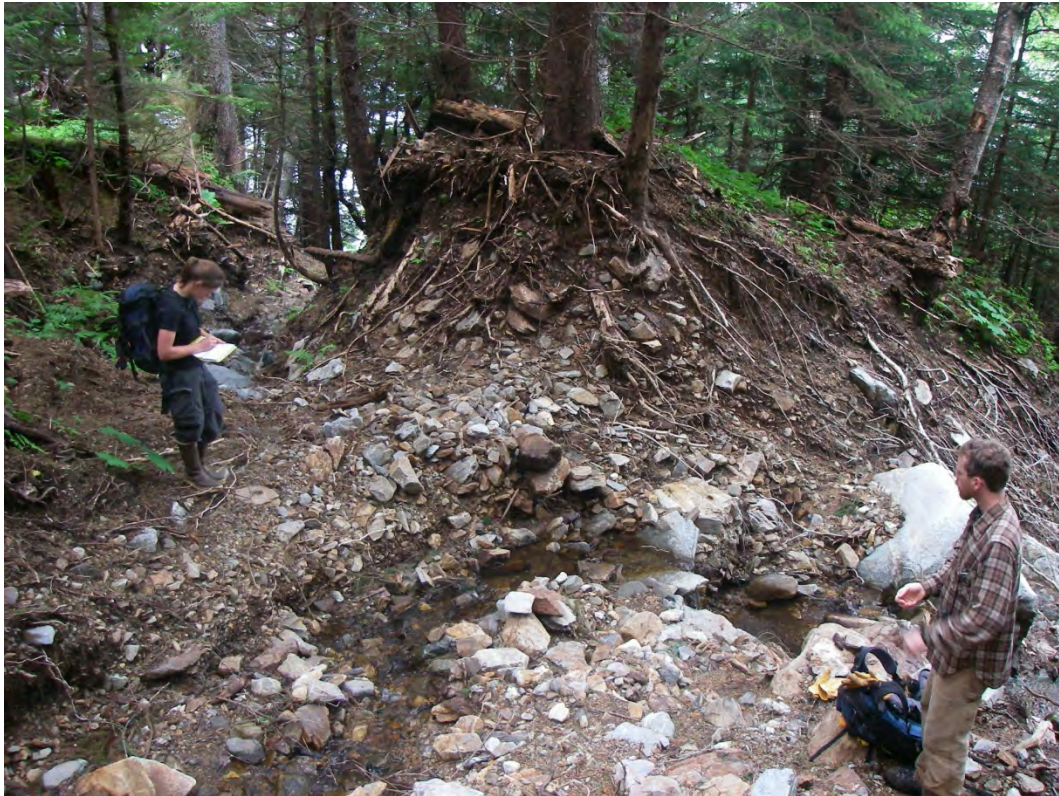
Hazard ID #:	DF10
Hazard Type:	debris_flow
HIN:	129
Rating:	A
2012 SEIS Alignment Location:	1743
Frequency (yrs):	1-5
Predictability:	high
Material Volume (CY):	10-100
Clast Size (ft):	0-1
Source Elev. (ft):	>1000
Centerline Slope:	multi_channel
Alignment Location:	path
Impact Alignment:	yes
Alignment Exposure (ft):	50-200
Vegetation:	denuded
Deciduous Trees:	no
2012 SEIS Alignment South Margin:	1742+80
2012 SEIS Alignment North Margin:	1743+90
Photo #:	4745-4748

DF10. View southwest (downslope and down alignment) at multichannel debris flow deposits.

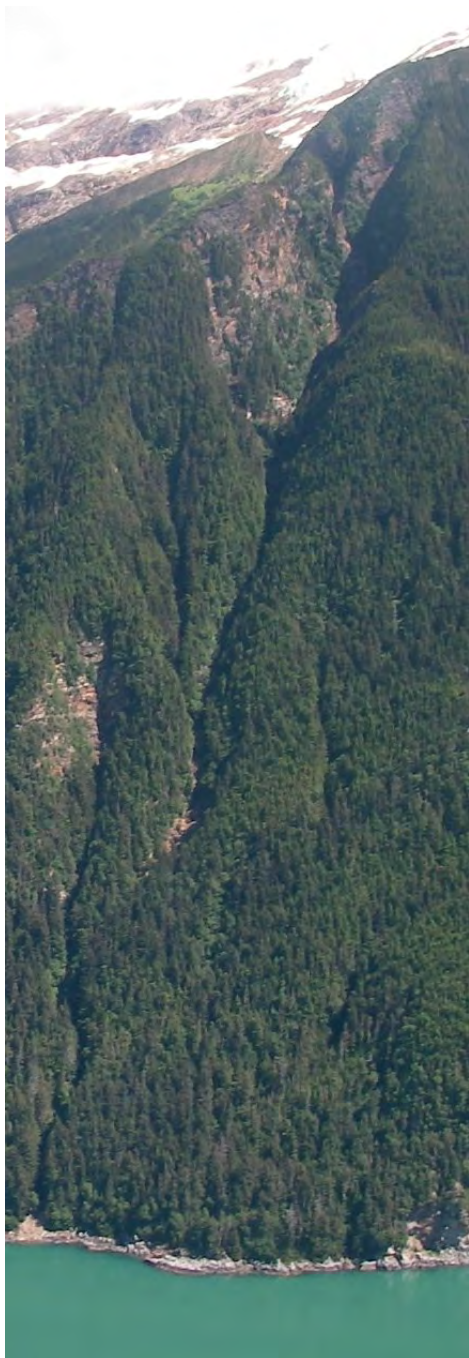
DF11. View east/upslope at debris flow channel and avalanche path.

Hazard ID #:	DF11
Hazard Type:	debris_flow
HIN:	129
Rating:	A
2012 SEIS Alignment Location:	1748
Frequency (yrs):	1-5
Predictability:	high
Material Volume (CY):	10-100
Clast Size (ft):	2-3
Source Elev. (ft):	>1000
Centerline Slope:	fan
Alignment Location:	deposition_zone
Impact Alignment:	yes
Alignment Exposure (ft):	50-200
Vegetation:	denuded
Deciduous Trees:	yes
2012 SEIS Alignment South Margin:	1747+40
2012 SEIS Alignment North Margin:	1748+50
Photo #:	4741, 4742, 5157

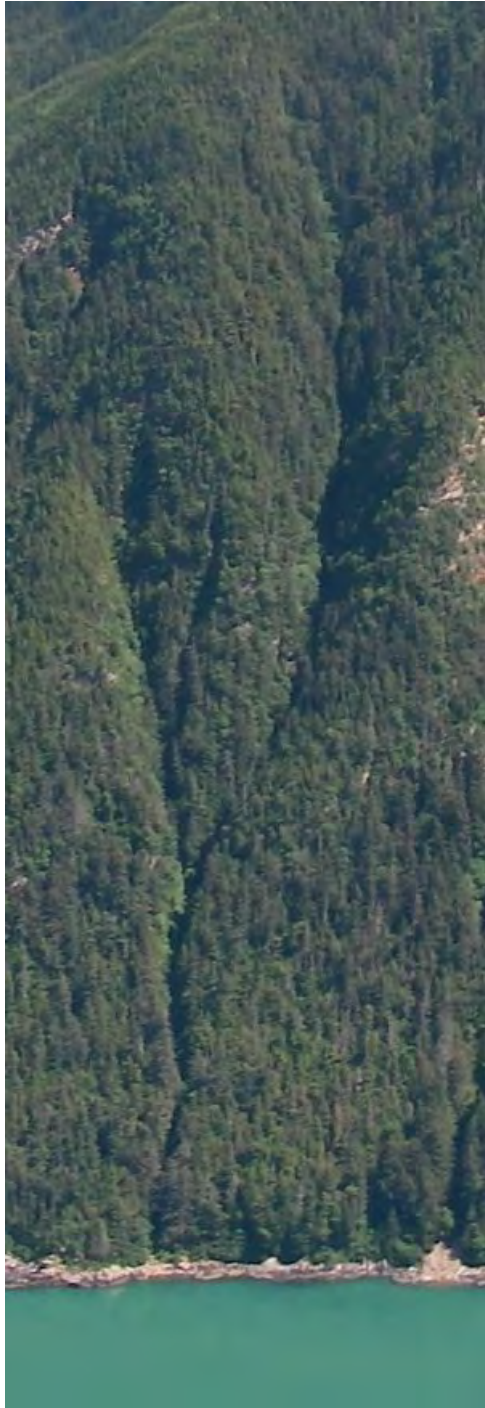
DF12. View east/upslope at debris flow channel and avalanche path.

Hazard ID #:	DF12
Hazard Type:	debris_flow
HIN:	111
Rating:	A
2012 SEIS Alignment Location:	1752
Frequency (yrs):	5-25
Predictability:	high
Material Volume (CY):	10-100
Clast Size (ft):	2-3
Source Elev. (ft):	>1000
Centerline Slope:	fan
Alignment Location:	deposition_zone
Impact Alignment:	yes
Alignment Exposure (ft):	50-200
Vegetation:	disturbed
Deciduous Trees:	yes
2012 SEIS Alignment South Margin:	1752+00
2012 SEIS Alignment North Margin:	1752+90
Photo #:	4738, 4739, 5157

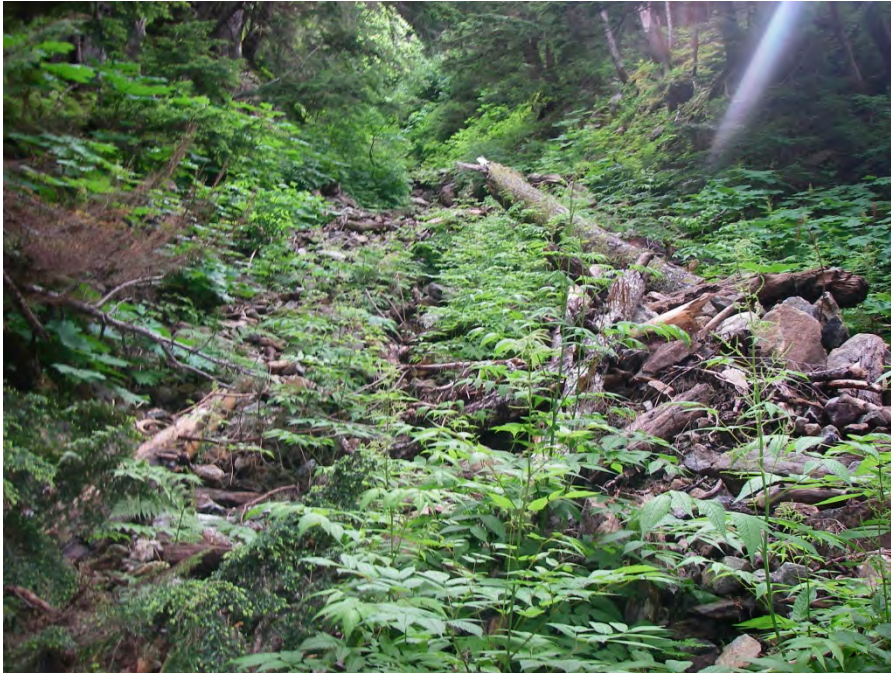
DF12. View east/upslope at debris flow channel and avalanche path.
