CADD	ECC	GEOLOGIC HAZARD SUMMARY ARRANGED BY 2012 SEIS STATIONING LYNN CANAL HIGHWAY PHASE 2 2012 SEIS ALIGNMENT HAZARD REVISIONS		
	DATE	9/10/12			
	CHECK	RGD			
	FILE No.	GEO_HAZ_SUMM.PPT			
PROJECT No.	113-95756	DATE	9/24/12	HDR / 2012 SEIS JUNEAU ACCESS / AK	G-2
		REV	1

TITLE
GEOLOGIC HAZARD SUMMARY
ARRANGED BY 2012 SEIS STATIONING
 LYNN CANAL HIGHWAY PHASE 2
 2012 SEIS ALIGNMENT HAZARD REVISIONS

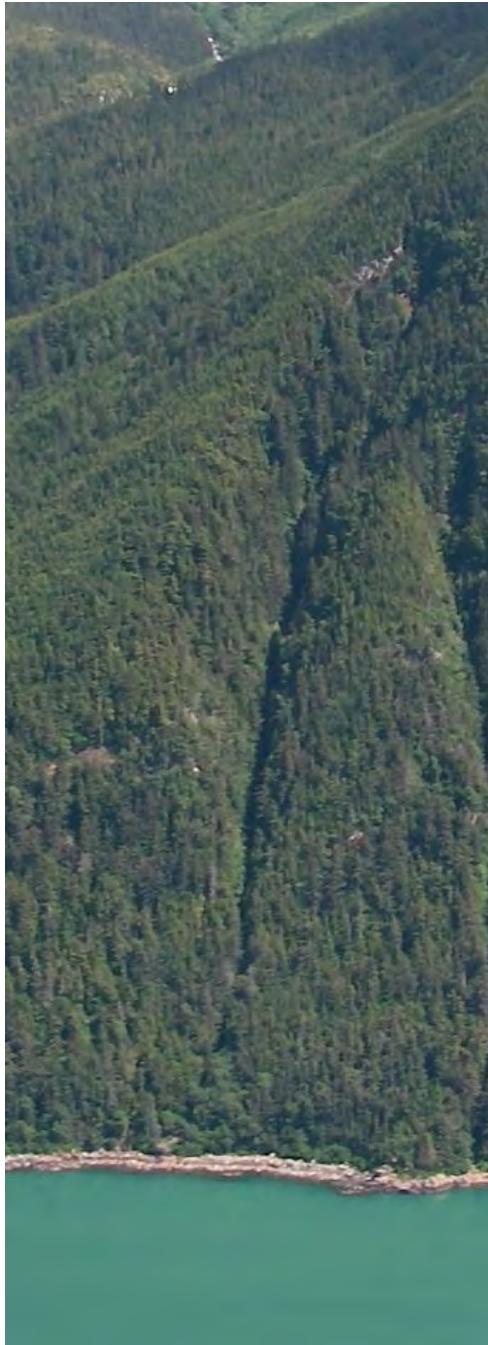
DF13. View east/upslope at debris flow channel and avalanche path.

Hazard ID #:	DF13
Hazard Type:	debris_flow
HIN:	129
Rating:	A
2012 SEIS Alignment Location:	1757
Frequency (yrs):	1-5
Predictability:	high
Material Volume (CY):	10-100
Clast Size (ft):	2-3
Source Elev. (ft):	>1000
Centerline Slope:	fan
Alignment Location:	deposition_zone
Impact Alignment:	yes
Alignment Exposure (ft):	50-200
Vegetation:	denuded
Deciduous Trees:	yes
2012 SEIS Alignment South Margin:	1757+00
2012 SEIS Alignment North Margin:	1757+90
Photo #:	4736, 4737, 5157

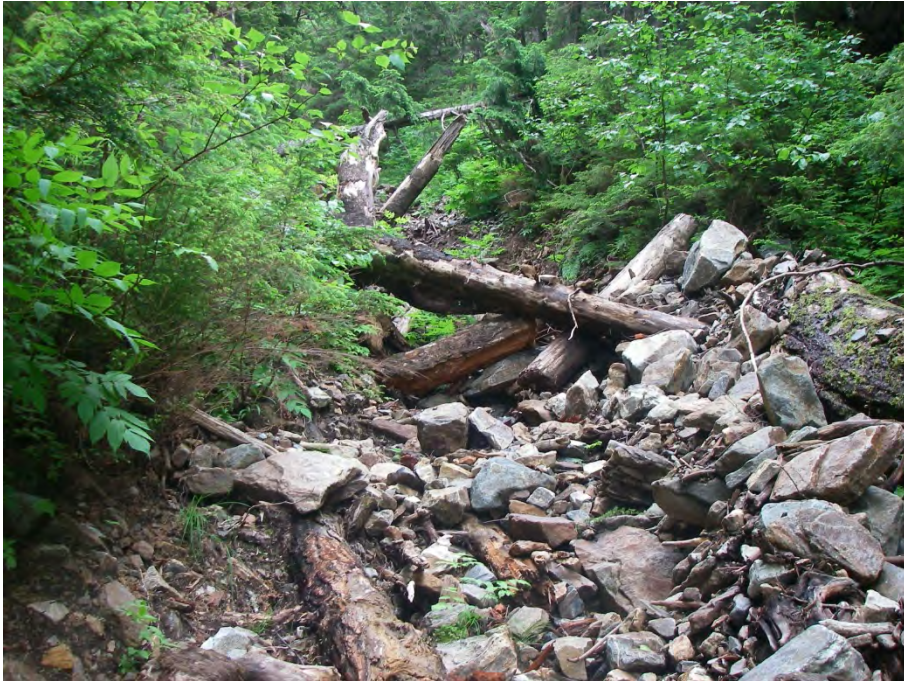
DF13. View east/upslope at debris flow channel and avalanche path.

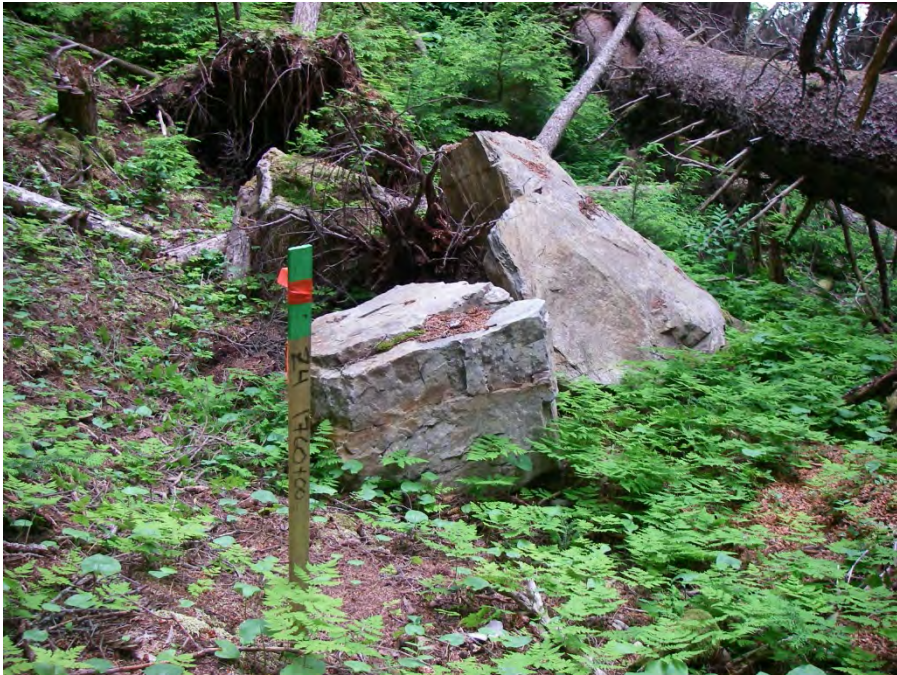
Hazard ID #:	RF08
Hazard Type:	rockfall
HIN:	183
Rating:	A
2012 SEIS Alignment Location:	1763
Frequency (yrs):	5-25
Predictability:	unpredictable
Material Volume (CY):	<10
Clast Size (ft):	4+
Source Elev. (ft):	100-500
Centerline Slope:	open_soil_slope
Alignment Location:	deposition_zone
Impact Alignment:	yes
Alignment Exposure (ft):	500+
Vegetation:	disturbed
Deciduous Trees:	no
2012 SEIS Alignment South Margin:	1760+10
2012 SEIS Alignment North Margin:	1767+60
Photo #:	5039, 5040, 5041, 5157, 6209

RF08. View southwest (downslope and down alignment) at rockfall debris. Survey lath represent previous IRP 2006 alignment.

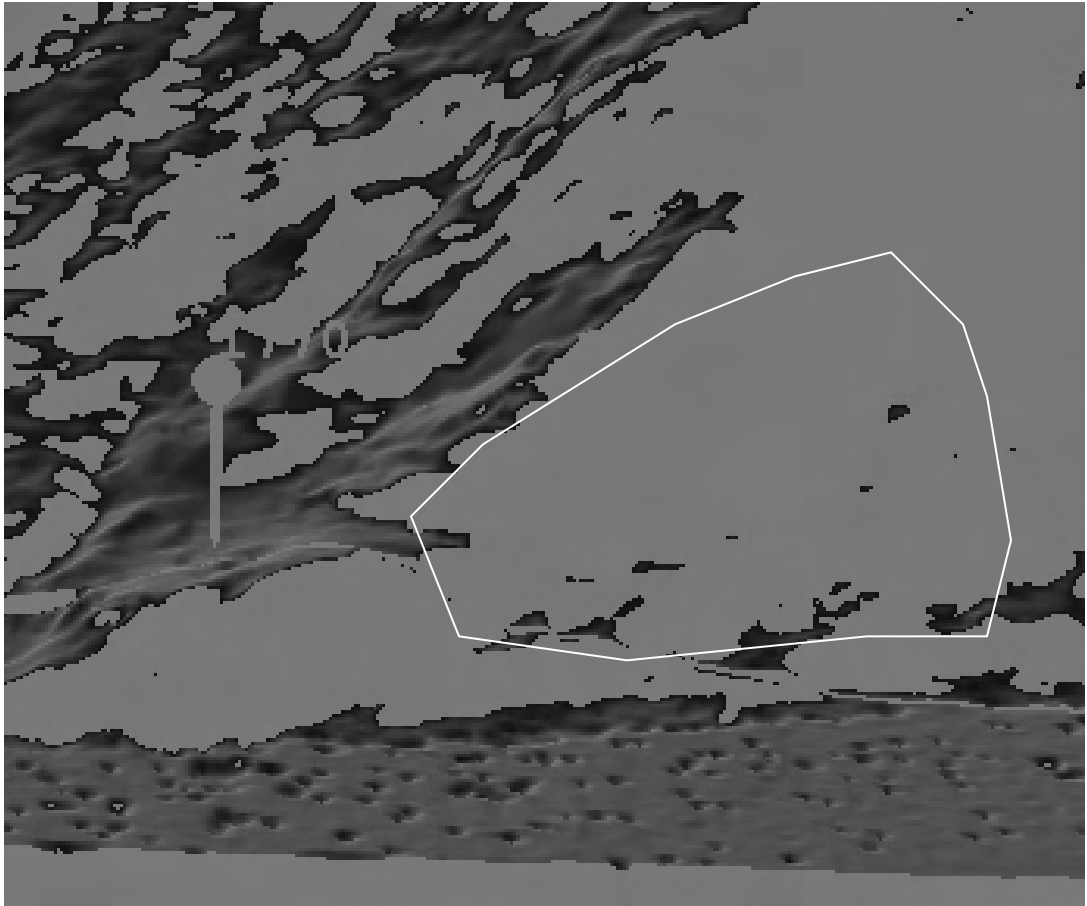
Hazard ID #:	RF09
Hazard Type:	rockfall
HIN:	129
Rating:	A
2012 SEIS Alignment Location:	1764
Frequency (yrs):	1-5
Predictability:	unpredictable
Material Volume (CY):	<10
Clast Size (ft):	2-3
Source Elev. (ft):	100-500
Centerline Slope:	open_soil_slope
Alignment Location:	deposition_zone
Impact Alignment:	yes
Alignment Exposure (ft):	50-200
Vegetation:	disturbed
Deciduous Trees:	yes
2012 SEIS Alignment South Margin:	1764+10
2012 SEIS Alignment North Margin:	1764+70
Photo #:	3878

RF09. Bare earth LIDAR image of rockfall hazard. Station label represents previous IRP 2006 alignment.

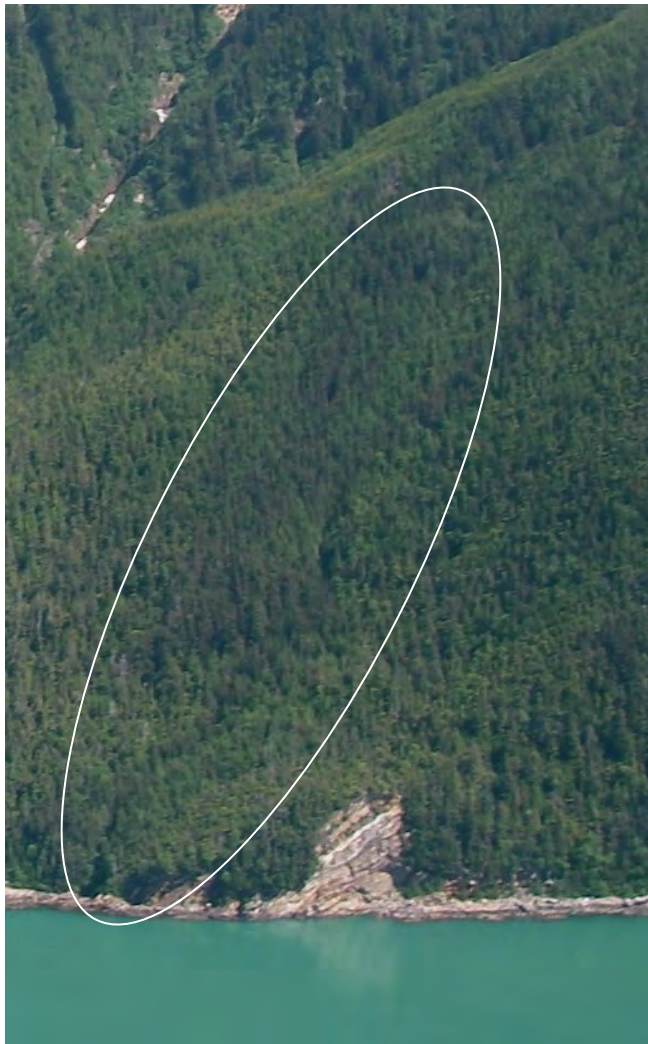
DF14. View east/upslope at debris flow channel.

Hazard ID #:	DF14
Hazard Type:	debris_flow
HIN:	111
Rating:	A
2012 SEIS Alignment Location:	1773
Frequency (yrs):	25+
Predictability:	moderate
Material Volume (CY):	10-100
Clast Size (ft):	2-3
Source Elev. (ft):	>1000
Centerline Slope:	single_channel
Alignment Location:	path
Impact Alignment:	yes
Alignment Exposure (ft):	50-200
Vegetation:	disturbed
Deciduous Trees:	no
2012 SEIS Alignment South Margin:	1772+40
2012 SEIS Alignment North Margin:	1773+20
Photo #:	2093, 4714

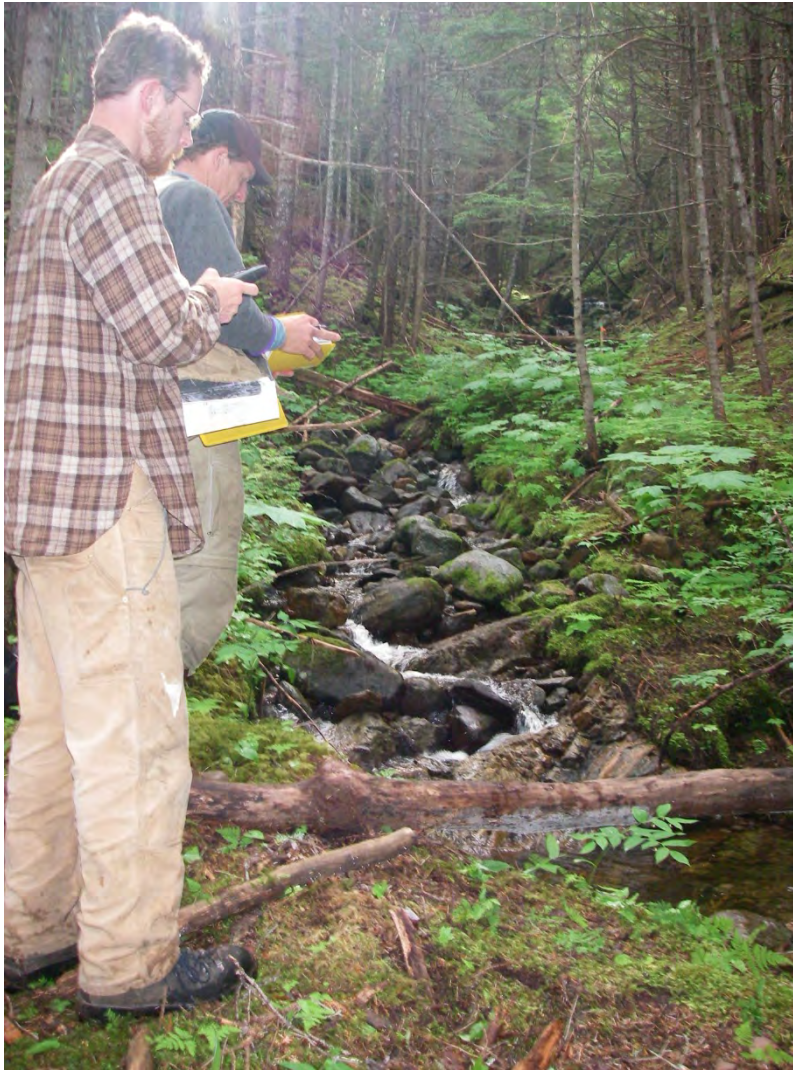
DF14. View east/upslope at debris flow channel. Old levee walls visible on far left and right sides of photo.

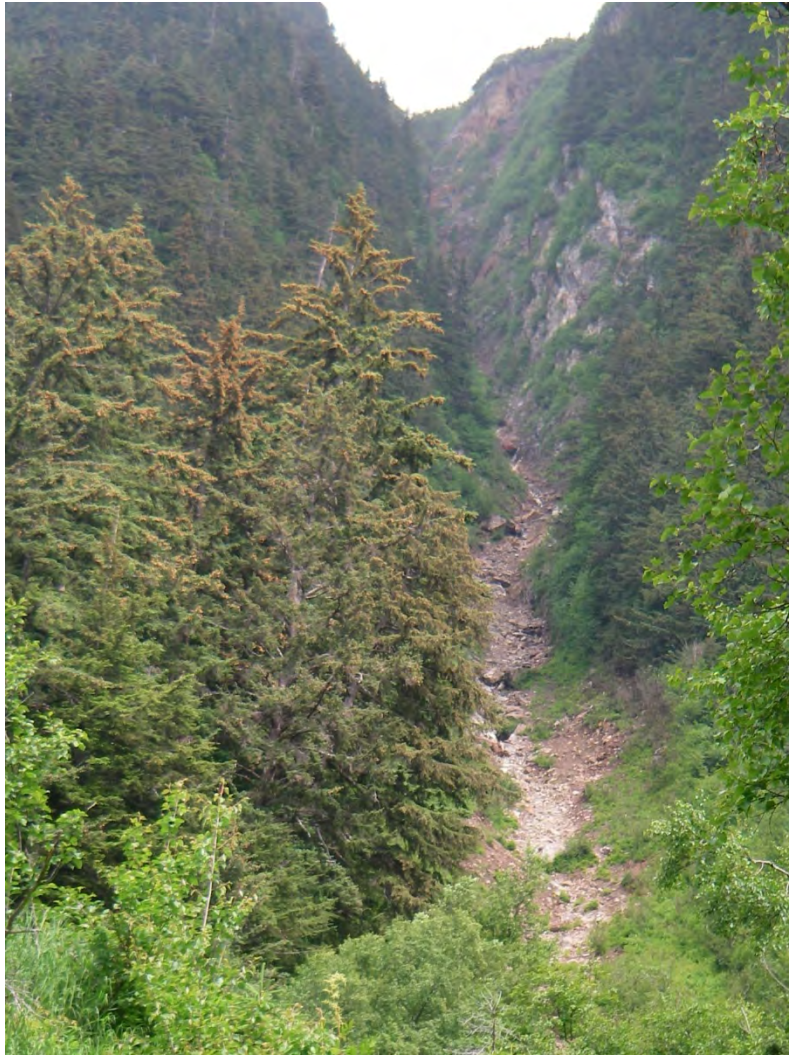
DF16. View east/upslope at tributary to debris flow channel and avalanche path.

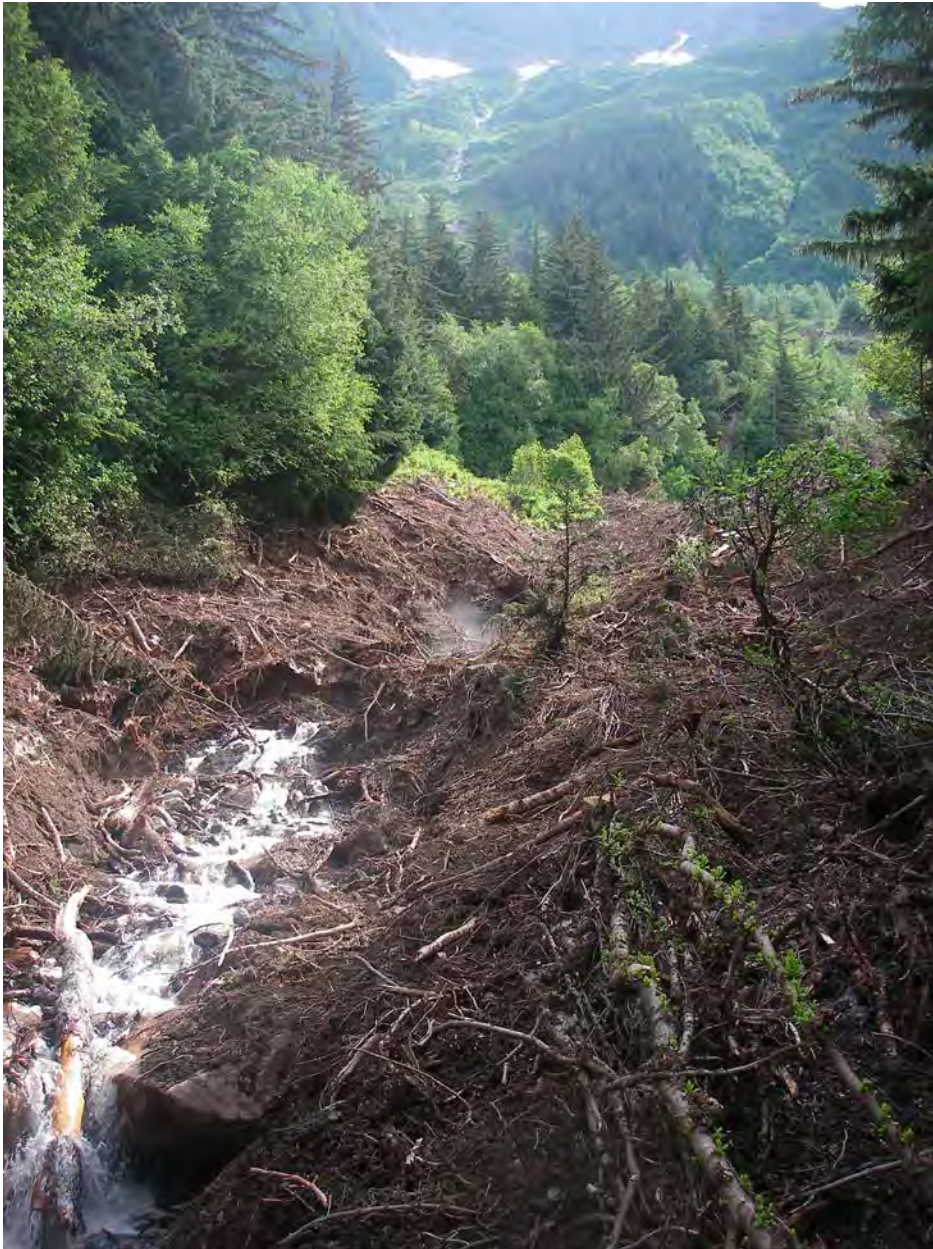
Hazard ID #:	DF18
Hazard Type:	debris_flow
HIN:	129
Rating:	A
2012 SEIS Alignment Location:	1828
Frequency (yrs):	1-5
Predictability:	high
Material Volume (CY):	10-100
Clast Size (ft):	0-1
Source Elev. (ft):	2000-3000
Centerline Slope:	fan
Alignment Location:	deposition_zone
Impact Alignment:	yes
Alignment Exposure (ft):	50-200
Vegetation:	disturbed
Deciduous Trees:	yes
2012 SEIS Alignment South Margin:	1827+00
2012 SEIS Alignment North Margin:	1829+00
Photo #:	1186, 4012, 4015, 5159, 6232

DF18. View east/upslope at debris flow and avalanche path.

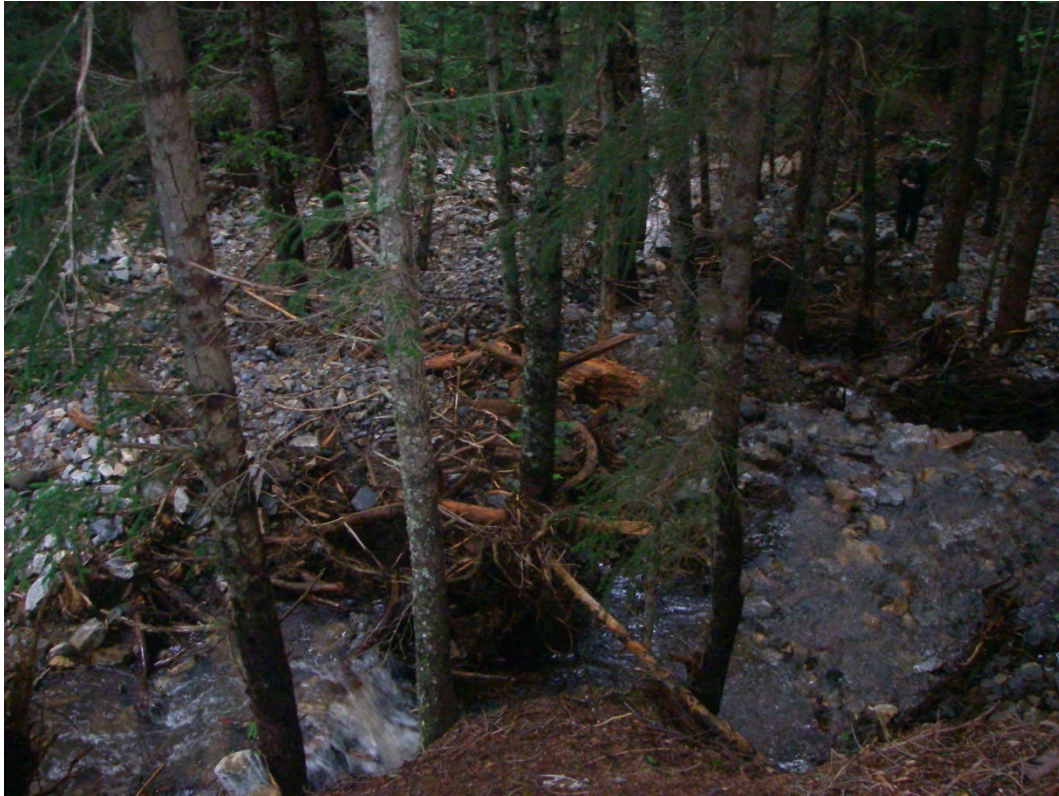
DF18. View southwest (downslope and down alignment) down a major creek, debris flow fan, and recent deposits that buried small conifer trees. Fan continues across alignment.

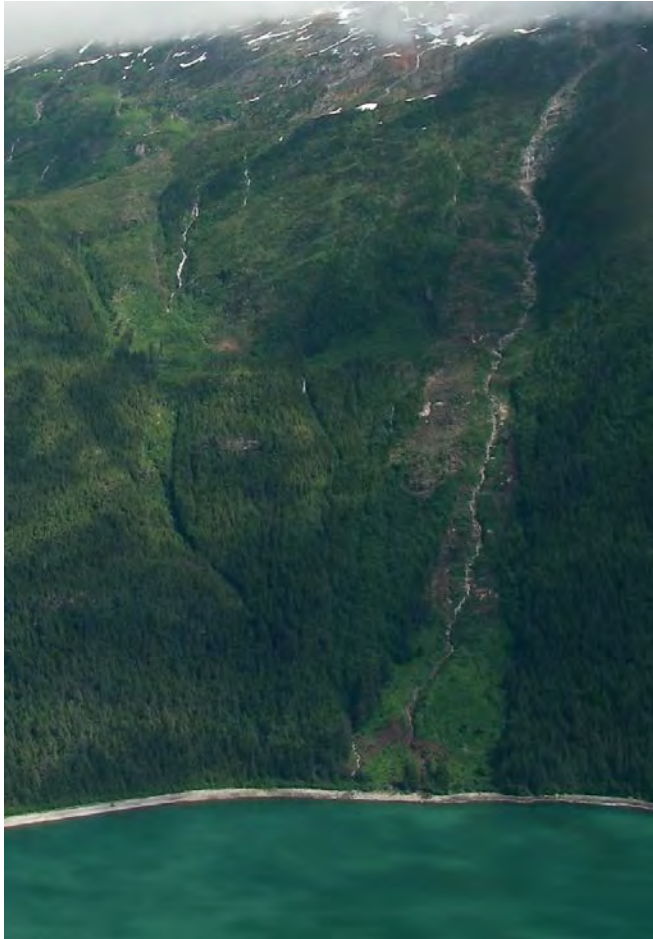
DF19. View east/upslope at debris flow channel and avalanche path.

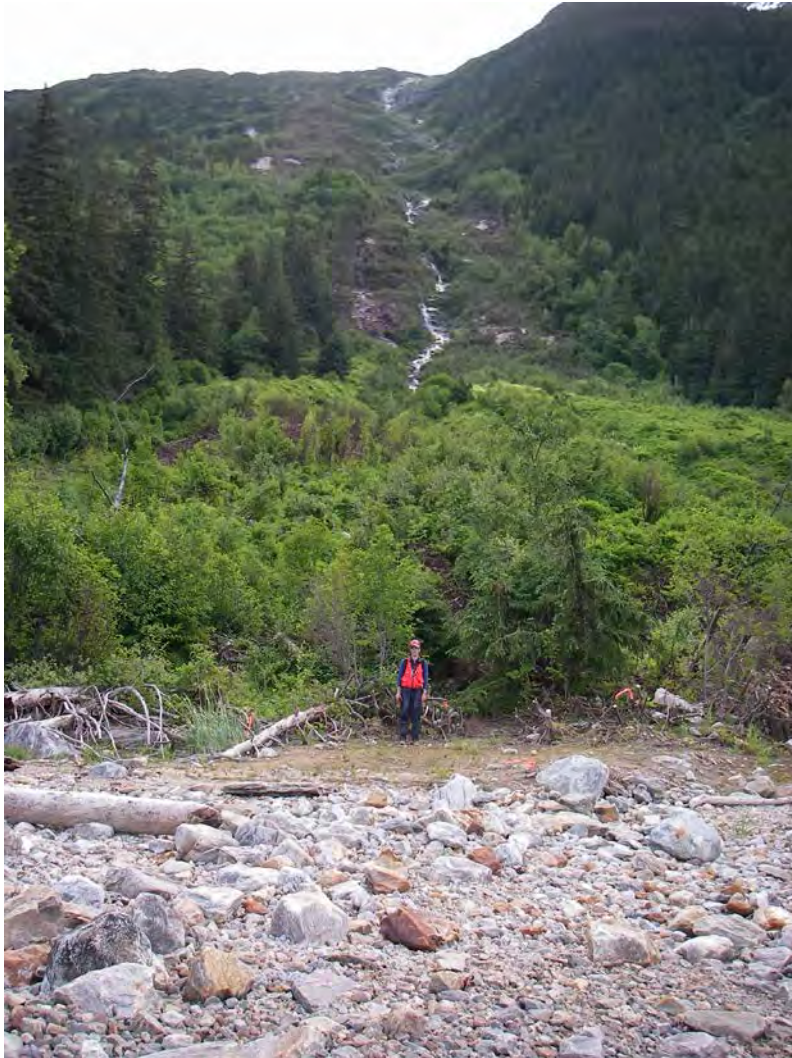
DF19. View east/upslope from beach at debris flow and avalanche path.

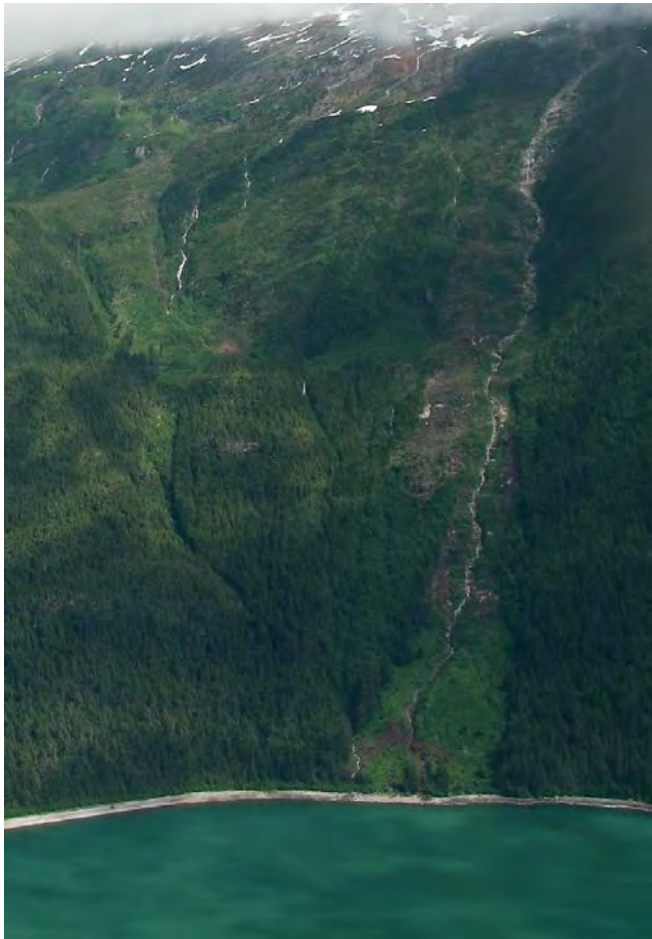
DF20. View east/upslope at debris flow channel.

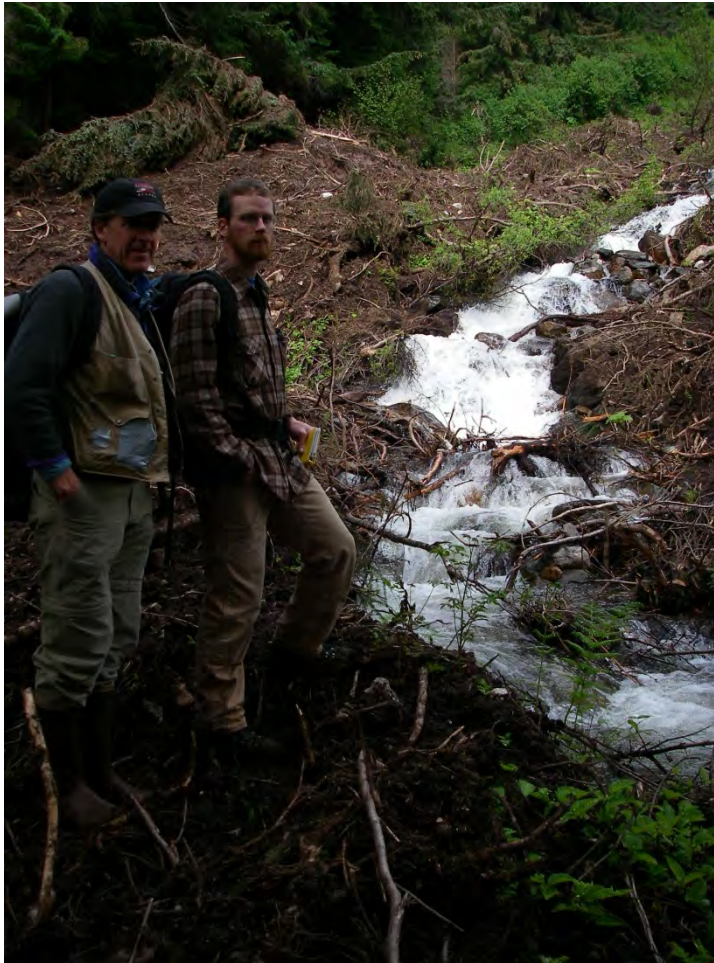
DF20. View east/upslope at debris channel. Stream is poorly channelized as a result of a high sediment/debris supply.

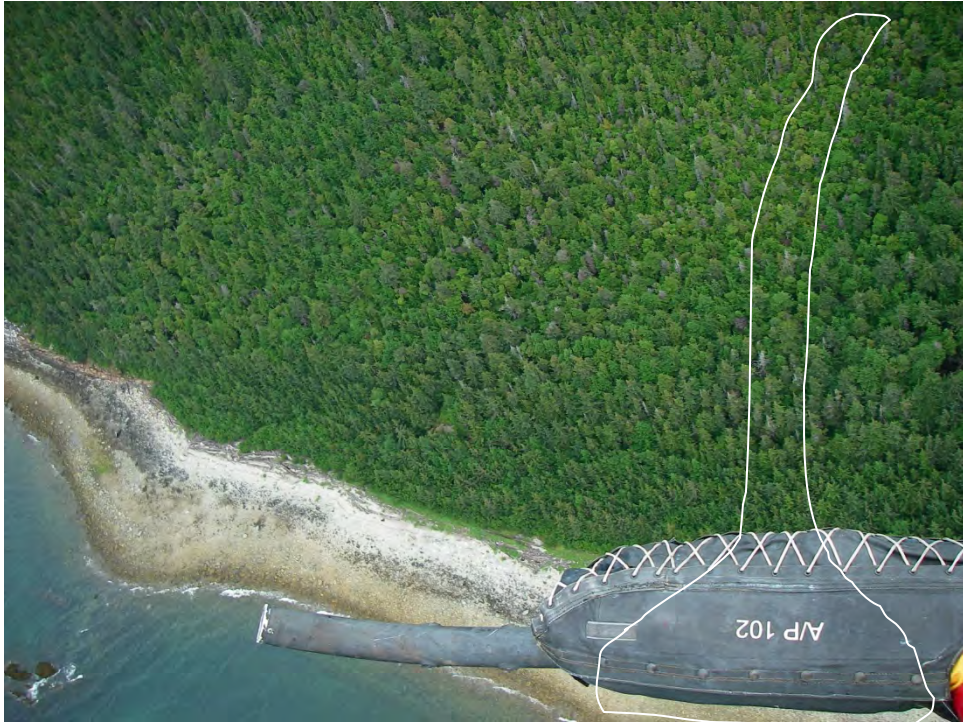
DF21. View east/upslope at moderate slope old growth covering the debris flow channel.

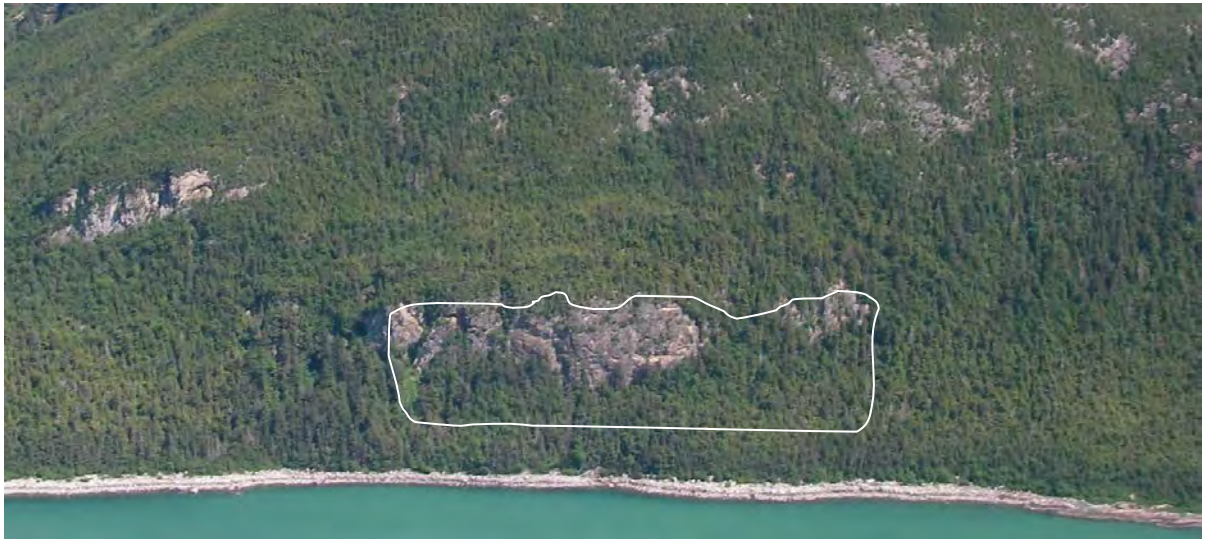
RF14. View east/upslope at moderate rockfall hazard below massive gneiss cliffs.

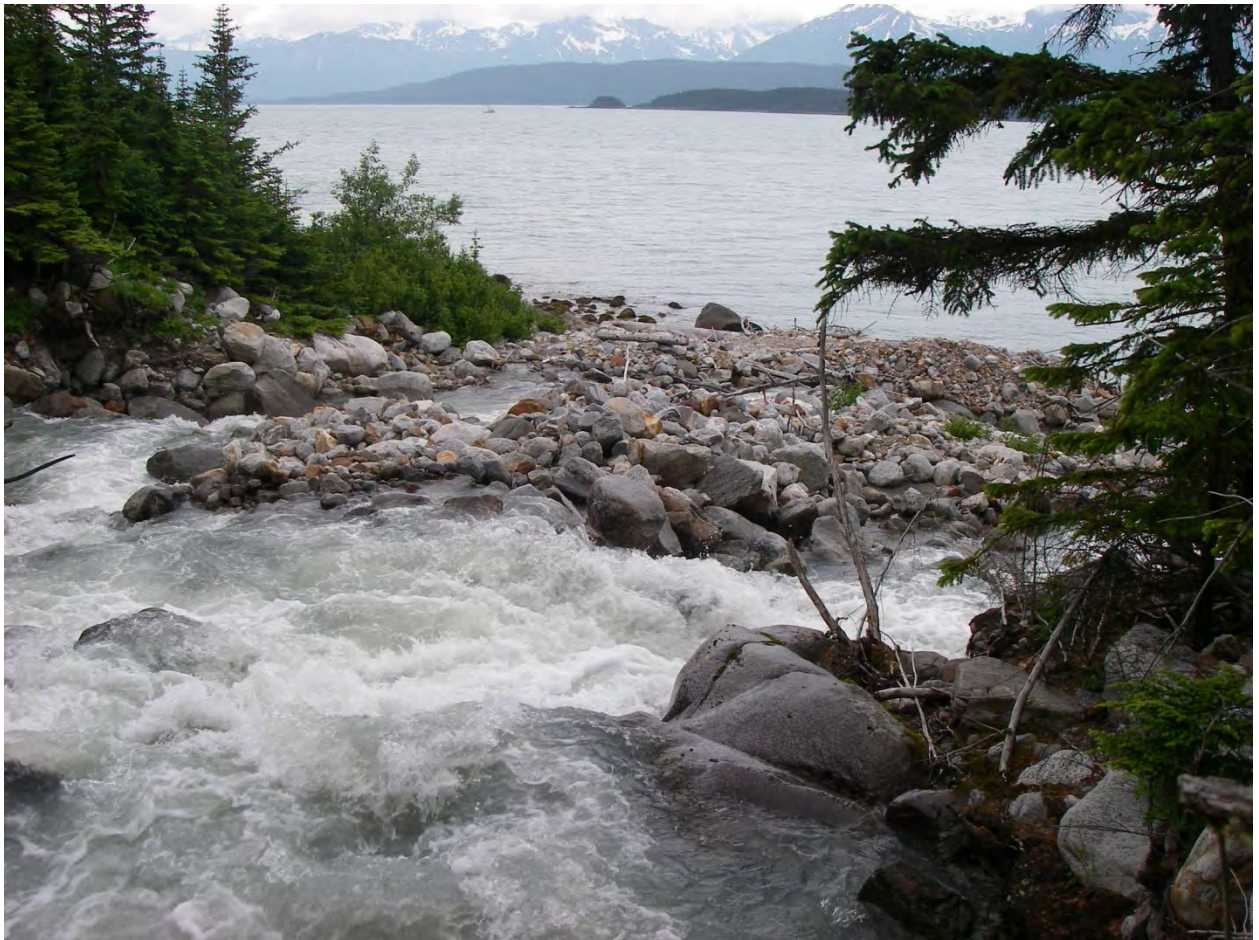
DF22. View southwest (downslope and down alignment) at debris flow fan and avalanche path.

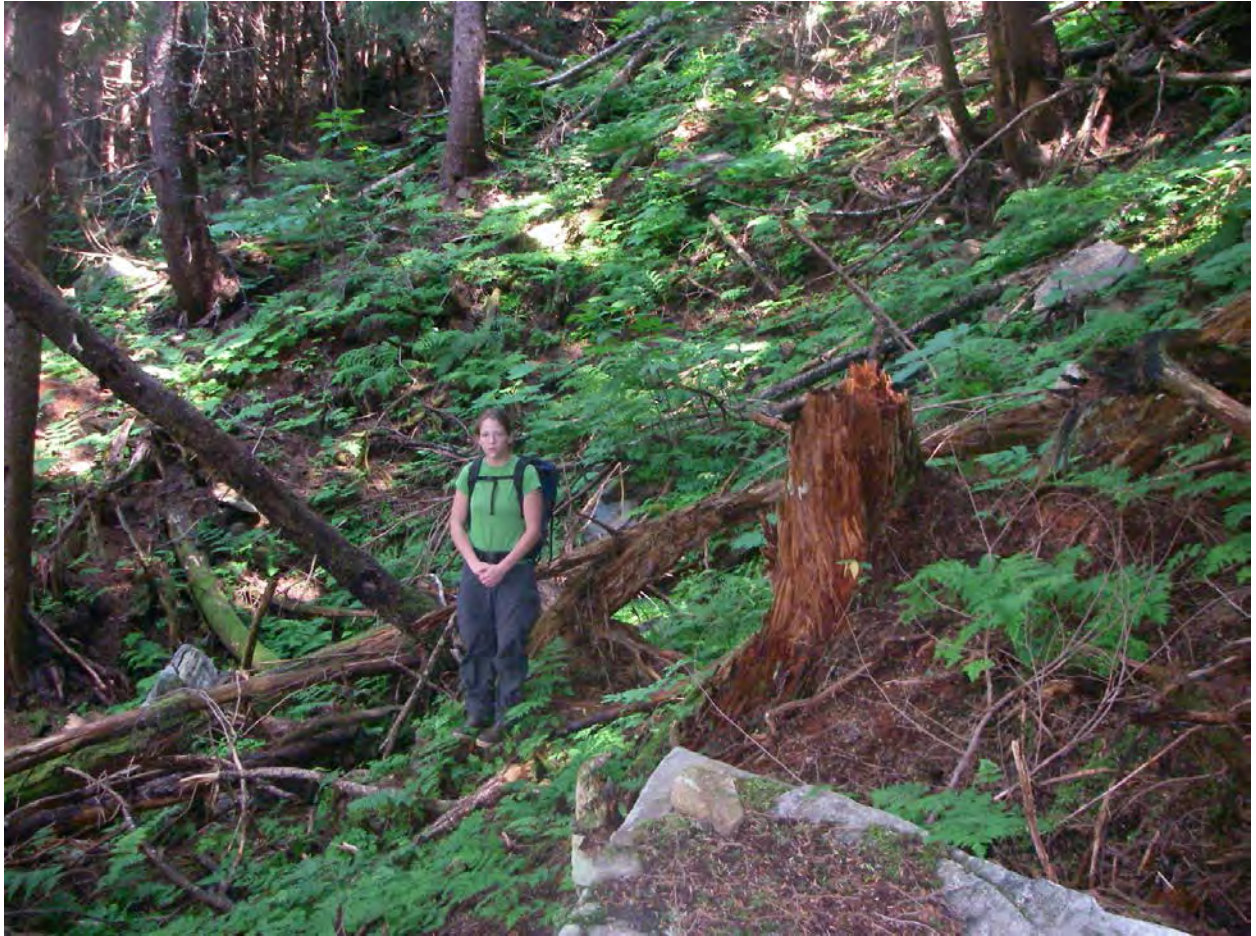
RF16. View north/up alignment across low frequency rockfall area.

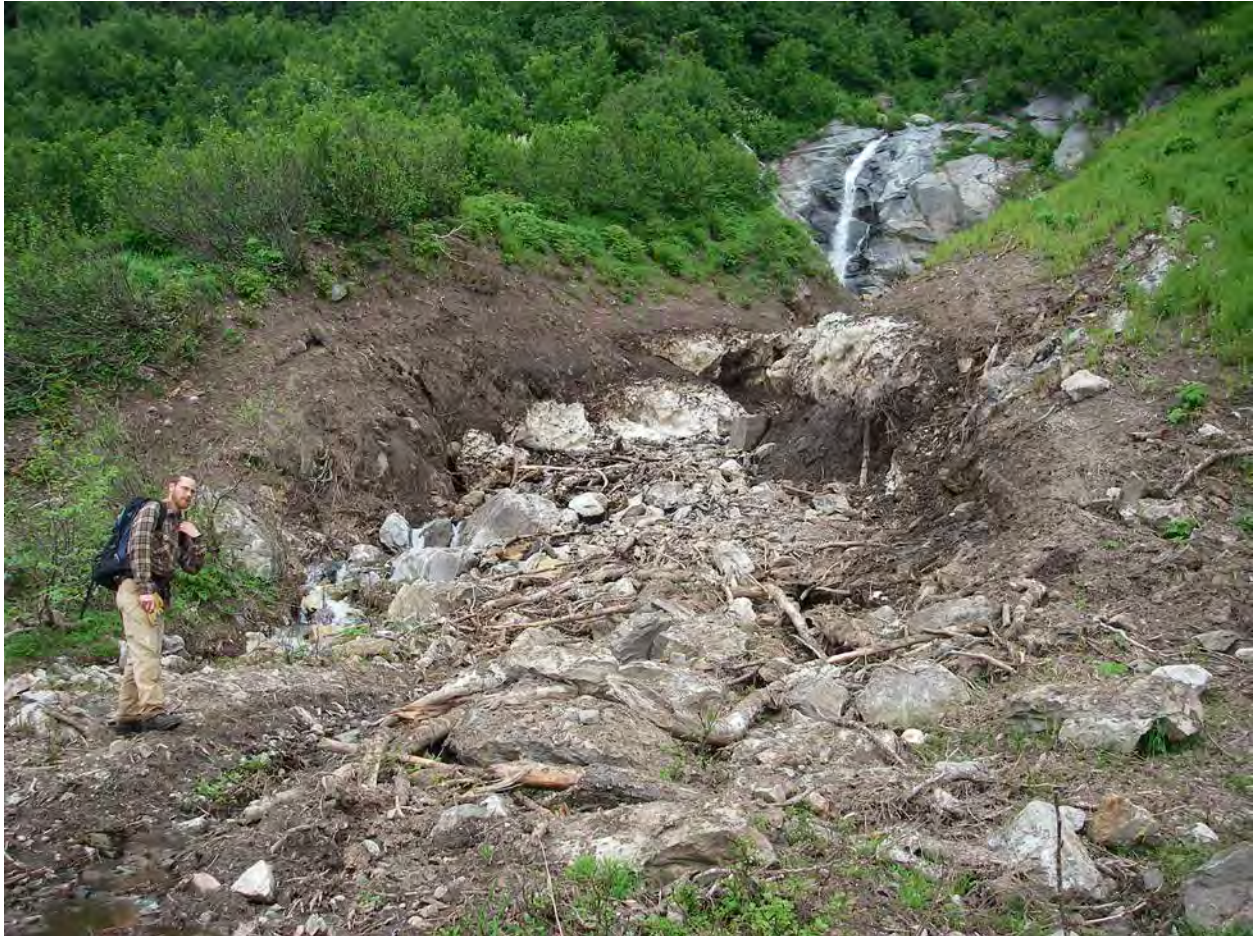
DF26. View east/upslope at debris flow channel and avalanche path.

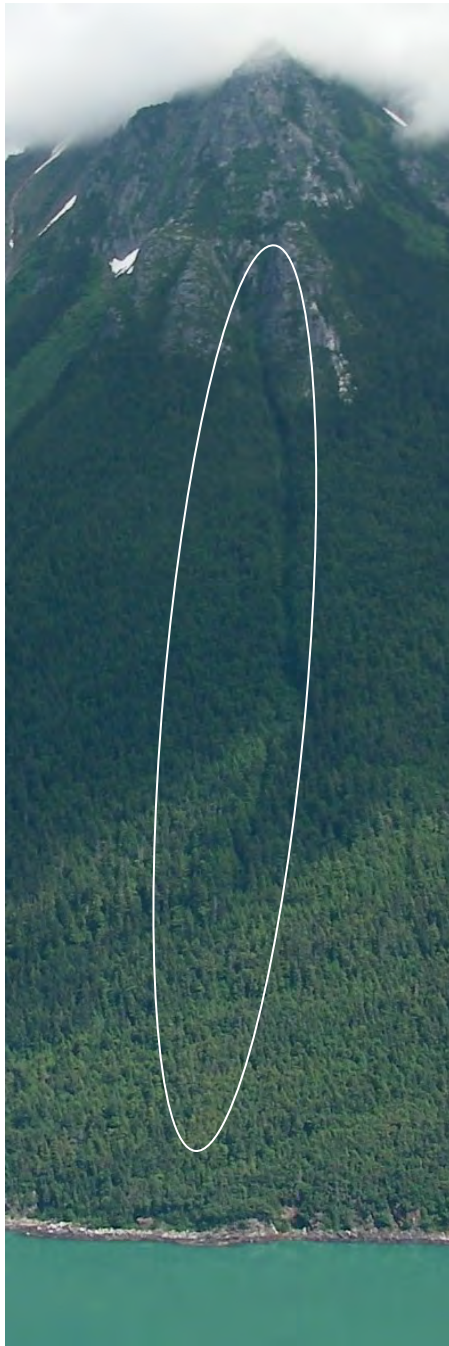
DF27. View east/upslope at debris flow channel and avalanche path.

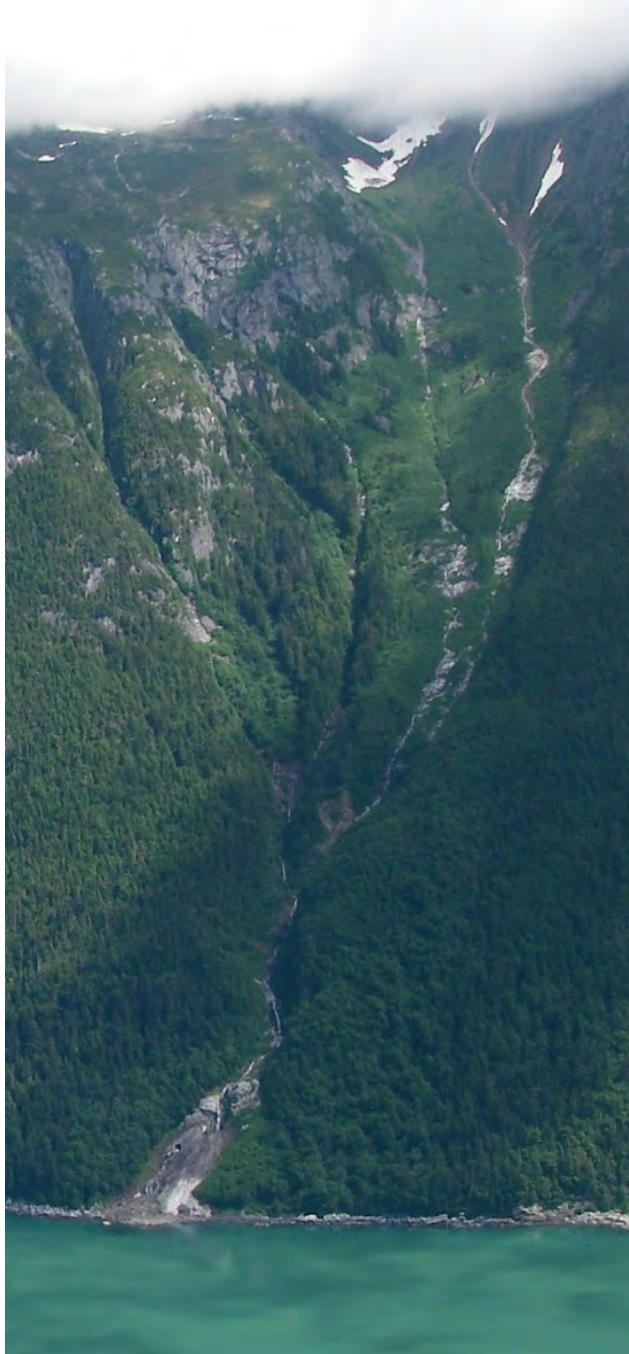
DF29. View east/upslope at debris flow channel and avalanche path.

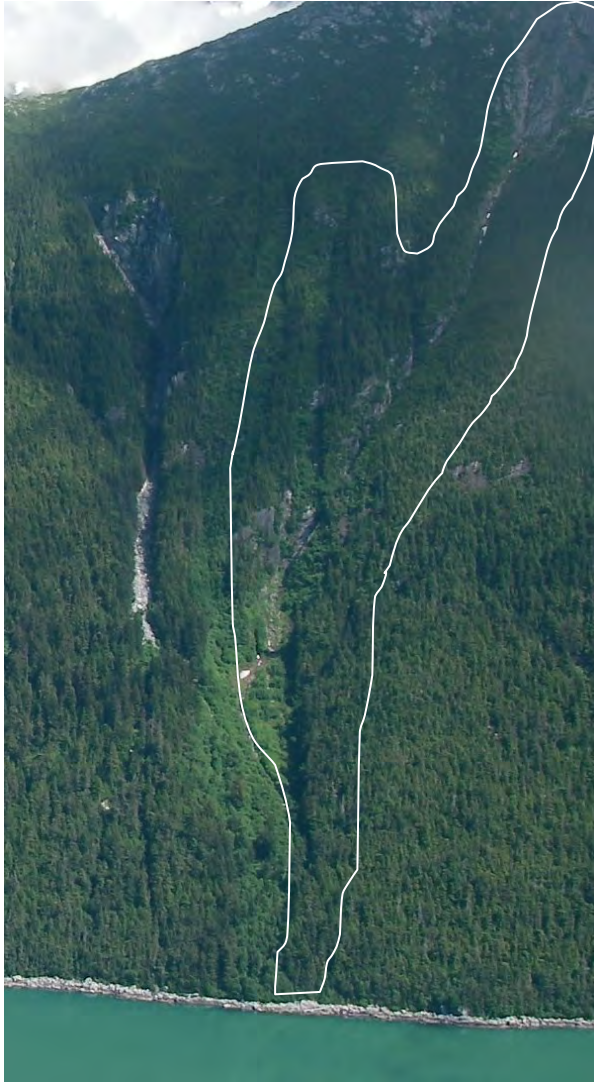
DF31. View east/upslope at debris flow path and base of avalanche path.

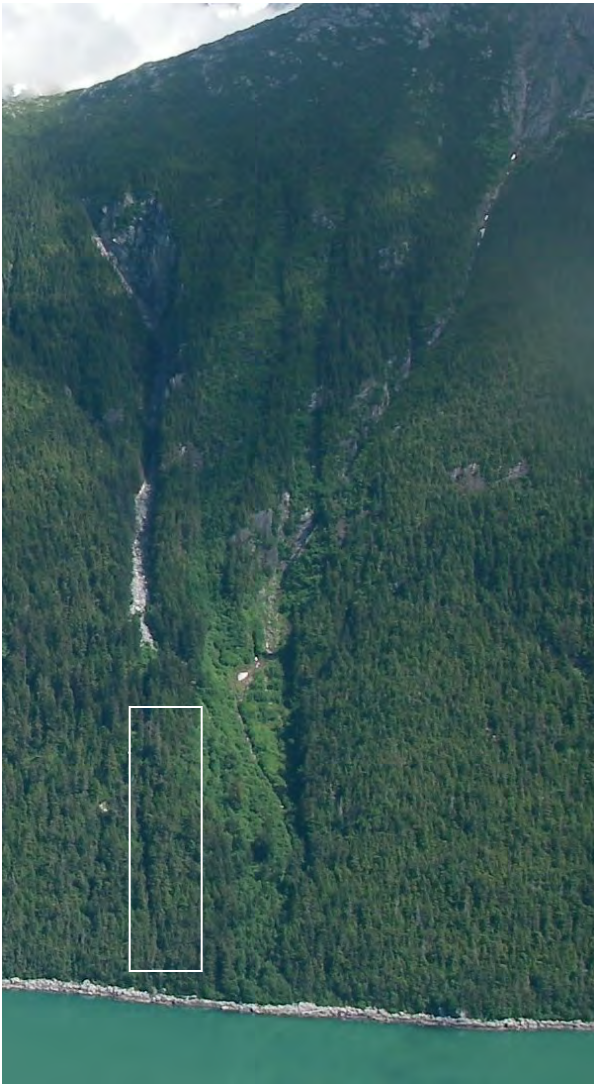
RF20. View east/upslope at rockfall area and avalanche path.

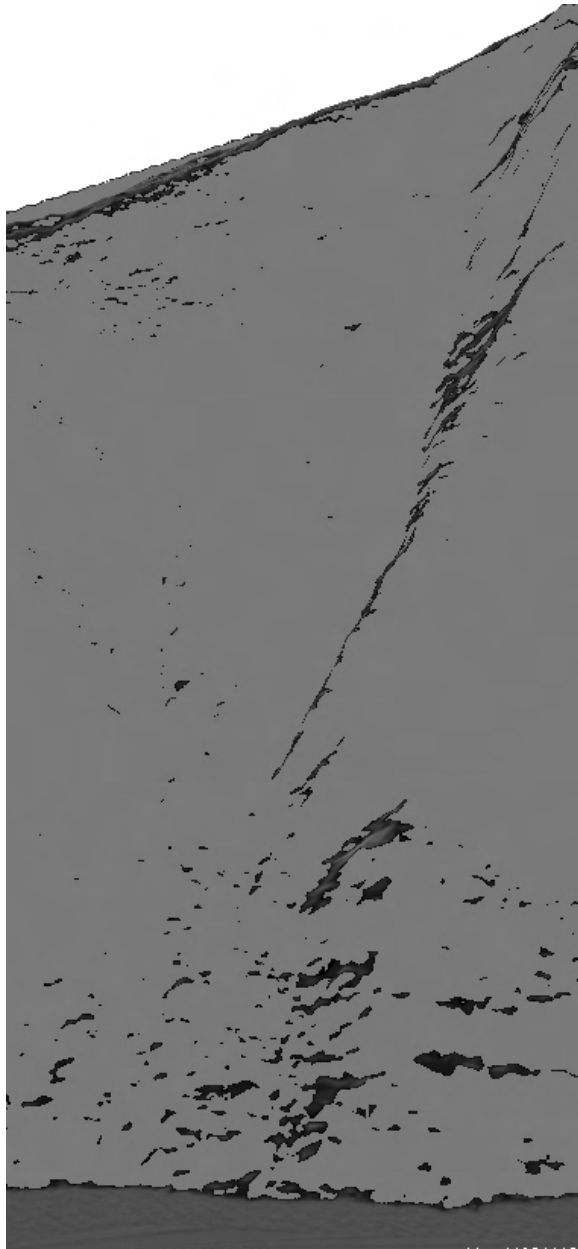
RF20. Bare earth LIDAR image view east/upslope at rockfall hazard area. Station labels represent previous IRP 2006 alignment.

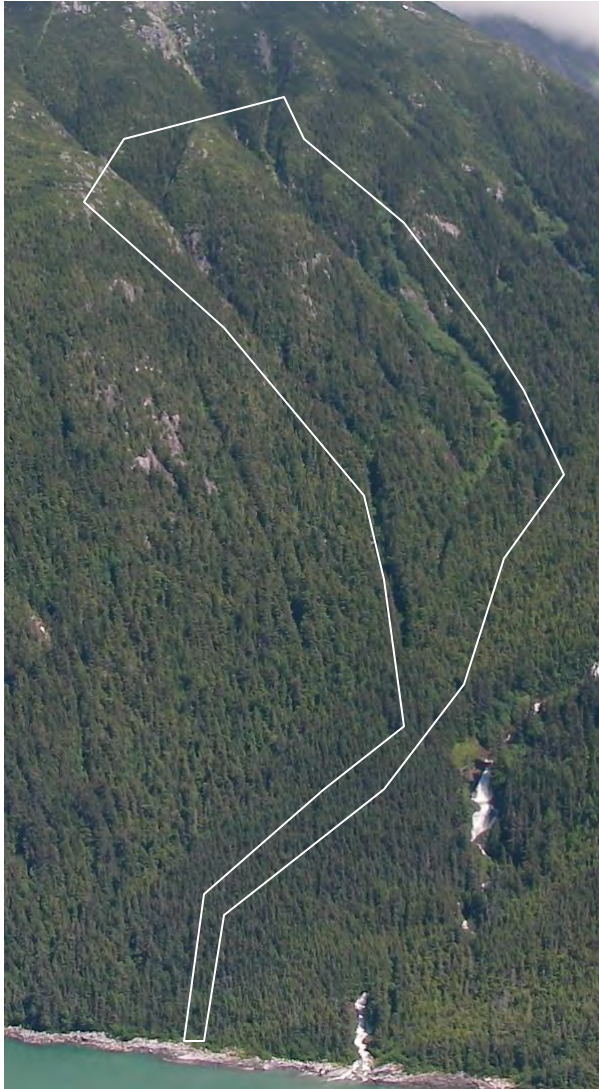
DF33. View east/upslope at debris flow channel.

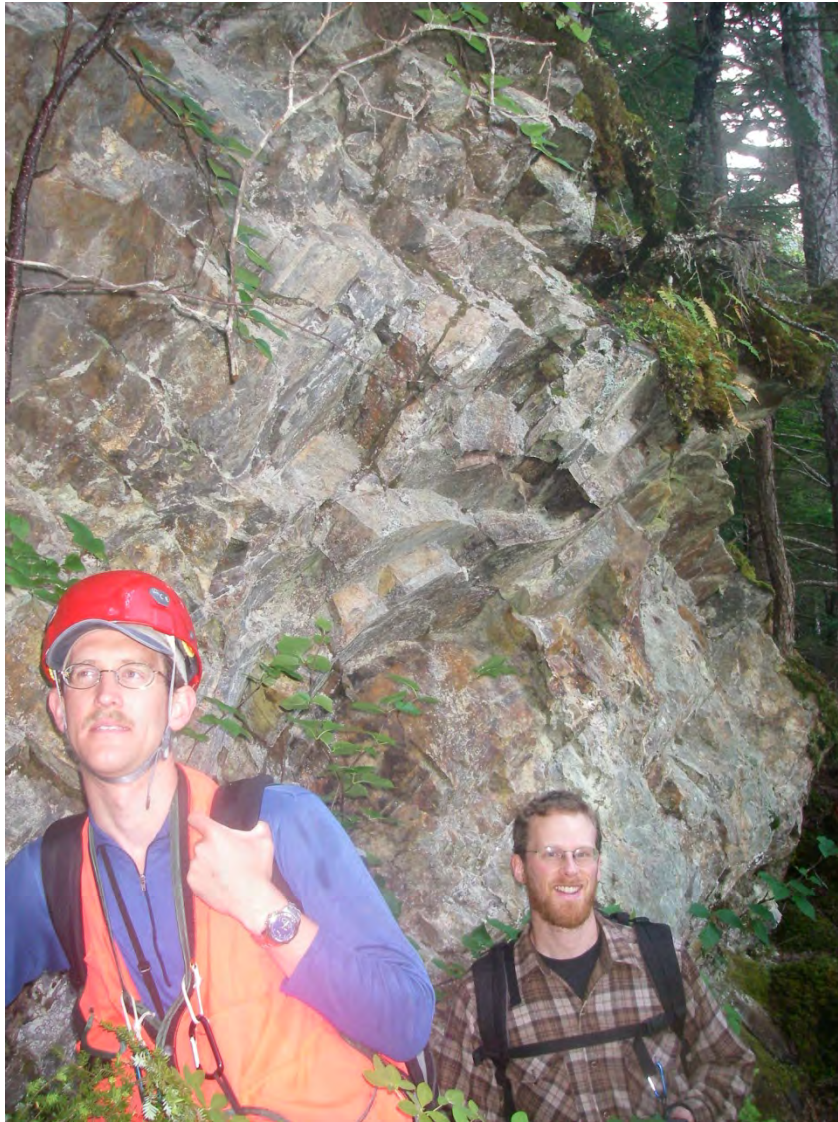
RF24. View east of rockfall hazard with fresh scarring.

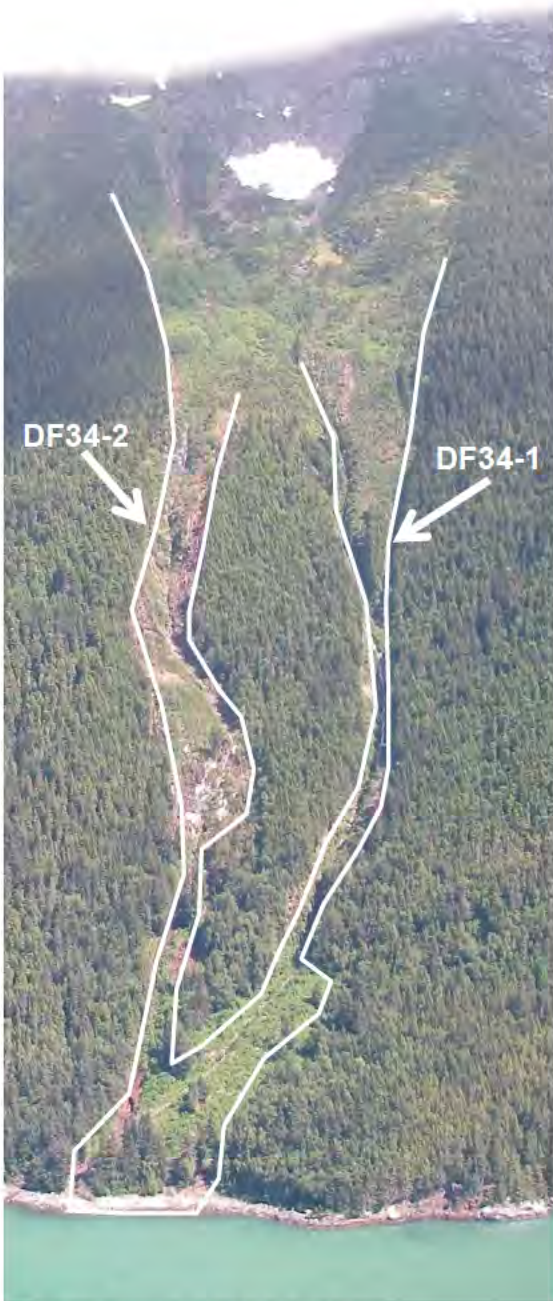
DF 34-1 and DH34-1. View east/upslope at debris flow channels and avalanche paths.

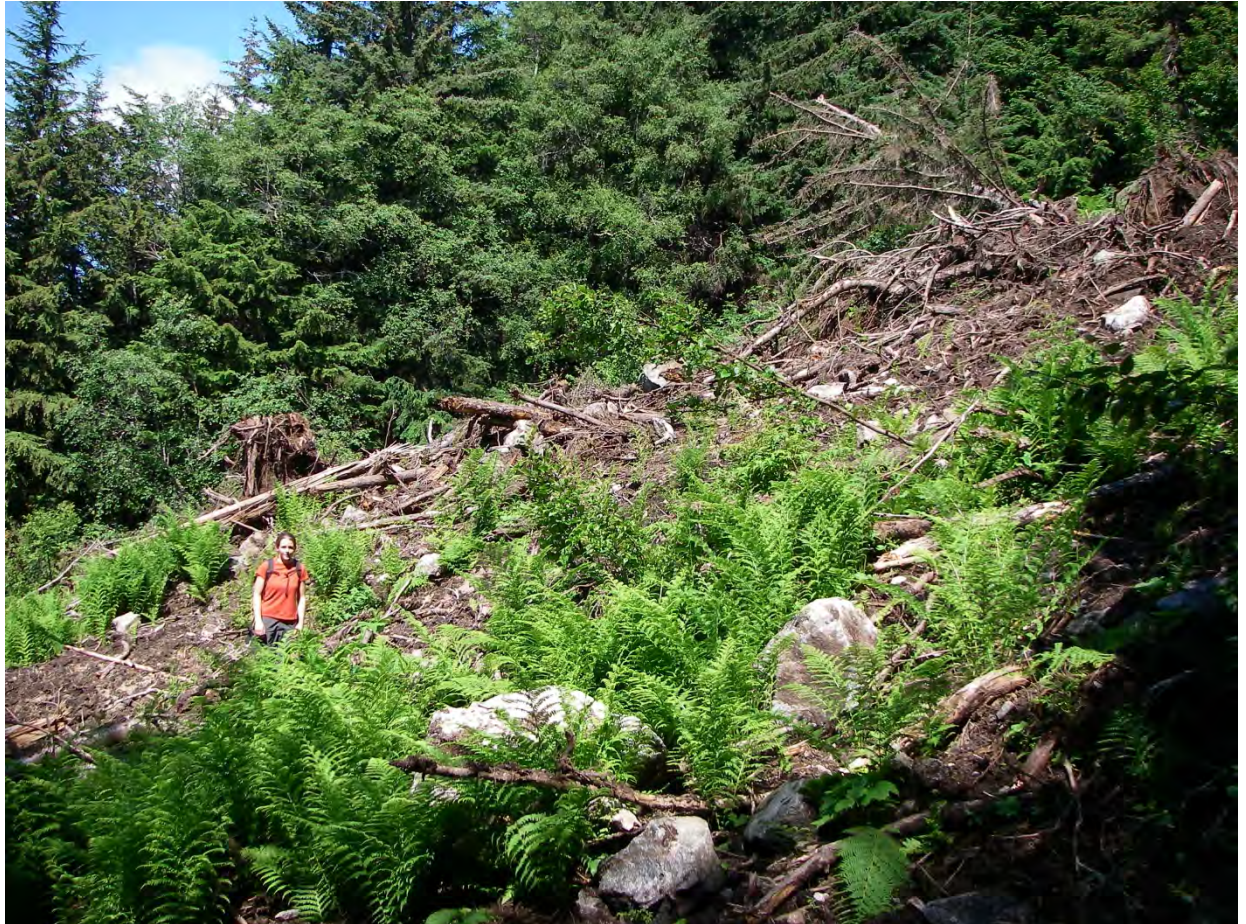
DF34-2. View north/up alignment at debris flow channel/avalanche path.
