CADD	ECC	GEOLOGIC HAZARD SUMMARY ARRANGED BY 2012 SEIS STATIONING LYNN CANAL HIGHWAY PHASE 2 2012 SEIS ALIGNMENT HAZARD REVISIONS		
	DATE	9/10/12			
	CHECK	RGD			
	FILE No.	GEO_HAZ_SUMM.PPT			
PROJECT No.	113-95756	DATE	9/24/12	HDR / 2012 SEIS JUNEAU ACCESS / AK	G-2
		REV	1

TITLE
GEOLOGIC HAZARD SUMMARY
ARRANGED BY 2012 SEIS STATIONING
 LYNN CANAL HIGHWAY PHASE 2
 2012 SEIS ALIGNMENT HAZARD REVISIONS

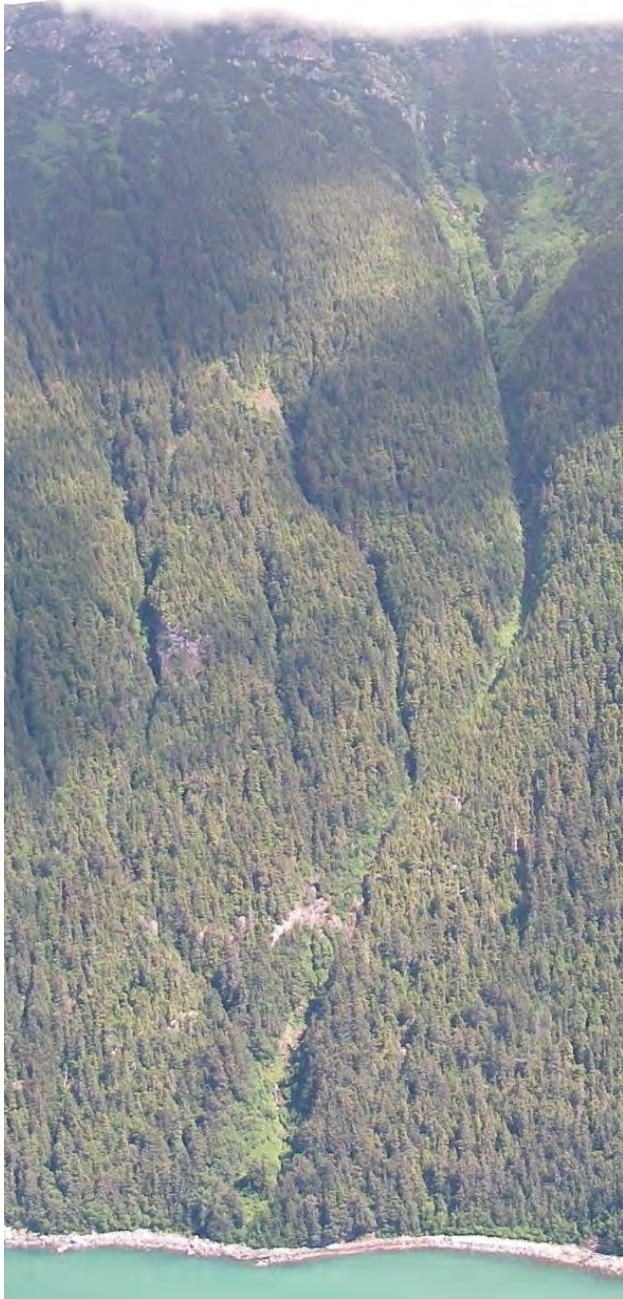
DF35. View east/upslope at debris flow channel and avalanche path.

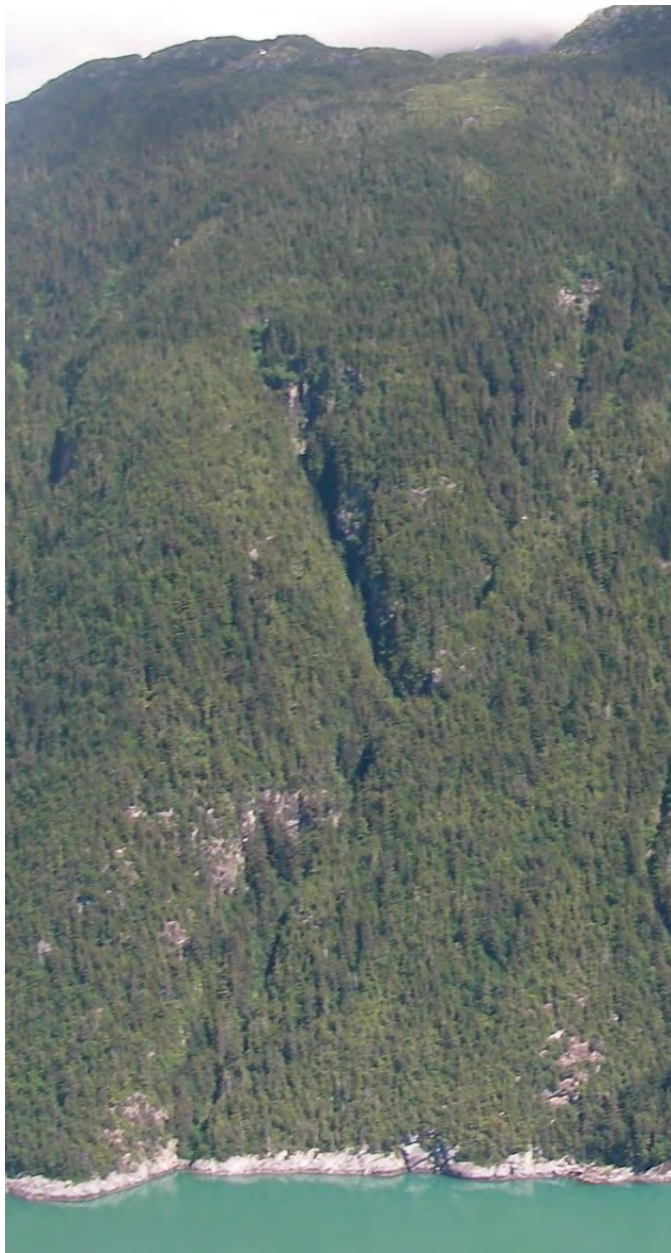
DF37. View east/upslope at debris flow channel and avalanche path.

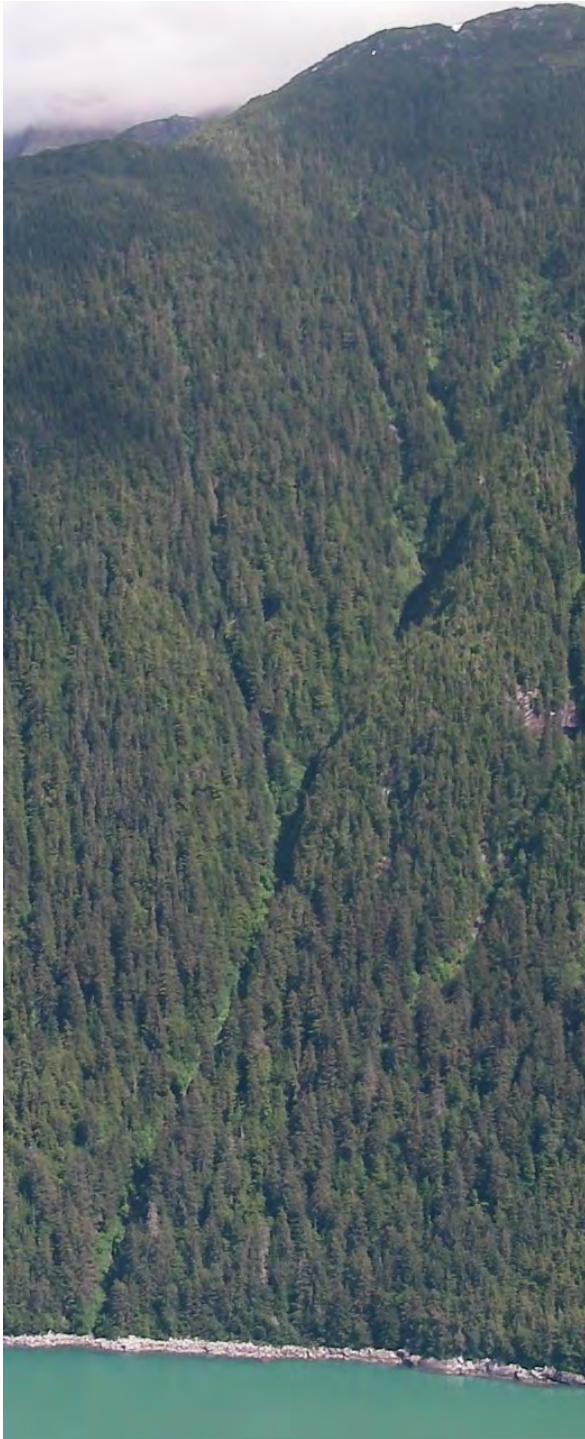
DF38. View east/upslope at debris flow channel and avalanche path.

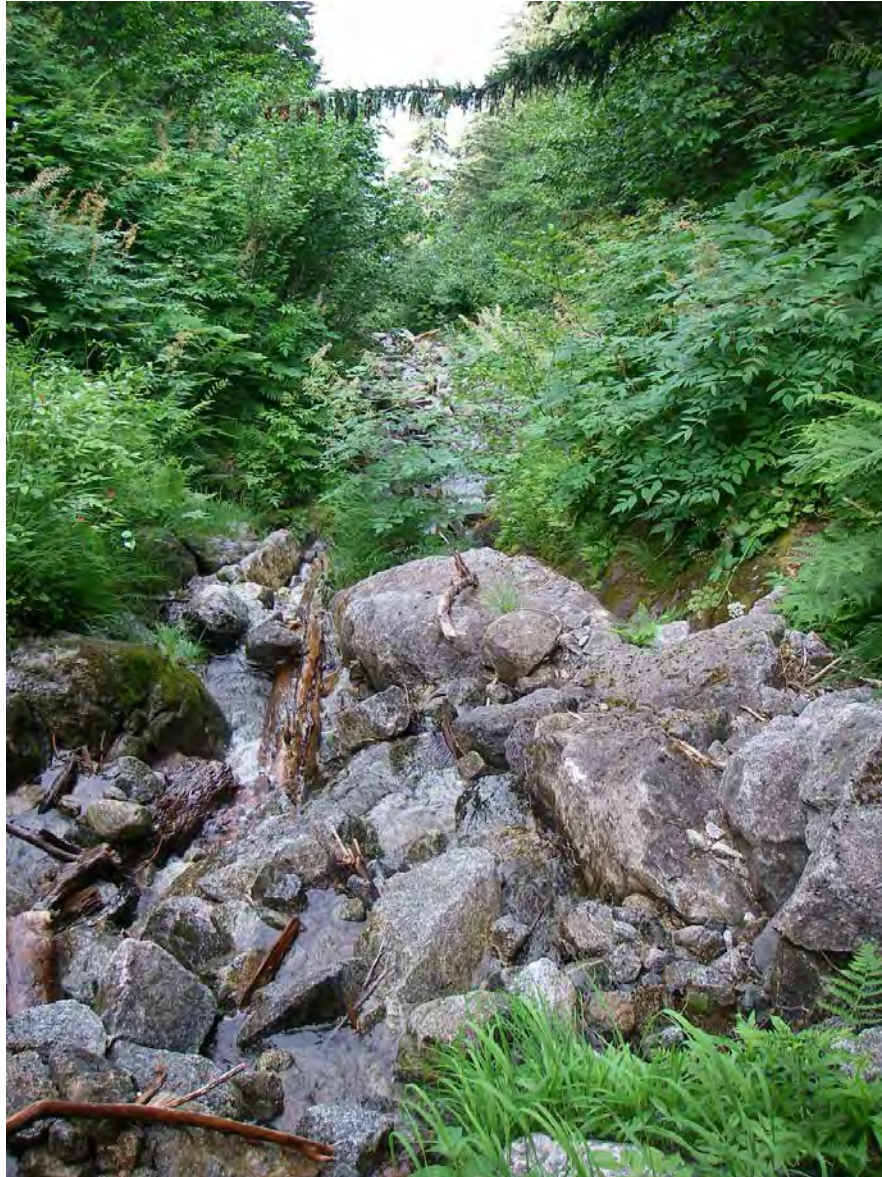
DF38. View west/downslope at debris flow channel.

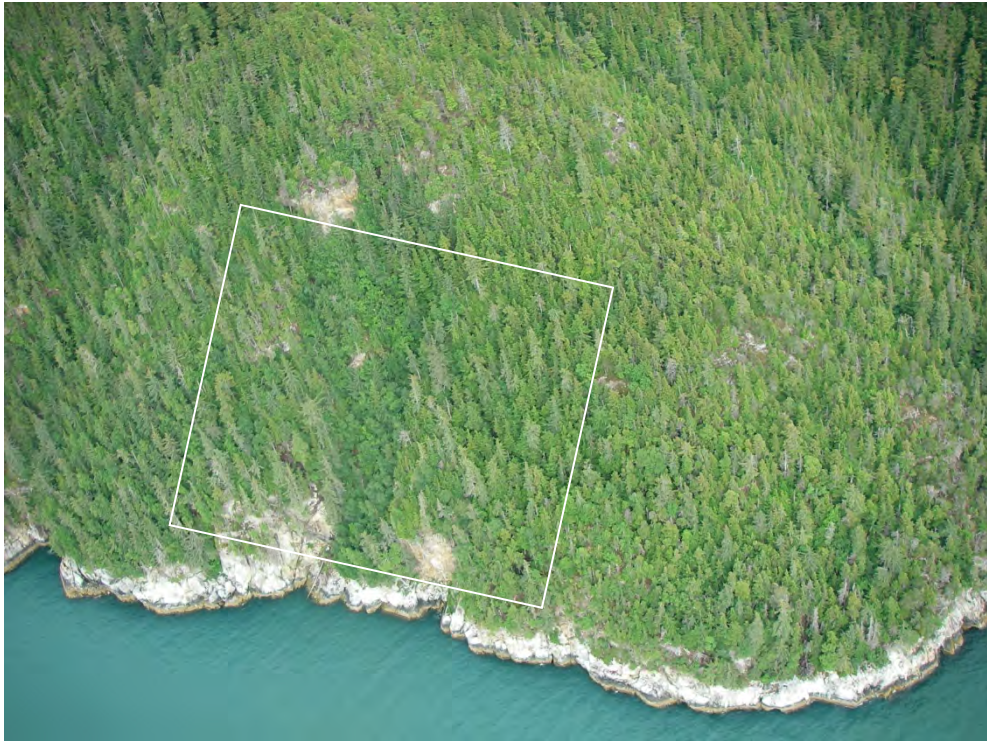
RF37. View east/upslope at rockfall hazard.

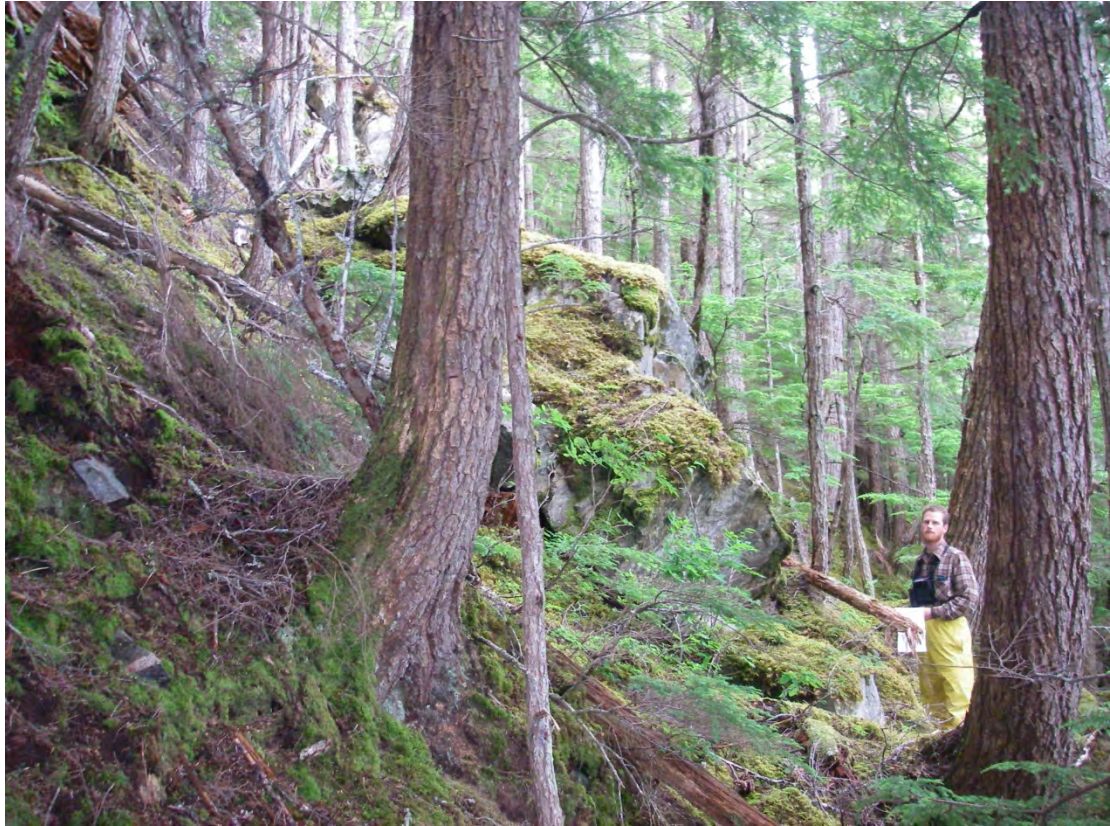
RF40. View south/down alignment at rockfall hazard.

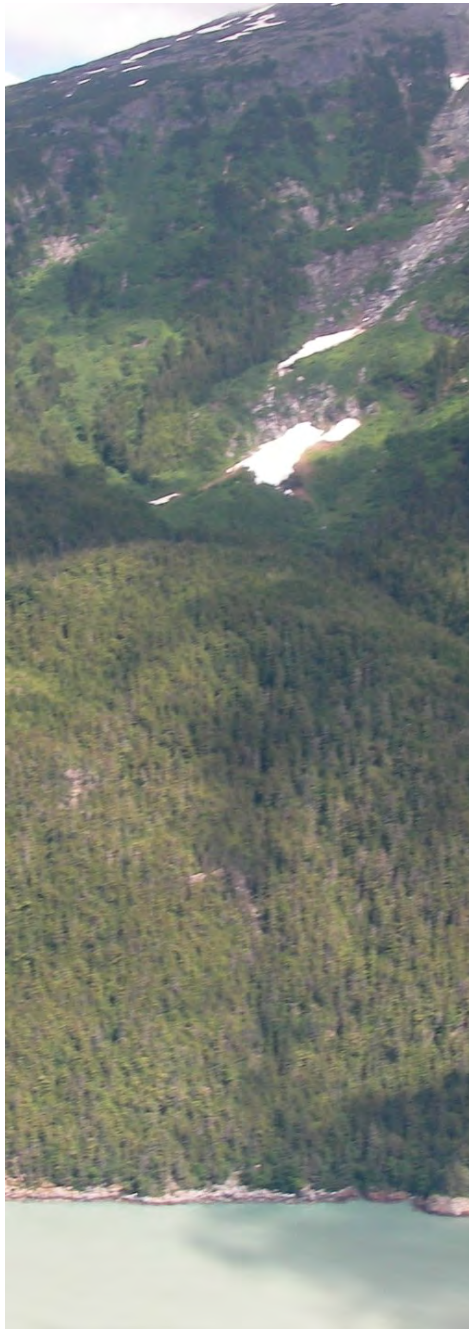
DF42. View east/upslope at debris flow channel.

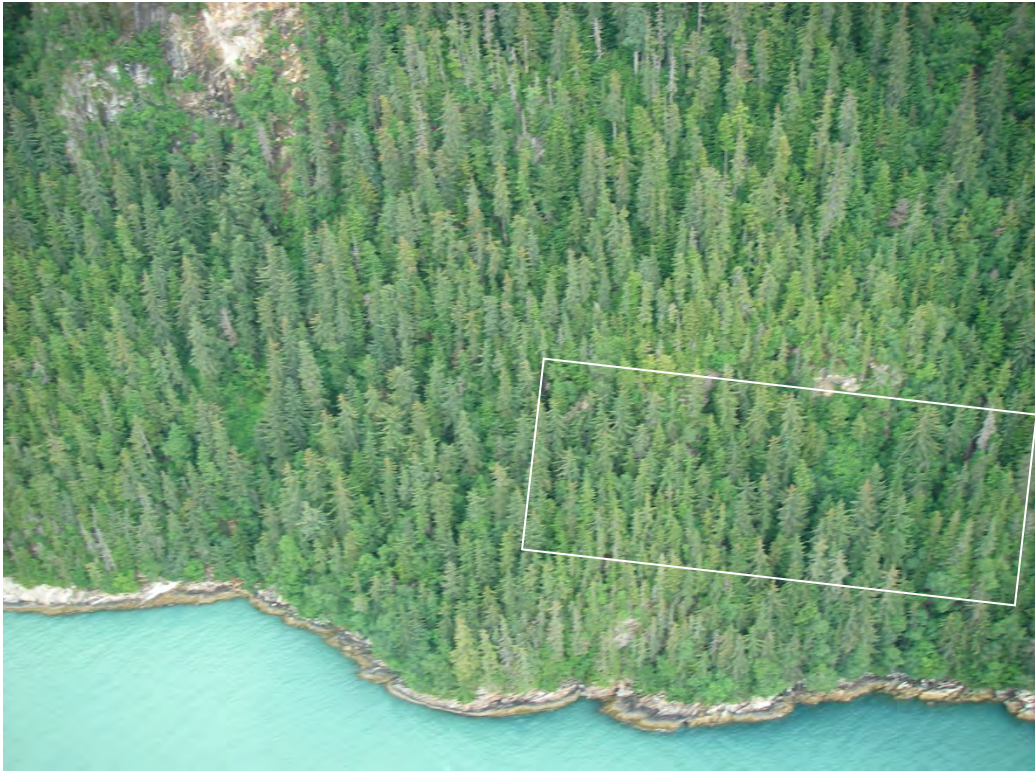
RF47. View east/upslope at rockfall hazard area.

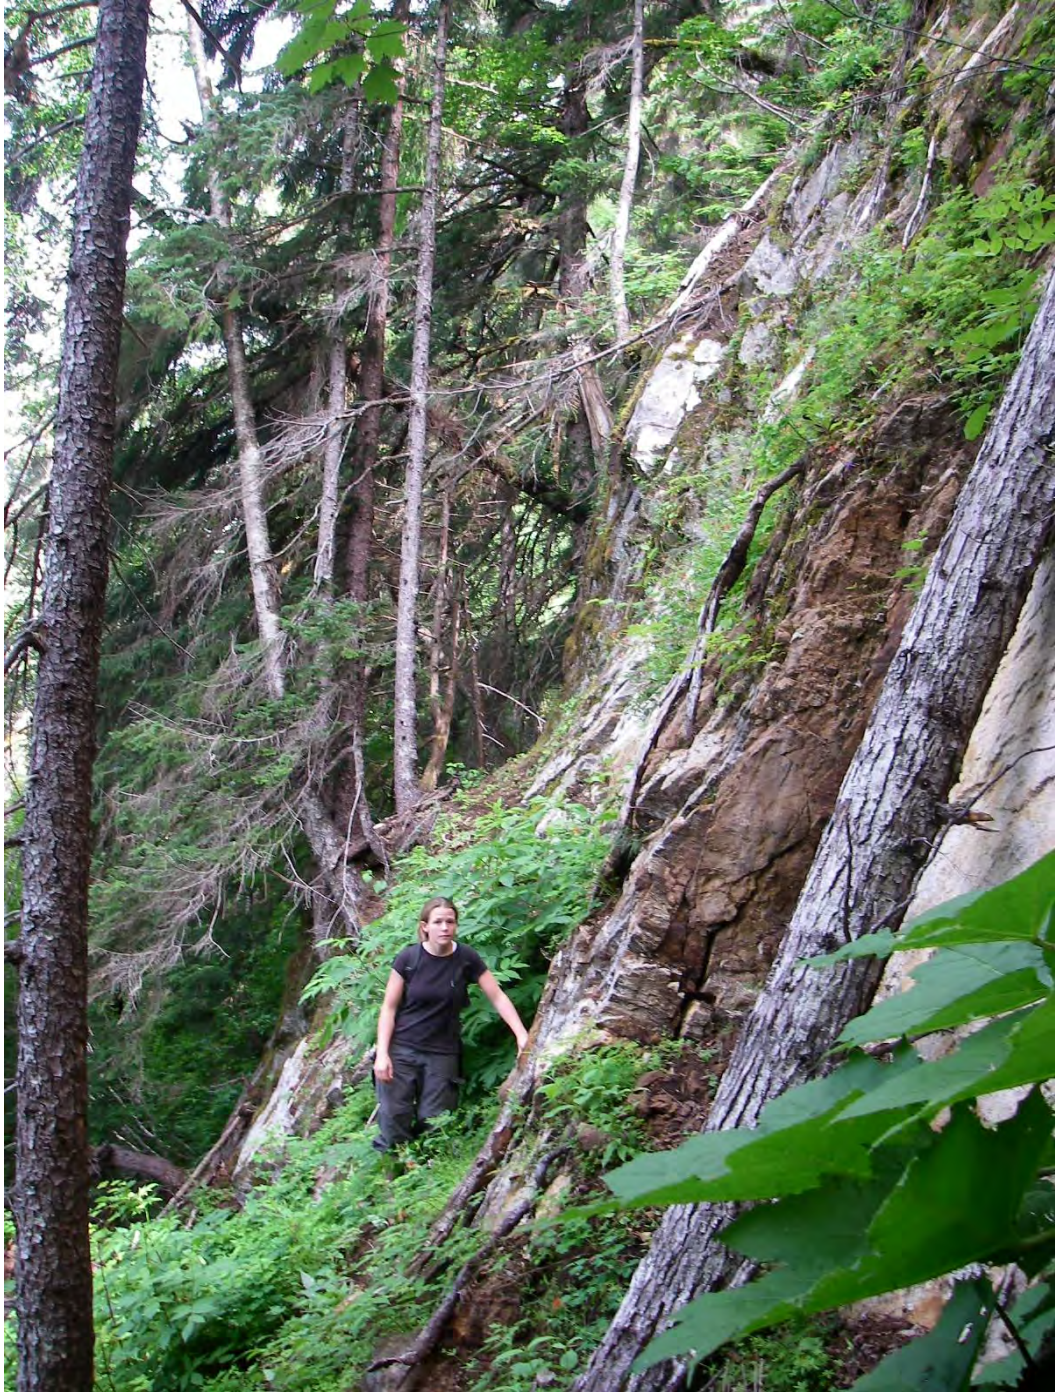
RF51. View north/up alignment across steep face of rockfall hazard.
