GENERAL LAYOUT
FALSE PASS

False Pass Dock

The most recent above water survey & fracture critical inspection were completed on September 22 & August 15, 2018, respectively. The underwater inspection occurred on July 16, 2014.

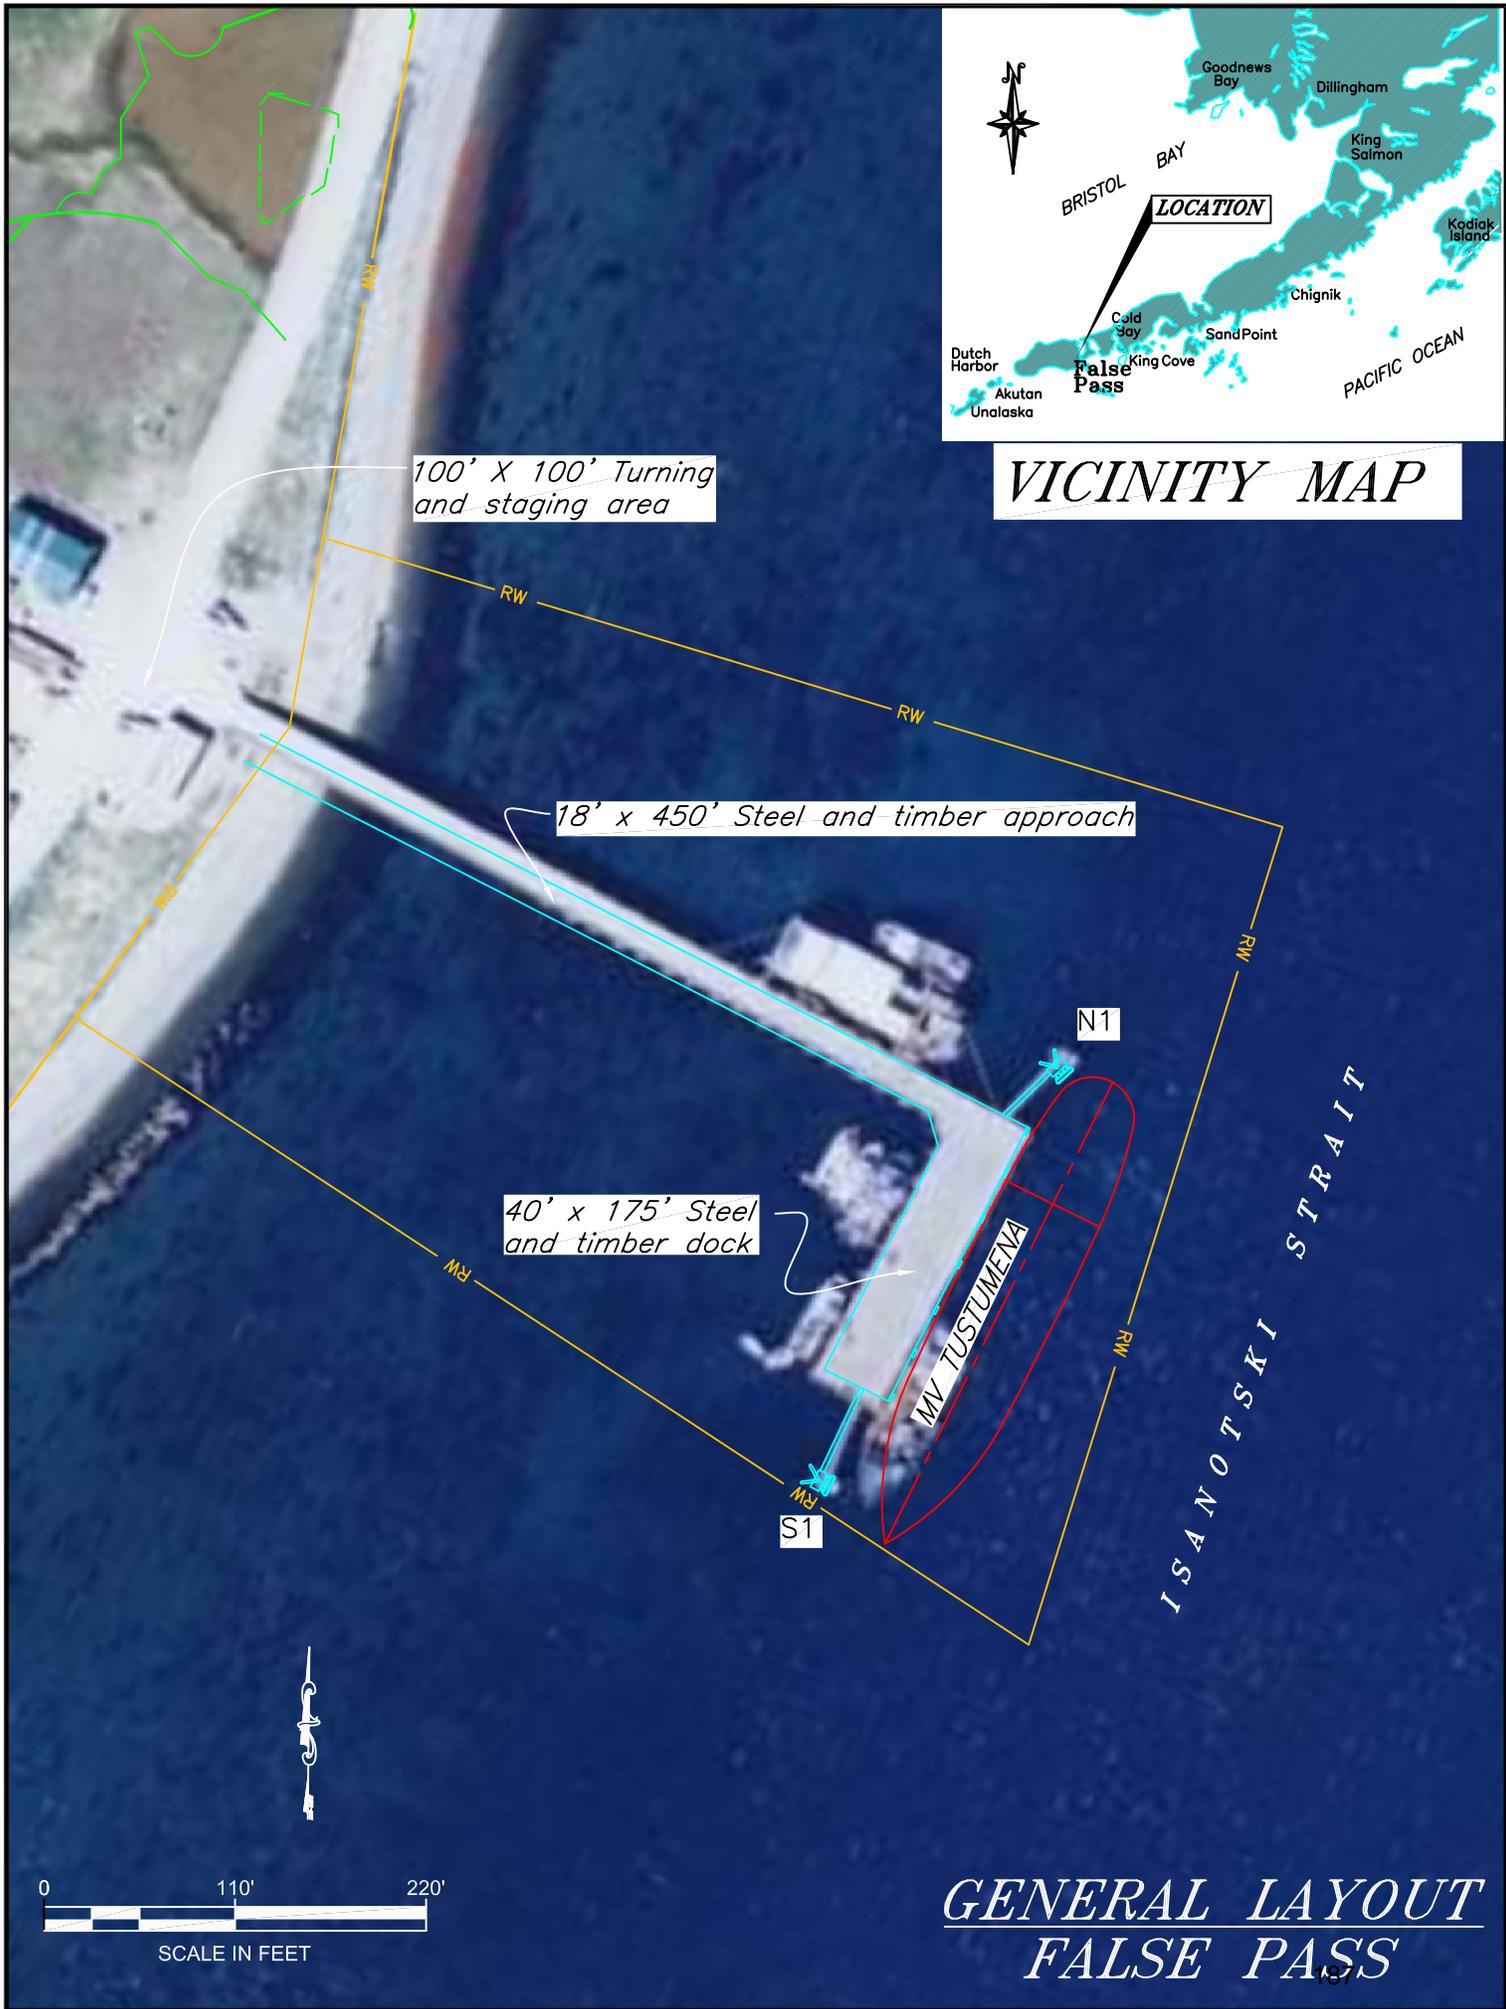
- The decking is 6x12 planks over glue-laminated timber beams. The city maintains a crab pot storage yard near the dock approach and transferring the pots across the dock has worn the deck. The City has banned pot hauling across the dock.
The deck planking is in fair condition with signs of wear. There is a large area of damage to the decking with up to 1-1/2" gouges, a portion of which is within the vehicle path for the Tustumena. Typical wear consists of intermittent areas of up to 1/2" deep surface checking.

- The superstructure consists of ten adjacent timber 8 3/4" x 27" glulam beams in the approach trestle and twenty-one glulam beams in the main dock section. The beams are supported on rolled steel bent caps with supplemental welded bearing stiffeners.
The glulam beams are in good condition, with minor damages from boat impacts along the north (harbor) side beams of the approach trestle. The most recent inspections also found a 1/4"-3/8" deep split, roughly 15' long, in a glulam beam on the north side of the approach trestle between the barge mooring dolphins but does not seem to be affecting structural capacity. Further investigation could be warranted.

- The bent caps consist of a rolled steel W18x76 beam with welded bearing stiffeners supported by two vertical and one battered steel pipe pile in the approach trestle. In the main dock section the W18x76 steel caps are supported by three vertical and one battered steel pipe pile. The pipe piles are beveled and fillet-welded directly to the steel cap bottom flanges.
The bent caps are in good condition with minor surface corrosion occurring at the welded connection between pile & cap. The most recent underwater inspection ('18) found new anodes installed since the '14 inspection with an average of 85% remaining section, and cathodic protection readings averaged -1.0V. Any reading more negative than -0.8V indicates the steel is adequately protected.

- The 16"φ x 1/2" wall dock support pipe piles are galvanized and filled with gravel. Without any cathodic protection system (i.e. anodes) installed, the galvanizing has failed within the splash zone. There are several areas of dents & gouges to the dock and fender piles along bent 17 from vessel impacts. There is one missing steel pipe pile at both the North and South gangway support dolphins.

- The mooring dolphins are in good condition. On the '18 underwater inspection, the northern batter pile on the north mooring dolphin was found with a dent and scrape at about -10' elevation. The dent is 2" deep, 6" wide and 2' long, probably caused by vessel impact.
The M/V Tustumena typically berths starboard, except for windy conditions when they berth portside.

- The fender/bollard pipe piles and ladders on the face of the dock are in good condition. The northernmost bollard is missing one of its two horns. The fender system is considered marginal for the berthing loads of the M/V TUSTUMENA.

7. The southernmost fender on the dock face has been damaged from vessel impact. Additionally, the pile cover plate is missing and the pile is full of water. The third fender from the north end of the dock has been hit hard and the upper portion of the backup structure has been bent.

8. A bolt is missing on the northernmost rubber donut fender mount on dolphin N1.
9. The north barge dolphin does not have tire fenders on the upper section as does the south barge dolphin.

10. The catwalks are welded to the dolphin caps on one end, and slide on a wood skid plate on the dockside end. The guide pin on the catwalk has been torn away, so that now the only guides for the catwalk are the bullrails. There are no safety chains/cables installed to keep the catwalk from falling in the ocean.

11. The opening in the bull rail for the ferry's vehicle-loading ramp is too narrow. The constricted opening makes vehicle loading difficult in all but favorable weather. A ladder near the north corner of the dock has been hit and subsequently cracked the bullrail up on deck.

12. A new fuel line on the approach has reduced the inside curb width to 15'-7". The approach width is still adequate for one-lane ferry traffic. The arctic pipe waterline, mounted beneath the dock, froze in the winter of 05-06 and an elbow, at the junction of the approach and main docks, was damaged. Several utility hangers that are loose, damaged, or missing including two between bents 18 and 19. Eventually the City abandoned the arctic pipe and installed a ½" HDPE plastic waterline to service water to the main dock.

13. Potholing is prevalent where the gravel approach road meets the approach dock. Surface water ponding and heavy dock traffic has worked to erode the gravel above and behind the timber backwall at the head of the dock. A gap has formed and surface water drains freely along the backwall.

14. Heavy chains around the vertical piles in the seaward barge dolphins contribute to corrosion/section loss. All horns on the seaward barge dolphin bollards are missing.

15. Both navigation lights are not functioning. The crane mounted to the main dock is also not functional; signs posted warn of 'electrical shock'.
16. All freight and POL operations have moved to the sheet pile dock near the City Harbor.

Inspection Summary		
Structure	Priority	Recommendations
<i>Category I - Safety Issues</i>		
Nothing required.		
<i>Category II - Rehabilitation Work</i>		
Bottom Debris	1	Remove crab pots from the front of the southernmost fender. The pots, lines, and buoys pose risk of fouling vessels during low tides.
Dock - Misc.	2	Widen bull rail opening to 16 ft. to accommodate M/V TUSTUMENA vehicle-loading ramp. Repair the damaged fender unit on the south dock, pump out the seawater, and re-weld the pile cover plate. Repair the upper bent portion of the third fender from the north end of the dock. Repair damaged bullrail near the north corner of the dock.
Anodes	3	Install anodes on dock support piling and dolphin S1.
Dock planks	4	Install timber wearing surface to protect timber planking of deck.
Catwalks	5	Install guide pins on the dock mounting plate connection.
Mooring Dolphins	6	Monitor the damaged batter pile of dolphin N1 and program the pile for replacement. Also install a bolt that is missing on the northern-most rubber donut fender mount on dolphin N1.

Barge Dolphins	7	Install tire fenders over the king pole of the north barge dolphin. Install chafe protection between heavy chains and vertical piles in the seaward barge dolphins. Repair mooring bollards on the seaward barge dolphins by installing full pipe section horns.

Inspection Summary (continued)		
Structure	Priority	Recommendations
<i>Category II - Rehabilitation Work</i>		
Mooring Bollard	8	Repair broken horn on northernmost bollard.
Approach Transition	9	Repair gravel-to-timber transition at head of dock.
<i>Category III - Upgrades Needed</i>		
None noted.
