TITLE
GEOLOGIC HAZARD SUMMARY
ARRANGED BY 2012 SEIS STATIONING
 LYNN CANAL HIGHWAY PHASE 2
 2012 SEIS ALIGNMENT HAZARD REVISIONS

HDR / 2012 SEIS JUNEAU ACCESS / AK

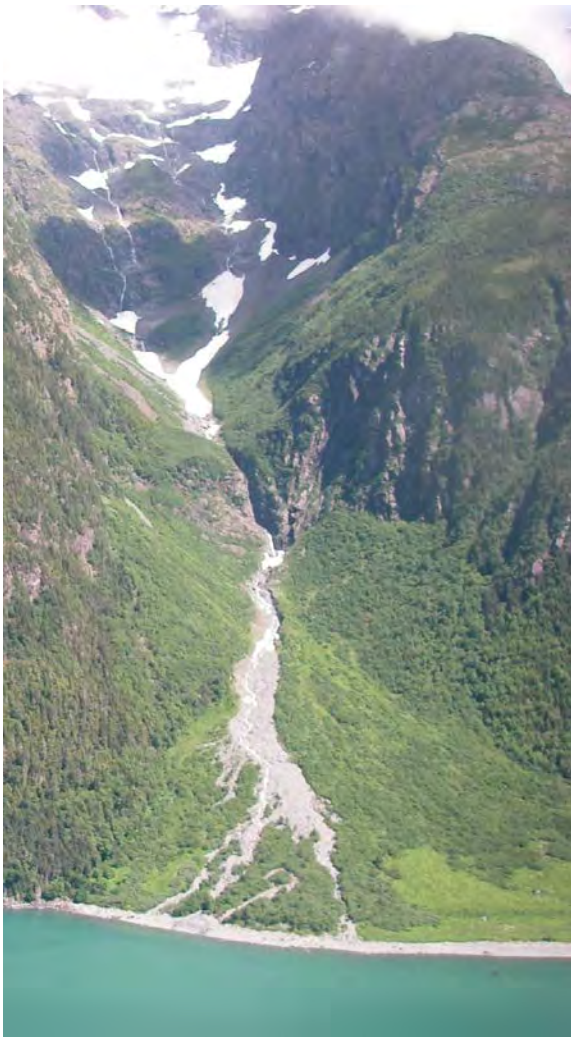
DF01. View east/upslope at alluvial fan with debris flow deposition zone (gray) and avalanche path.

Hazard ID #:	DF01
Hazard Type:	debris_flow
HIN:	225
Rating:	A
2012 SEIS Alignment Location:	1495
Frequency (yrs):	1-5
Predictability:	moderate
Material Volume (CY):	100-1000
Clast Size (ft):	1-2
Source Elev. (ft):	>1000
Centerline Slope:	fan
Alignment Location:	deposition_zone
Impact Alignment:	yes
Alignment Exposure (ft):	500+
Vegetation:	denuded
Deciduous Trees:	yes
2012 SEIS Alignment South Margin:	1492+00
2012 SEIS Alignment North Margin:	1498+00
Photo #:	4098, 4099, 5146

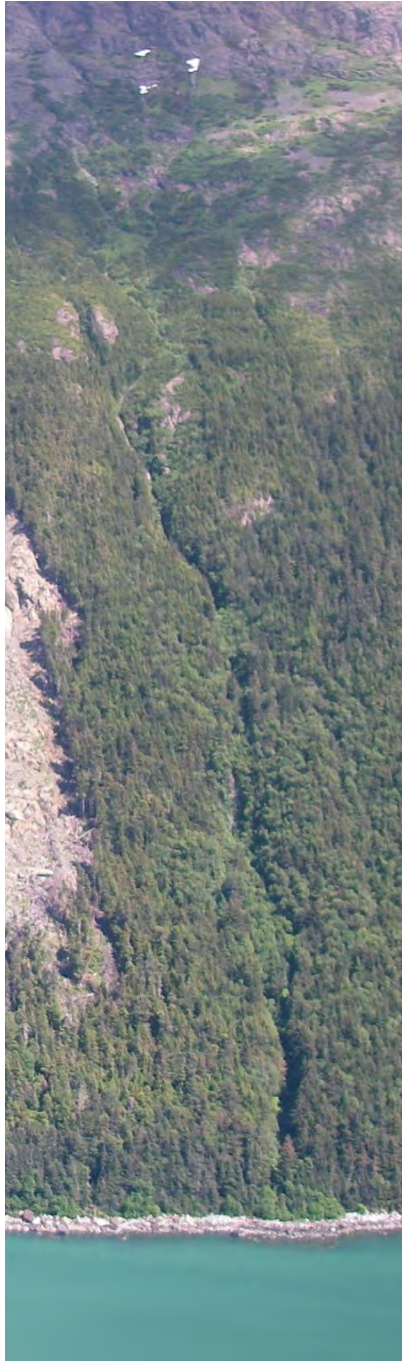
DF02. View east/upslope at debris flow channel and avalanche path.

Hazard ID #:	DF02
Hazard Type:	debris_flow
HIN:	129
Rating:	A
2012 SEIS Alignment Location:	1514
Frequency (yrs):	1-5
Predictability:	moderate
Material Volume (CY):	<10
Clast Size (ft):	0-1
Source Elev. (ft):	2000-3000
Centerline Slope:	fan
Alignment Location:	deposition_zone
Impact Alignment:	yes
Alignment Exposure (ft):	50-200
Vegetation:	disturbed
Deciduous Trees:	yes
2012 SEIS Alignment South Margin:	1514+00
2012 SEIS Alignment North Margin:	1514+70
Photo #:	1515, 2036, 5865

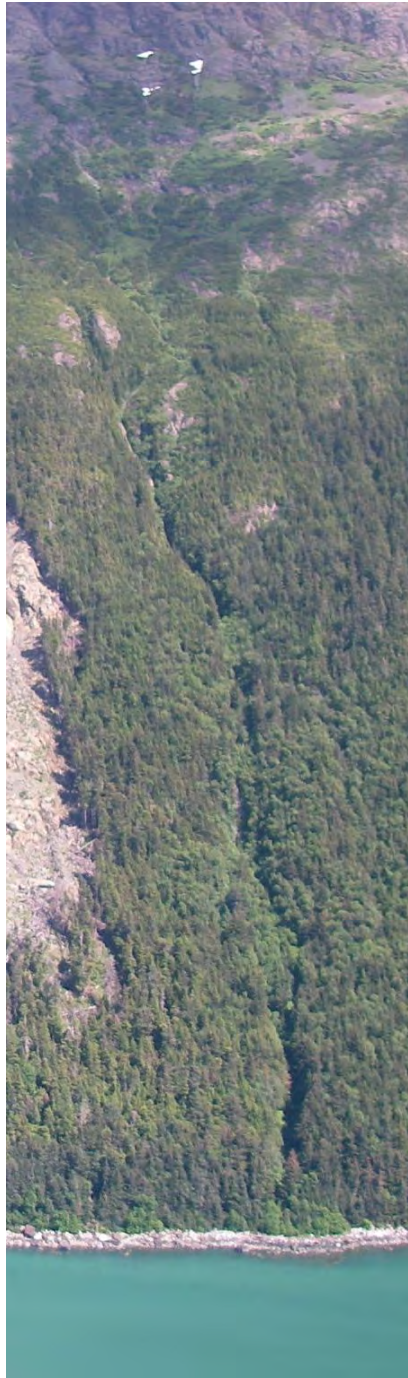
DF03. View east/upslope at debris flow channel.

Hazard ID #:	DF03
Hazard Type:	debris_flow
HIN:	183
Rating:	A
2012 SEIS Alignment Location:	1517
Frequency (yrs):	0-1
Predictability:	moderate
Material Volume (CY):	<10
Clast Size (ft):	0-1
Source Elev. (ft):	2000-3000
Centerline Slope:	fan
Alignment Location:	deposition_zone
Impact Alignment:	yes
Alignment Exposure (ft):	50-200
Vegetation:	disturbed
Deciduous Trees:	yes
2012 SEIS Alignment South Margin:	1516+70
2012 SEIS Alignment North Margin:	1517+70
Photo #:	3893, 5148, 5865, 6256

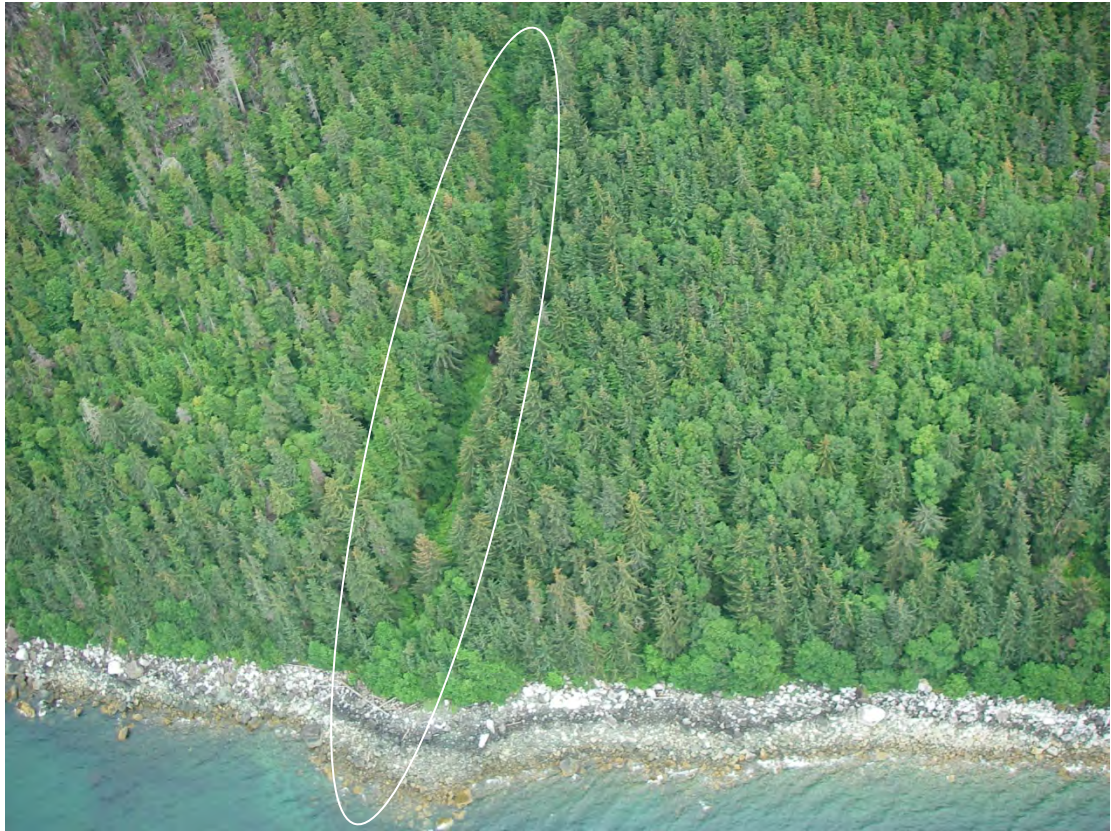
DF03. View east/upslope at debris flow channel, deposition zone, and fan.

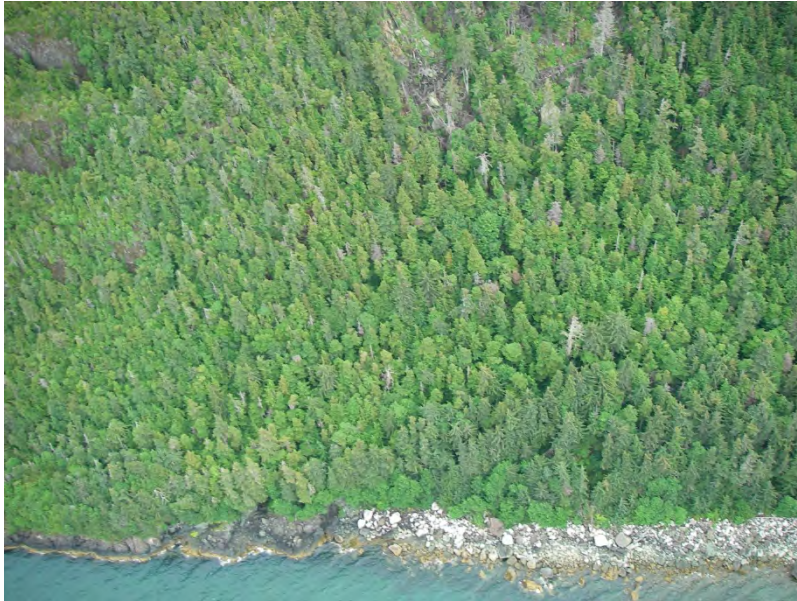
RS01. View east/upslope of area directly under rockslide. Some debris approaches the 2012 SEIS alignment which is located just east/upslope of the beach.

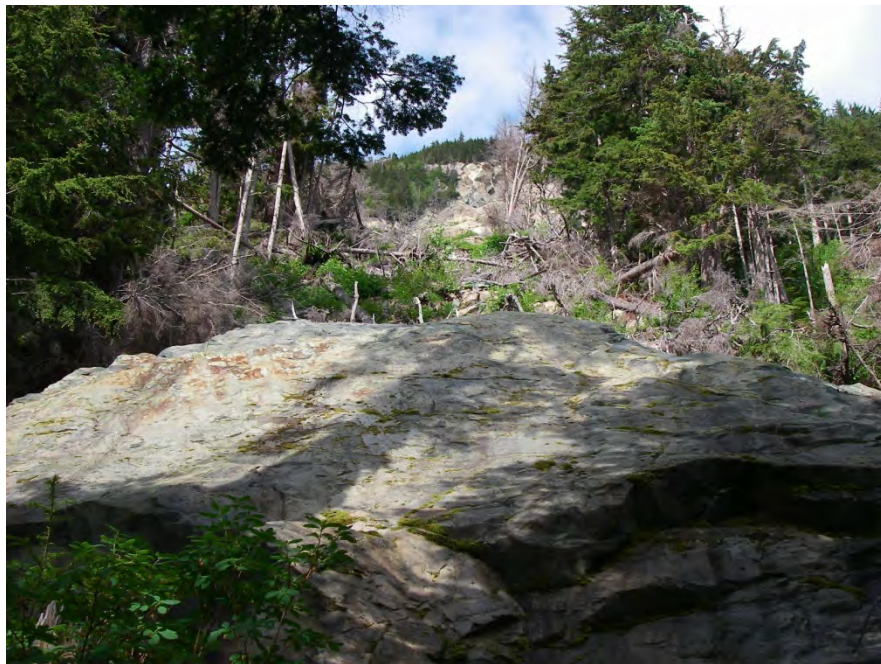
RS01. View east/upslope of 40 ft diameter boulder at bottom of rockslide and avalanche path.

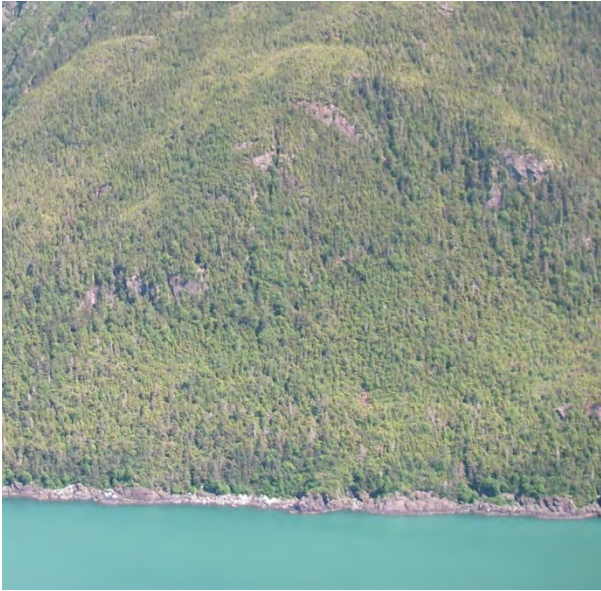
RF01. View east/upslope at rockfall hazard area.

Hazard ID #:	RF01
Hazard Type:	rockfall
HIN:	147
Rating:	C
2012 SEIS Alignment Location:	1550
Frequency (yrs):	1-5
Predictability:	unpredictable
Material Volume (CY):	<10
Clast Size (ft):	3-4
Source Elev. (ft):	100-500
Centerline Slope:	open_soil_slope
Alignment Location:	below_deposition_zone
Impact Alignment:	no
Alignment Exposure (ft):	200-500
Vegetation:	disturbed
Deciduous Trees:	yes
2012 SEIS Alignment South Margin:	1548+00
2012 SEIS Alignment North Margin:	1553+00
Photo #:	4212, 4214, 5148

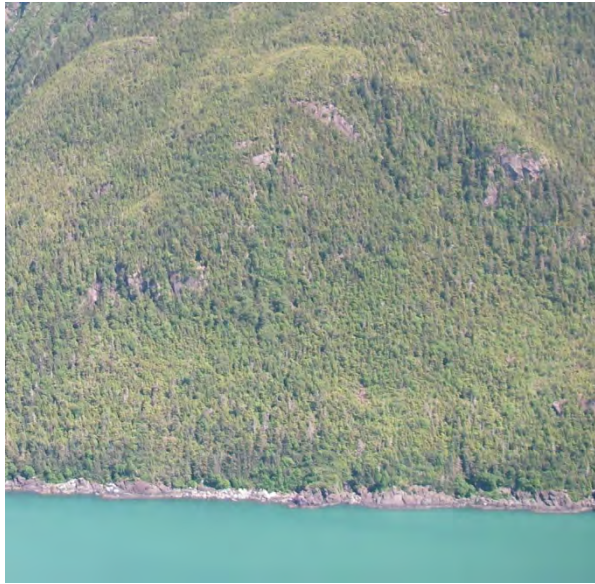
RF02. View east/upslope at rockfall hazard area.

Hazard ID #:	RF02
Hazard Type:	rockfall
HIN:	111
Rating:	C
2012 SEIS Alignment Location:	1550
Frequency (yrs):	5-25
Predictability:	unpredictable
Material Volume (CY):	<10
Clast Size (ft):	0-1
Source Elev. (ft):	100-500
Centerline Slope:	open_soil_slope
Alignment Location:	below_deposition_zone
Impact Alignment:	no
Alignment Exposure (ft):	50-200
Vegetation:	disturbed
Deciduous Trees:	yes
2012 SEIS Alignment South Margin:	1547+40
2012 SEIS Alignment North Margin:	1552+70
Photo #:	3049, 5149

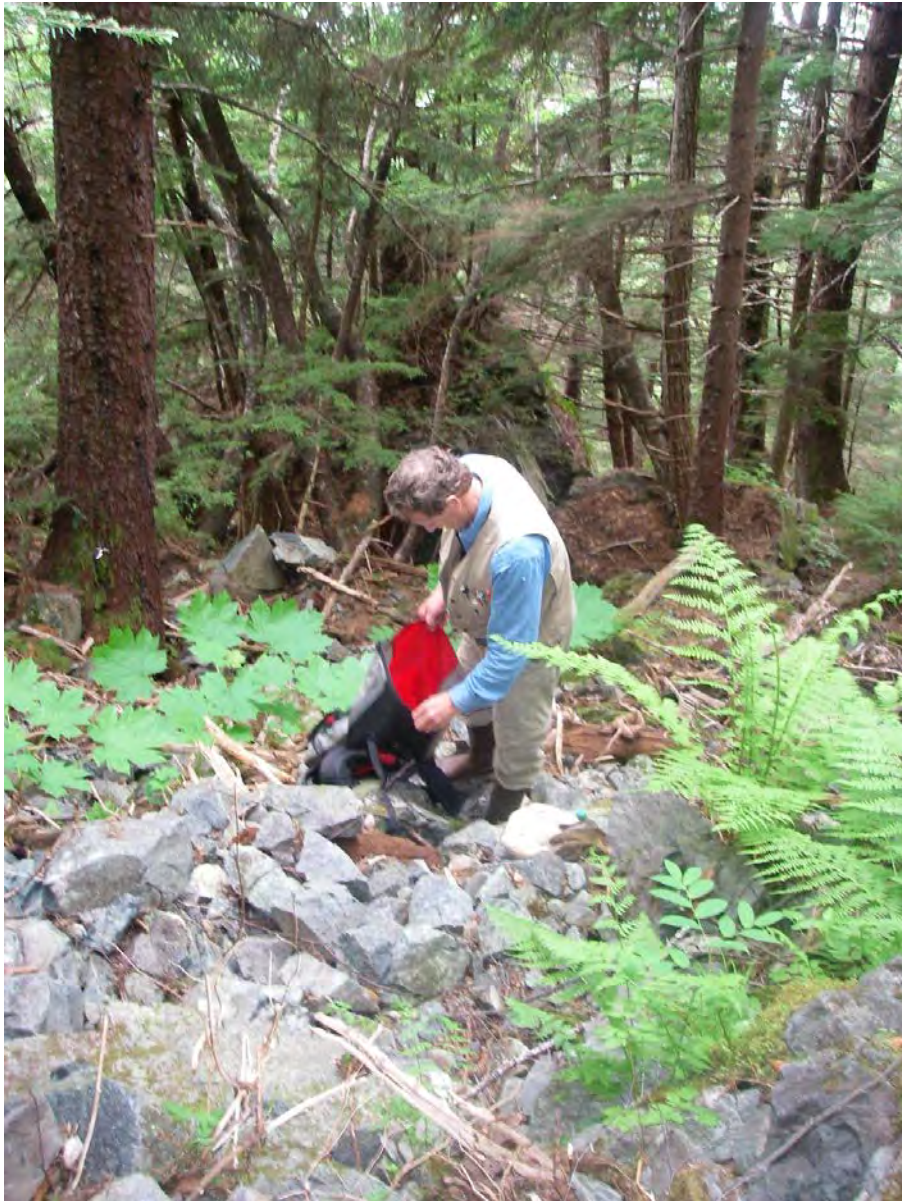
RF02. View west/downslope at rockfall deposition.

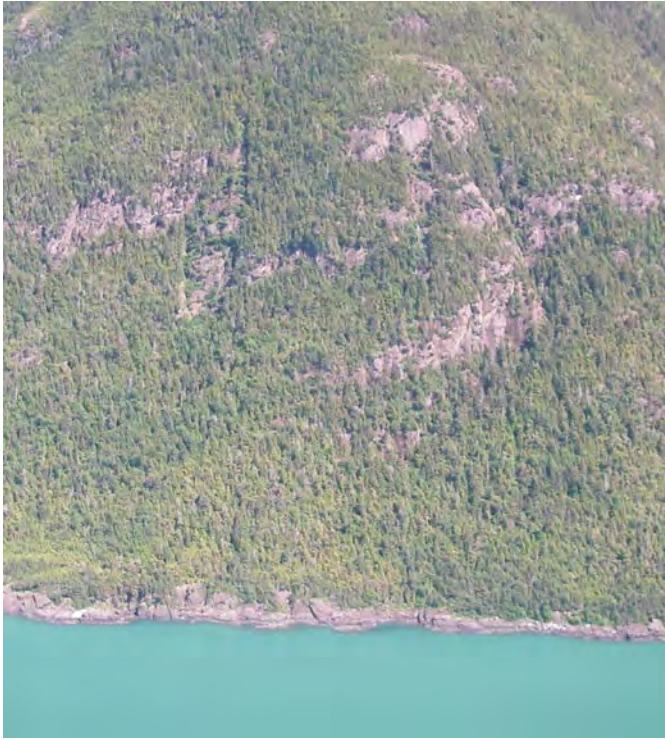
RF03. View east/upslope at rockfall area.

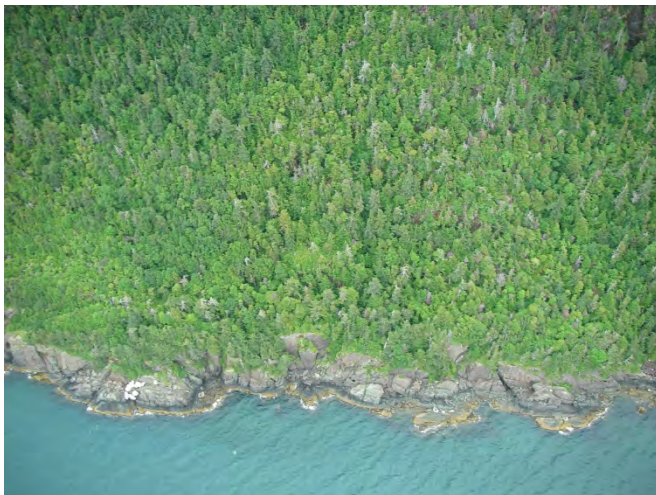
RF03. View east/upslope at rockfall area.

Hazard ID #:	RF03
Hazard Type:	rockfall
HIN:	129
Rating:	B
2012 SEIS Alignment Location:	1586
Frequency (yrs):	5-25
Predictability:	unpredictable
Material Volume (CY):	<10
Clast Size (ft):	4+
Source Elev. (ft):	100-500
Centerline Slope:	single_channel
Alignment Location:	deposition_zone
Impact Alignment:	yes
Alignment Exposure (ft):	200-500
Vegetation:	disturbed
Deciduous Trees:	yes
2012 SEIS Alignment South Margin:	1584+70
2012 SEIS Alignment North Margin:	1587+40
Photo #:	4259, 5873

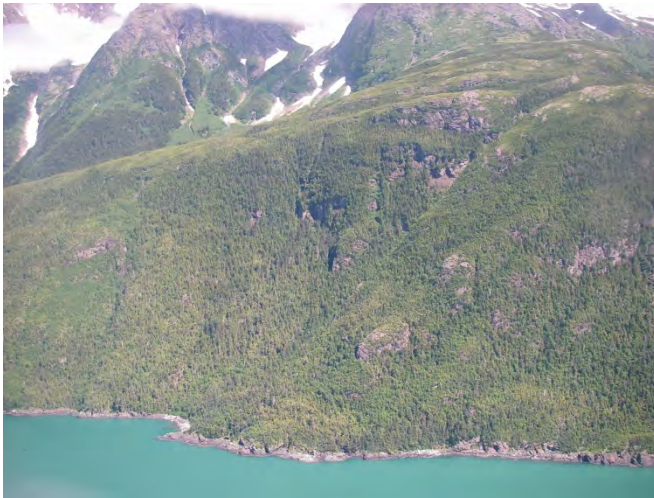
RF04. View east/upslope at rockfall area.

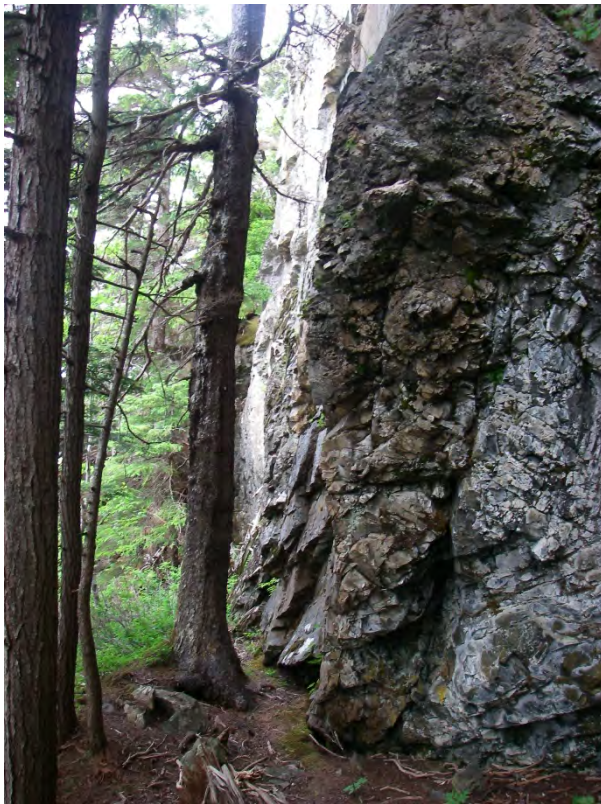
RF04. Base of vertical basalt cliff creating rockfall hazard.

Hazard ID #:	RF04
Hazard Type:	rockfall
HIN:	183
Rating:	B
2012 SEIS Alignment Location:	1609
Frequency (yrs):	unknown (5-25?)
Predictability:	unpredictable
Material Volume (CY):	<10
Clast Size (ft):	4+
Source Elev. (ft):	100-500
Centerline Slope:	open_soil_slope
Alignment Location:	deposition_zone
Impact Alignment:	yes
Alignment Exposure (ft):	500+
Vegetation:	disturbed
Deciduous Trees:	yes
2012 SEIS Alignment South Margin:	1606+20
2012 SEIS Alignment North Margin:	1611+60
Photo #:	4245, 4246, 4247, 4249

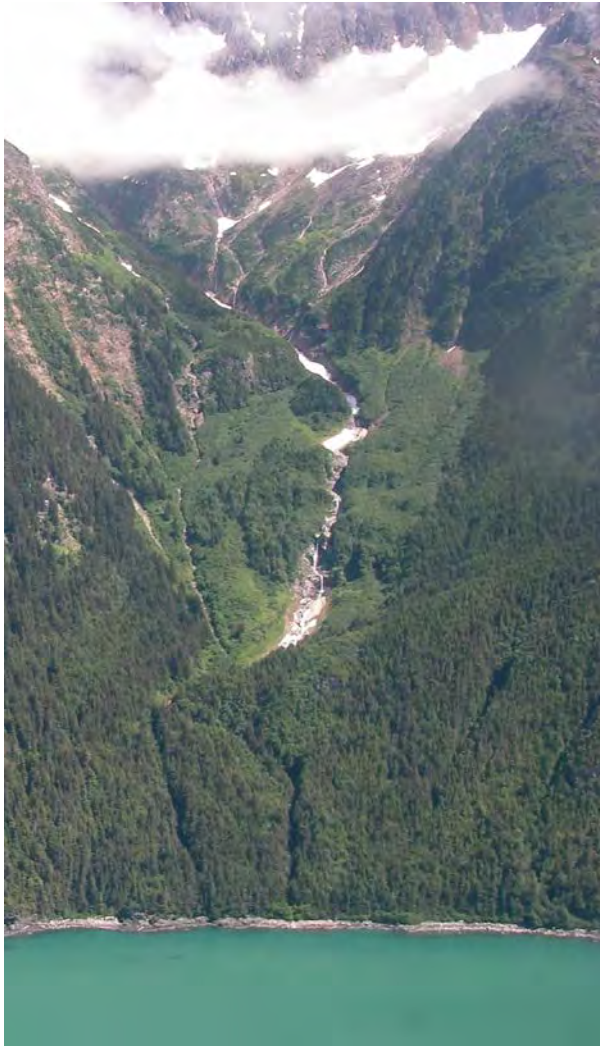
DF05. Debris flow channel visible as incised gully through trees in lower part of photo, left of center.

Hazard ID #:	DF05
Hazard Type:	debris_flow
HIN:	129
Rating:	A
2012 SEIS Alignment Location:	1675
Frequency (yrs):	1-5
Predictability:	high
Material Volume (CY):	10-100
Clast Size (ft):	0-1
Source Elev. (ft):	1000-2000
Centerline Slope:	single_channel
Alignment Location:	deposition_zone
Impact Alignment:	yes
Alignment Exposure (ft):	50-200
Vegetation:	denuded
Deciduous Trees:	no
2012 SEIS Alignment South Margin:	1674+20
2012 SEIS Alignment North Margin:	1675+40
Photo #:	6203, 6204

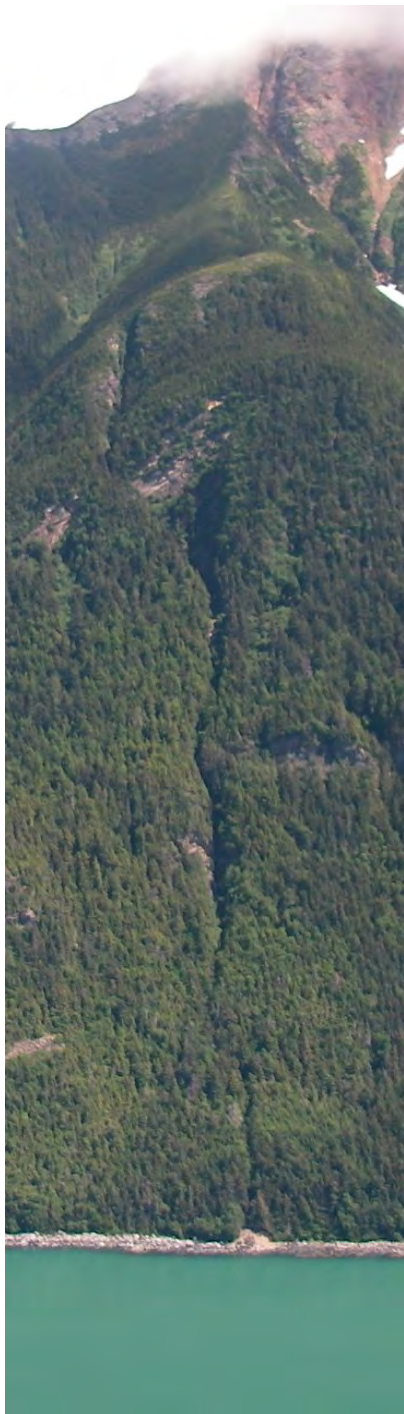
DF08. View east/upslope at debris flow channel and avalanche path.

Hazard ID #:	DF08
Hazard Type:	debris_flow
HIN:	129
Rating:	A
2012 SEIS Alignment Location:	1721
Frequency (yrs):	1-5
Predictability:	high
Material Volume (CY):	10-100
Clast Size (ft):	1-2
Source Elev. (ft):	>1000
Centerline Slope:	fan
Alignment Location:	deposition_zone
Impact Alignment:	yes
Alignment Exposure (ft):	50-200
Vegetation:	denuded
Deciduous Trees:	yes
2012 SEIS Alignment South Margin:	1720+30
2012 SEIS Alignment North Margin:	1721+30
Photo #:	1126, 5156

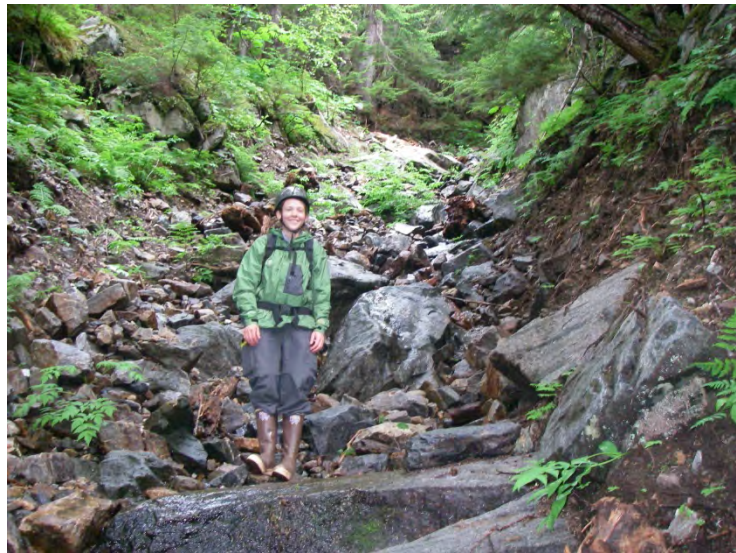
DF08. View east/upslope at debris flow chute and avalanche path.

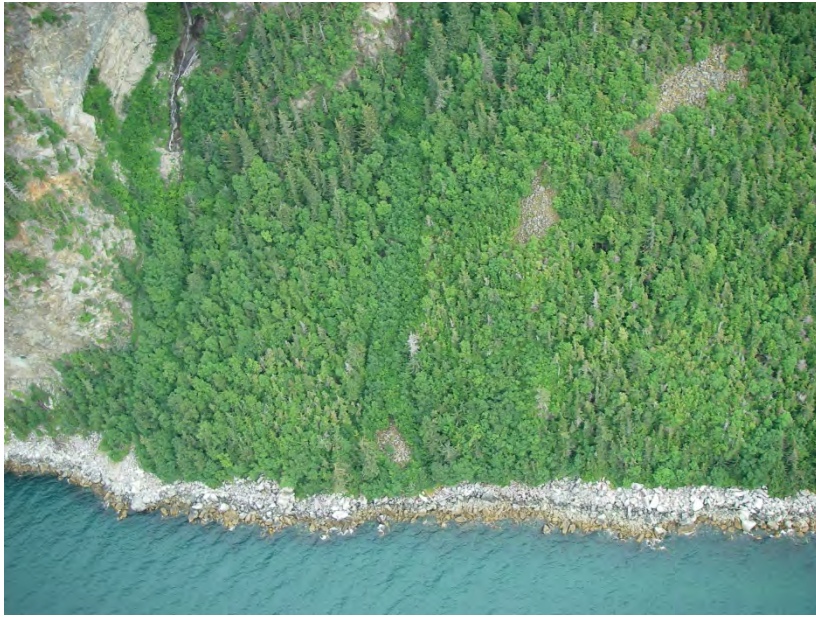
RF06. View east/upslope at rockfall zone.

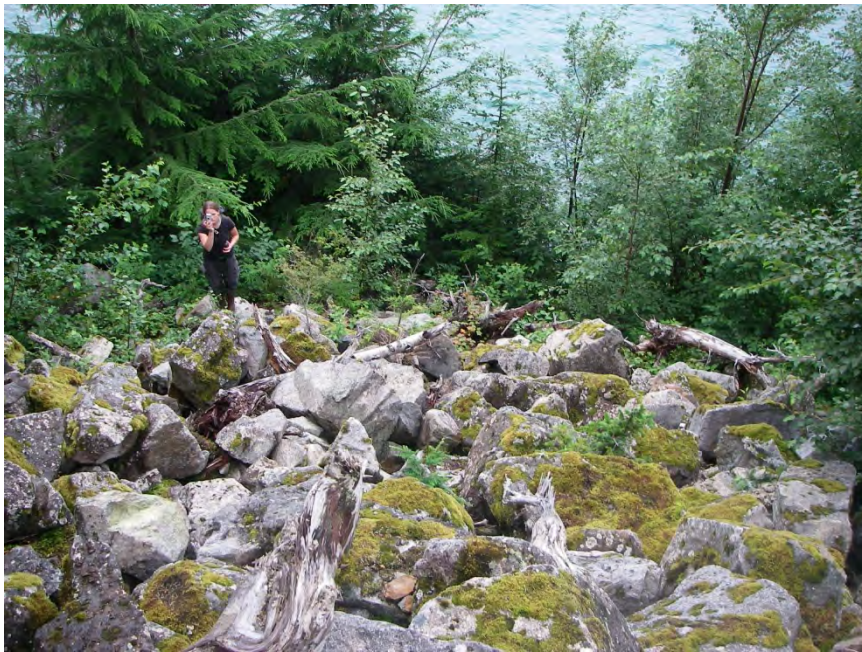
RF06. View west/downslope at rockfall.

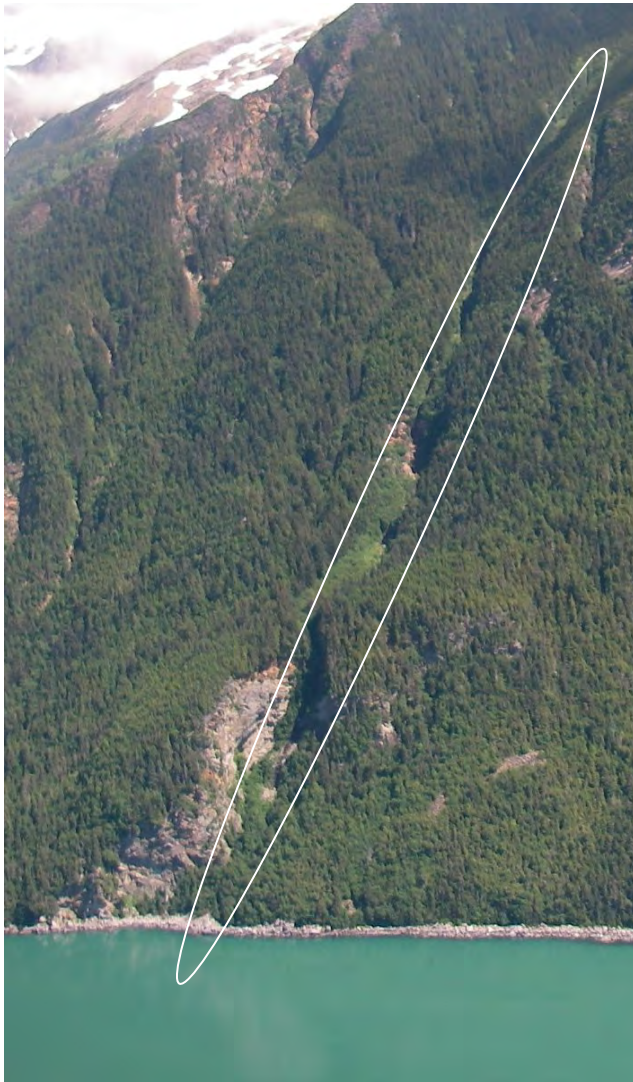
DF09. View east/upslope at debris flow channel and avalanche path.

Hazard ID #:	DF09
Hazard Type:	debris_flow
HIN:	153
Rating:	A
2012 SEIS Alignment Location:	1734
Frequency (yrs):	unknown (1-5?)
Predictability:	low
Material Volume (CY):	10-100
Clast Size (ft):	1-2
Source Elev. (ft):	>1000
Centerline Slope:	single_channel
Alignment Location:	path
Impact Alignment:	yes
Alignment Exposure (ft):	50-200
Vegetation:	disturbed
Deciduous Trees:	yes
2012 SEIS Alignment South Margin:	1732+90
2012 SEIS Alignment North Margin:	1734+90
Photo #:	3307

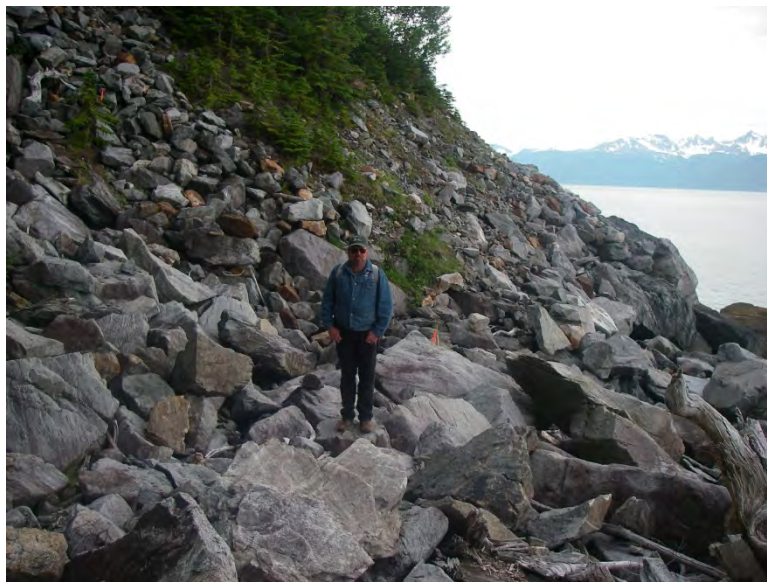
DF09. Debris flow and talus cone at base of debris flow and avalanche path.

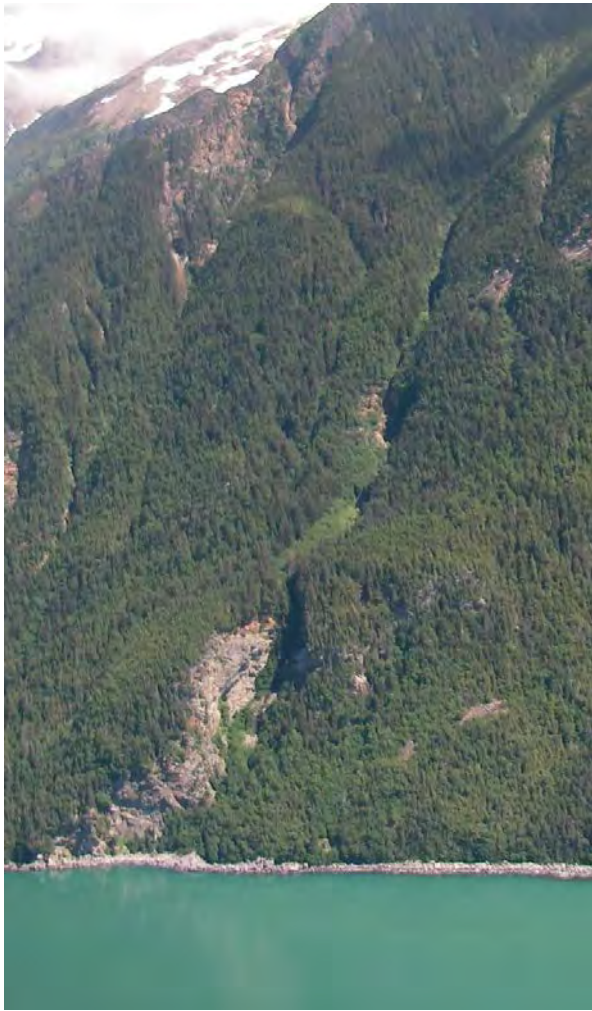
RF07. View east/upslope at rockfall hazard area.

Hazard ID #:	RF07
Hazard Type:	rockfall
HIN:	279
Rating:	A
2012 SEIS Alignment Location:	1738
Frequency (yrs):	0-1
Predictability:	unpredictable
Material Volume (CY):	10-100
Clast Size (ft):	4+
Source Elev. (ft):	500-1000
Centerline Slope:	open_bedrock_slope
Alignment Location:	deposition_zone
Impact Alignment:	yes
Alignment Exposure (ft):	>1000
Vegetation:	disturbed
Deciduous Trees:	yes
2012 SEIS Alignment South Margin:	1725+20
2012 SEIS Alignment North Margin:	1740+20
Photo #:	4674

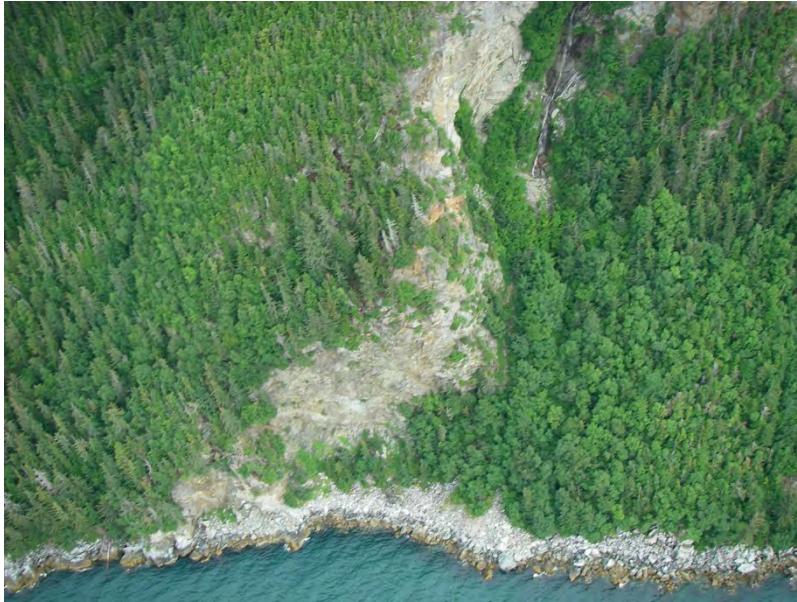
RF07. View east/upslope at 500 ft high gneiss cliffs with strong jointing and rockfall.

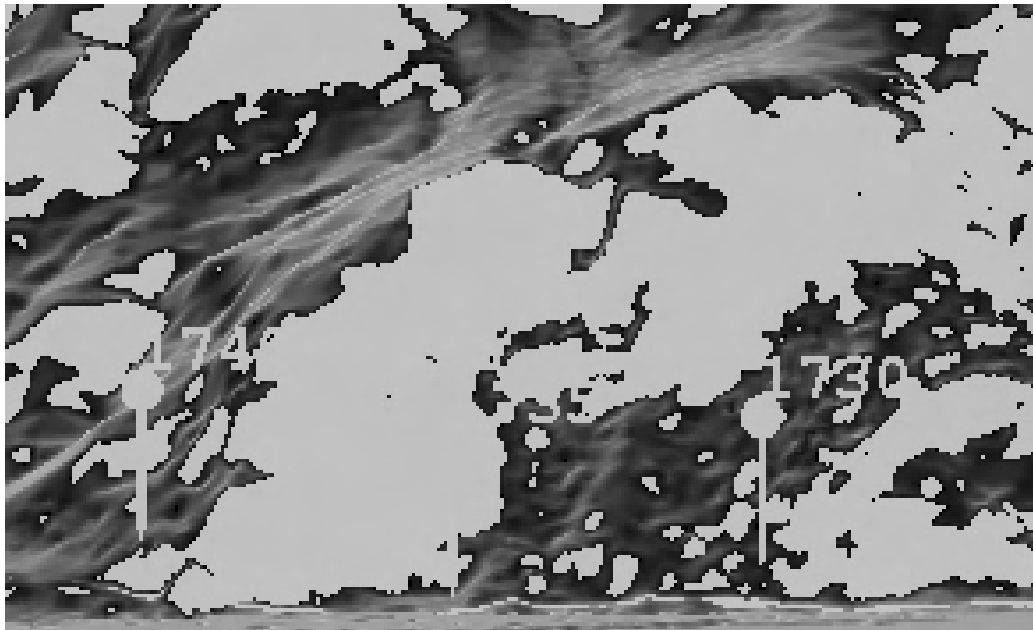
RF07. Bare earth LIDAR image of rockfall hazard area. Station labels represent previous IRP 2006 alignment.

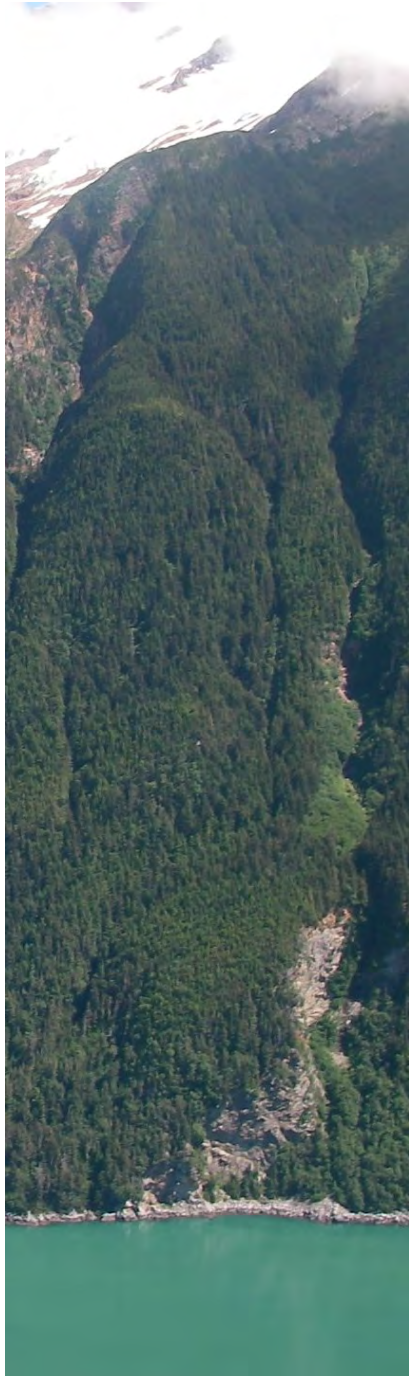
DF10. View east/upslope at debris flow channel.

Hazard ID #:	DF10
Hazard Type:	debris_flow
HIN:	129
Rating:	A
2012 SEIS Alignment Location:	1743
Frequency (yrs):	1-5
Predictability:	high
Material Volume (CY):	10-100
Clast Size (ft):	0-1
Source Elev. (ft):	>1000
Centerline Slope:	multi_channel
Alignment Location:	path
Impact Alignment:	yes
Alignment Exposure (ft):	50-200
Vegetation:	denuded
Deciduous Trees:	no
2012 SEIS Alignment South Margin:	1742+80
2012 SEIS Alignment North Margin:	1743+90
Photo #:	4745-4748

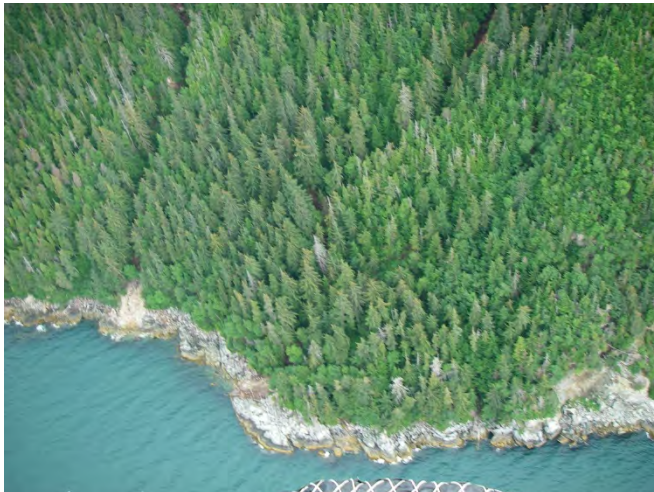
DF10. View east/upslope at debris flow terminus and deposition zone.

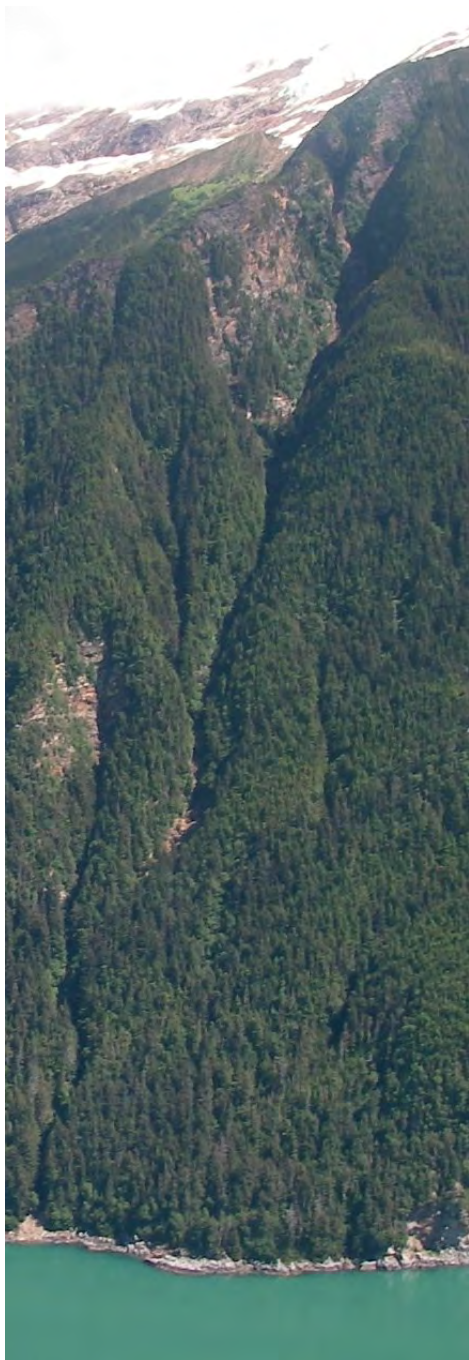
DF11. View east/upslope at debris flow channel and avalanche path.

Hazard ID #:	DF11
Hazard Type:	debris_flow
HIN:	129
Rating:	A
2012 SEIS Alignment Location:	1748
Frequency (yrs):	1-5
Predictability:	high
Material Volume (CY):	10-100
Clast Size (ft):	2-3
Source Elev. (ft):	>1000
Centerline Slope:	fan
Alignment Location:	deposition_zone
Impact Alignment:	yes
Alignment Exposure (ft):	50-200
Vegetation:	denuded
Deciduous Trees:	yes
2012 SEIS Alignment South Margin:	1747+40
2012 SEIS Alignment North Margin:	1748+50
Photo #:	4741, 4742, 5157

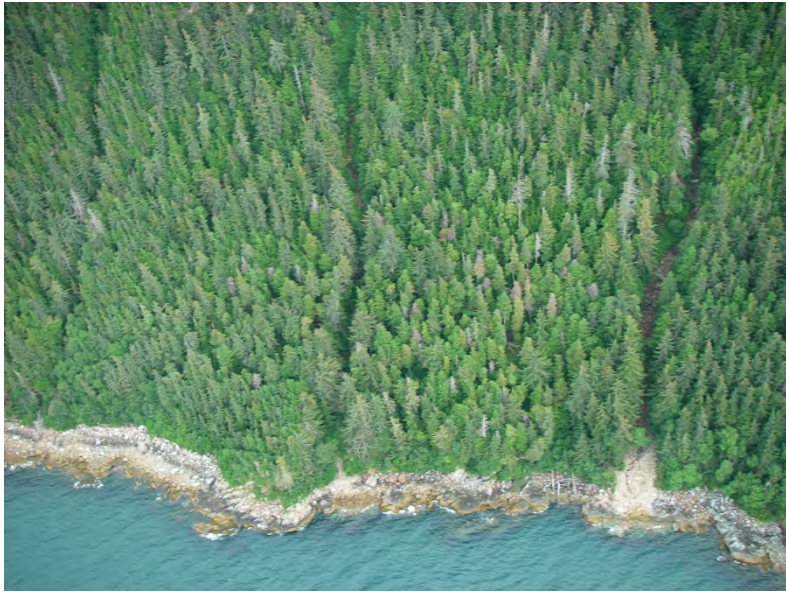
DF11. View east/upslope at debris flow deposition zone.

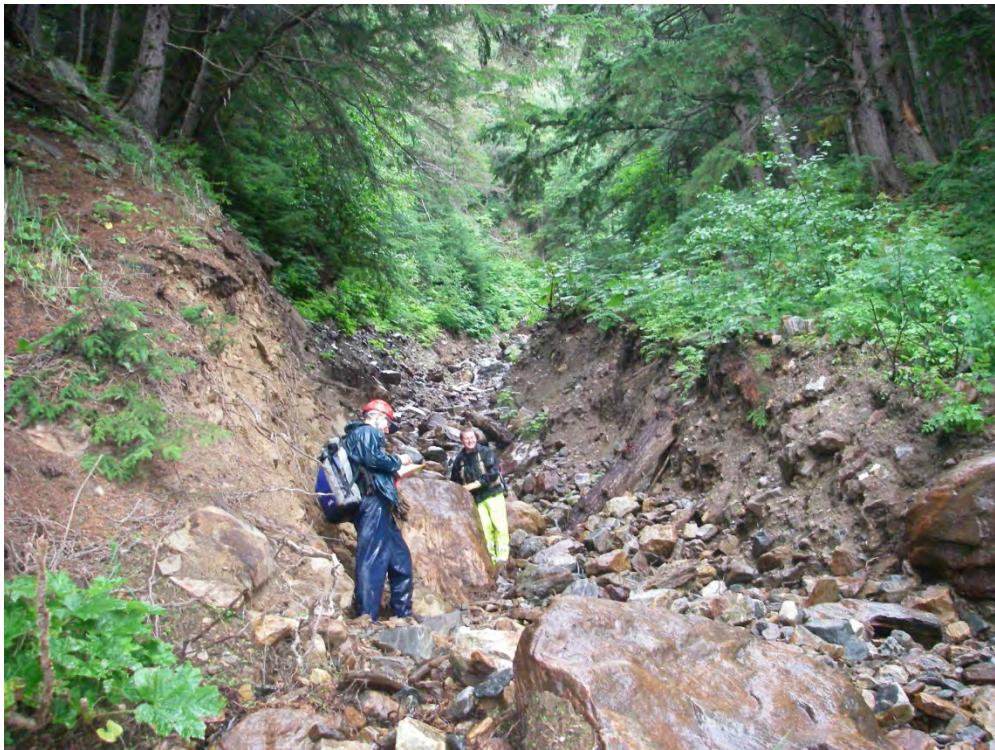
DF11. View east/upslope at debris flow channel and avalanche path.

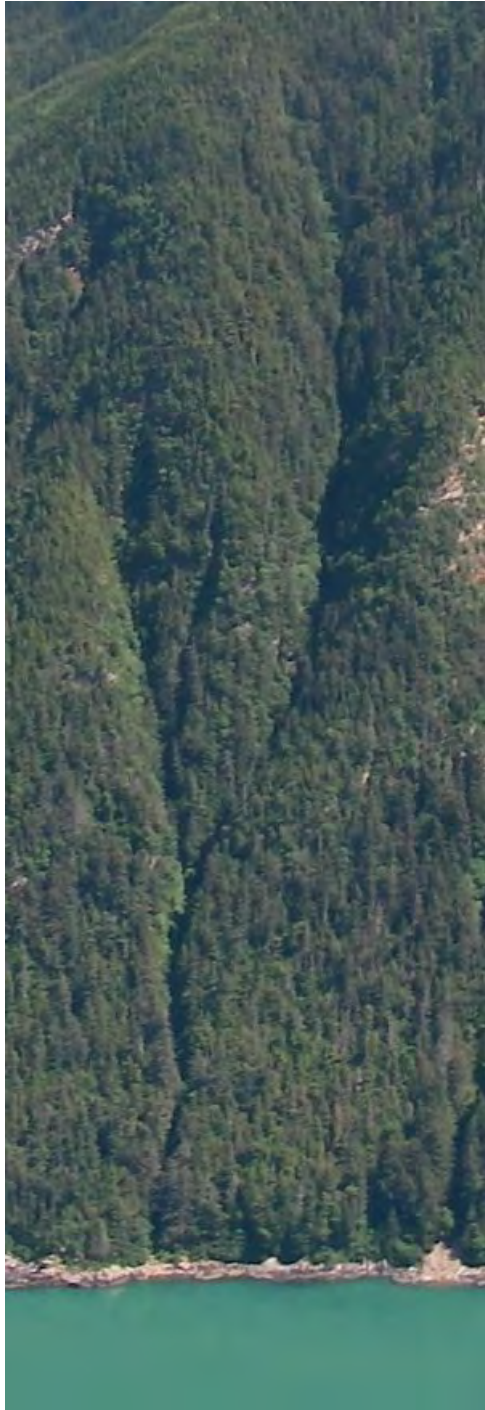
DF12. View east/upslope at debris flow channel and avalanche path.

Hazard ID #:	DF12
Hazard Type:	debris_flow
HIN:	111
Rating:	A
2012 SEIS Alignment Location:	1752
Frequency (yrs):	5-25
Predictability:	high
Material Volume (CY):	10-100
Clast Size (ft):	2-3
Source Elev. (ft):	>1000
Centerline Slope:	fan
Alignment Location:	deposition_zone
Impact Alignment:	yes
Alignment Exposure (ft):	50-200
Vegetation:	disturbed
Deciduous Trees:	yes
2012 SEIS Alignment South Margin:	1752+00
2012 SEIS Alignment North Margin:	1752+90
Photo #:	4738, 4739, 5157

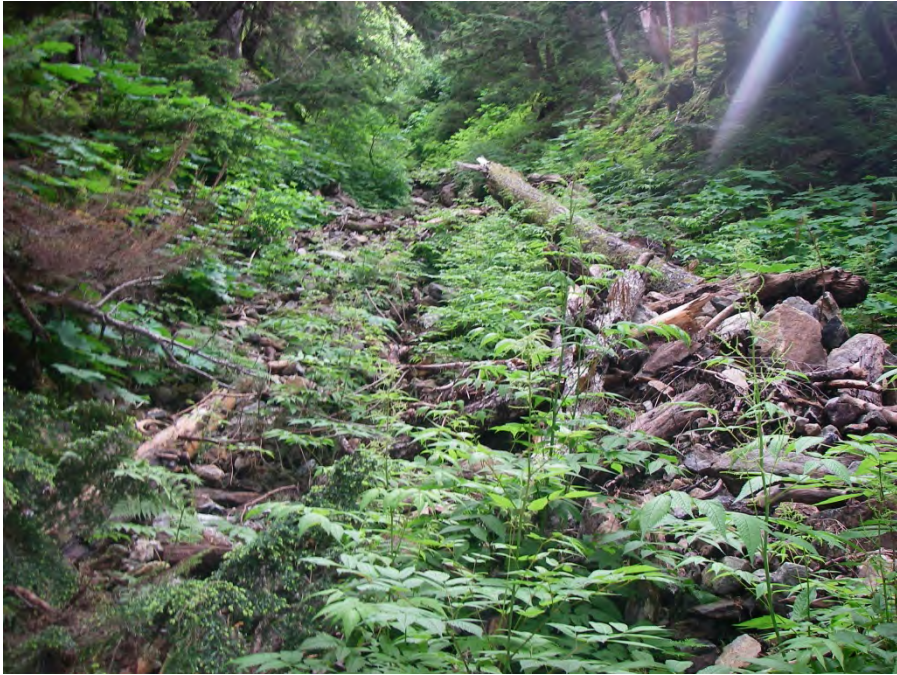
DF12. View east/upslope at debris flow channel and avalanche path.

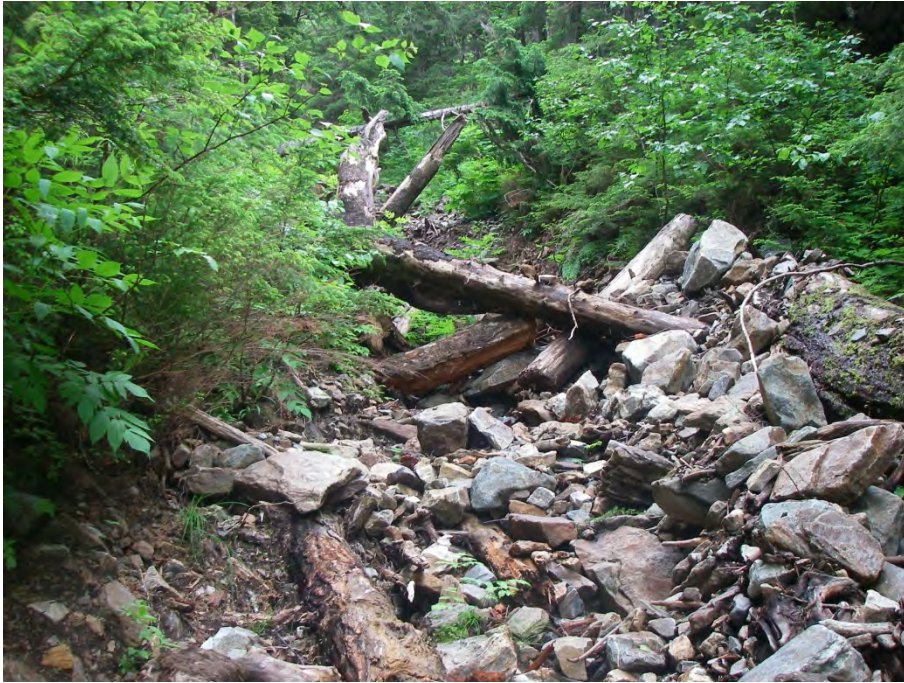
DF13. View east/upslope at debris flow channel and avalanche path.
