HYDROLOGIC AND HYDRAULIC REPORT

Hydrologic and Hydraulic Report
Kwigillingok Airport Improvements Project
Final

Hydraulic Mapping and Modeling
1091 West Chena Hills Drive
Fairbanks, AK 99709

February 2014

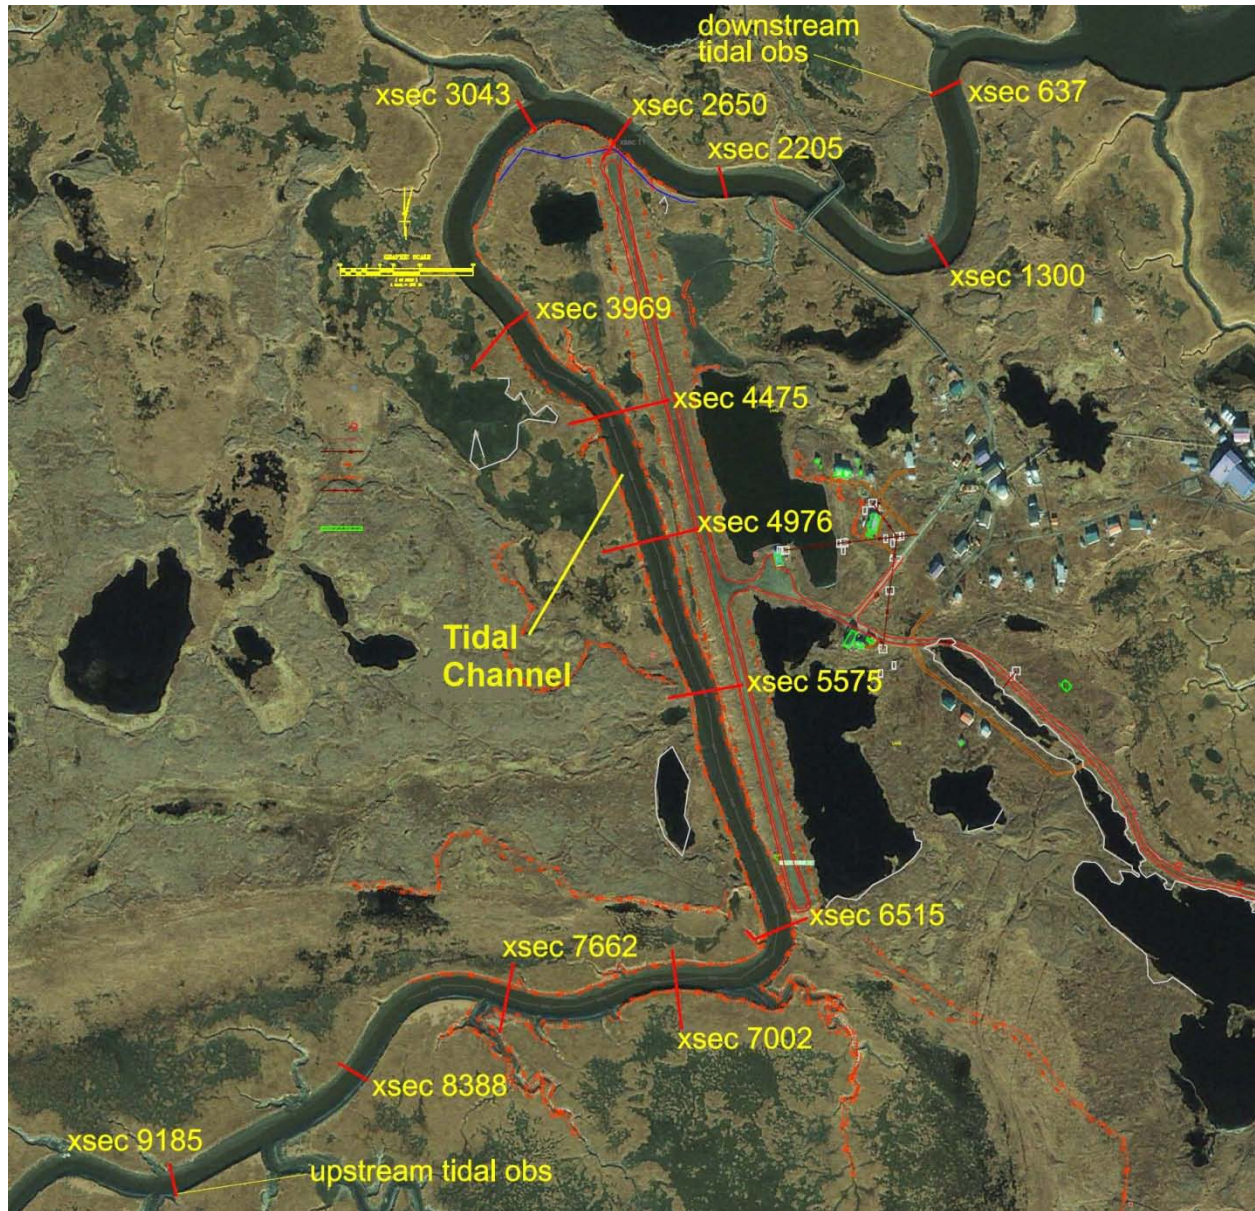
Figure 2. Cross-sections and tidal observation locations for HEC-RAS hydraulic analysis.

A numerical model of the tidal channel was constructed in HEC-RAS, using cross-sections surveyed by a PDC survey crew in August 2011. Fourteen cross-sections, labeled from 637 (downstream) to 9185 (upstream) were used in the model. Station 0 (zero) starts at the confluence of the tidal channel and the Kwigillingok River. See Figure 2 for cross-section location. Field observations, published tables, and engineering judgment were used to determine estimates of the Manning's n values. The selected n values used in the model are 0.03 (channel) and 0.10 (floodplain).

On 08/15/ 2011, PDC, Inc surveyors surveyed a series of water surface elevations during a period from 12:00 pm to 3:41 pm local time at the upstream tidal observation location on the tidal channel, and a set of simultaneous water surface elevations at both the upstream and downstream tidal observation locations at 3:41 pm local time, approximately 2 hours following the observed high tide (see Figure 2). The difference between simultaneous water surface elevations (0.13 feet) and the distance between the tidal observation locations (8,550 feet) were used to estimate a normal depth slope for a calibration of the HEC-RAS model. The estimated

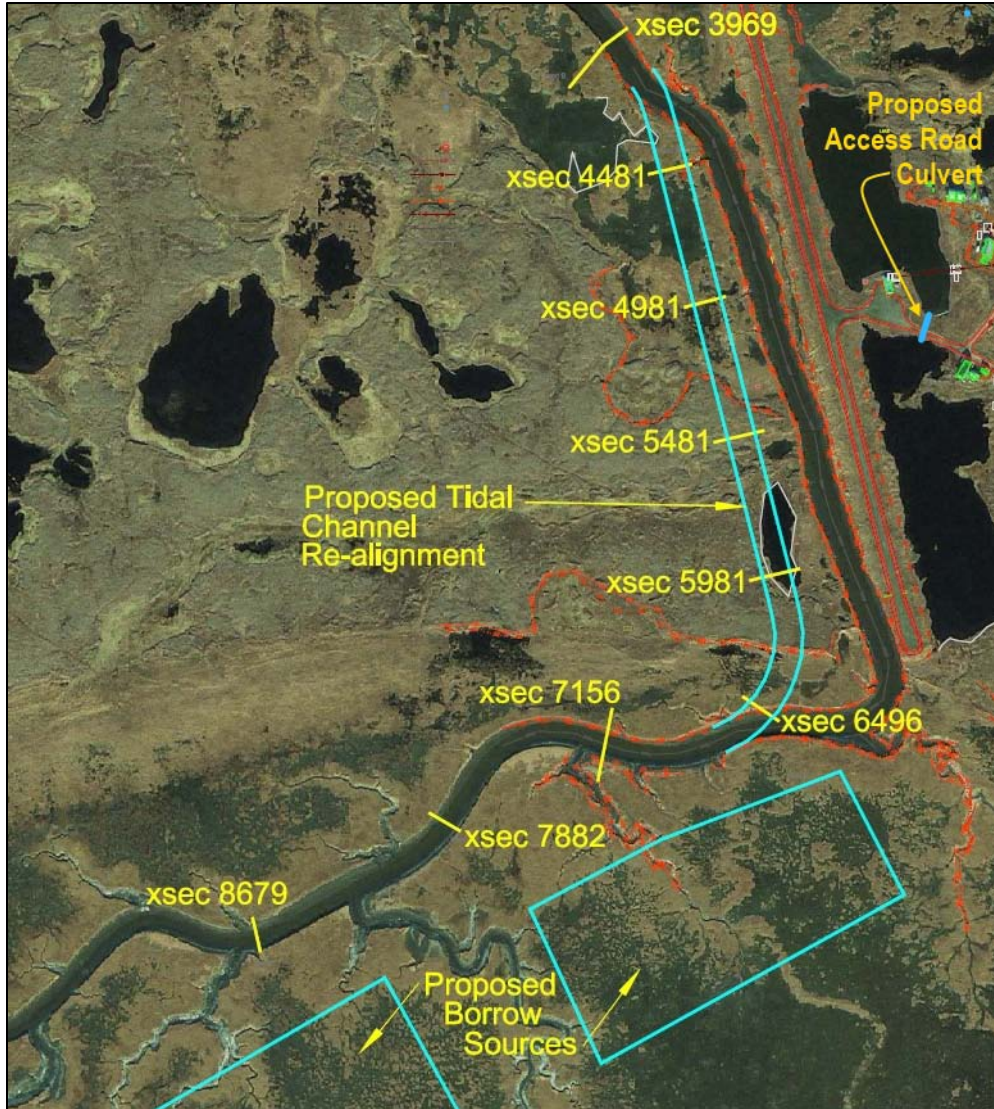
Figure 4. Proposed tidal channel realignment and HEC-RAS cross-sections.

To realign the tidal channel, a new channel approximately 2500 feet in length must be excavated. To determine how channel geometry affects the channel hydraulic performance, four channel shapes were selected for analysis. The four geometries are described in Table 7 and shown in Figure 5.

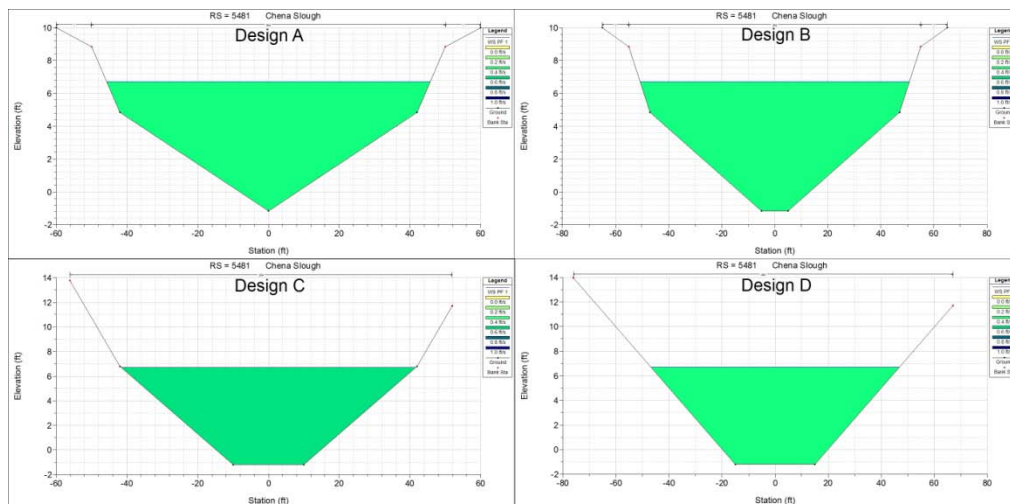
Figure 5. Design shapes for tidal channel realignment.

Design A	Design B	Design C	Design D
Shallow V-shaped, no flat channel, banks 7:1 for 6 vertical feet then 2:1 for 4 vertical feet	Shallow V-shaped channel with 10 foot flat middle, banks 7:1 for 6 vertical feet then 2:1 for 4 vertical feet	V-shaped channel with 20 foot flat middle; banks 4:1 for 8 vertical feet then 2:1 for 4 vertical feet	V-shaped channel with 30 foot flat middle, single slope banks 4:1

The tidal channel realignment results in a shorter channel than the existing channel it replaces. The realignment shortens the existing 3270-foot reach by 506 feet, upstream of Cross-section 3969. The slope of the existing channel is 0.0006 ft/ft. The slope of the shortened channel is 0.0007 ft/ft. The hydraulic modeling is based on the assumption that the same quantity of water will flow upstream during the flood tide and downstream during the ebb tide, even though the channel is shorter and slightly steeper. Results shown are from Cross-section 5481, located approximately in the center of the new channel alignment. A comparison of average channel velocities and other characteristics for the four channel design geometries is shown in Table 8. Channel shapes and water surface elevations for the 4 design geometries are shown in Figure 5.
