MATERIAL SITE INVESTIGATION

AMBLER AIRPORT REHABILITATION

AKSAS PROJECT NO. 61303

MARCH 2005

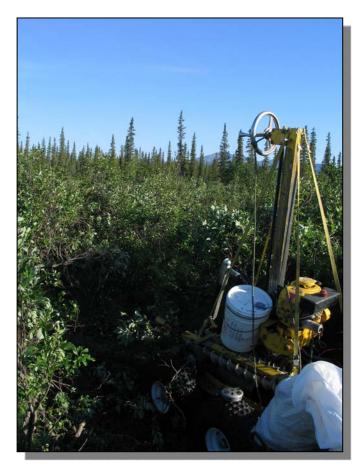
FIGURE 2

GENERAL SURFACE CONDITIONS AT THE CANDIDATE MATERIAL SOURCE AREAS (Photographs from the Reconnaissance Explorations)

Area "A" (near RM-P-A4)

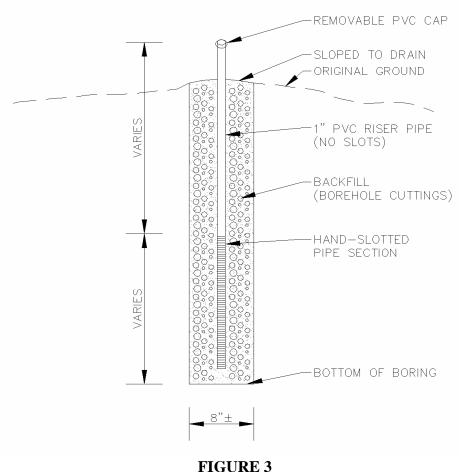
TYPICAL GROUNDWATER OBSERVATION WELL

drilling, borings RM-04, RM-12 and RM-18 were completed with slotted PVC pipe for the purpose of observing groundwater levels, as illustrated in Figure 3. All of our groundwater measurements are summarized in Table 4. Note that the site lies in the floodplain of the Ambler River, and the depth to groundwater is expected to fluctuate with the water level in the river.

Groundwater was observed in all 24 test holes drilled during the design explorations at this site; at depths (measured while drilling) typically ranging from approximately 7.5 to 14.1 feet. After

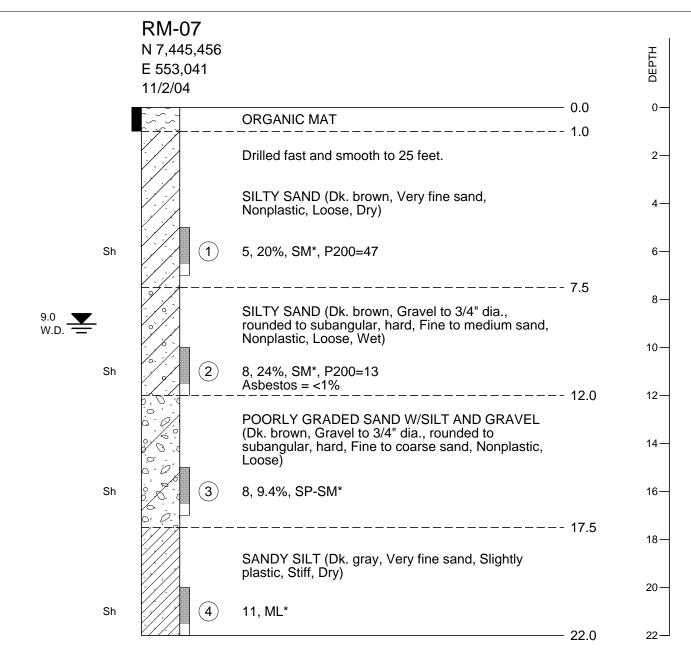
DWN:	P.K.H.	PREPARED BY: R&M CONSULTANTS, INC.	MATERIAL SITE EXPLORATION	FB: NA
CKD:	R.L.S.		AMBLER, ALASKA	GRID: AMBLER R.
DATE:	NOV. 04		LOG OF TEST BORING	PROJ.NO: 041030
SCALE:	1"=4'		RM-07	DWG.NO: B-09

Coordinates are in UTM UPS Zone 4W (meters), WGS84 map datum.

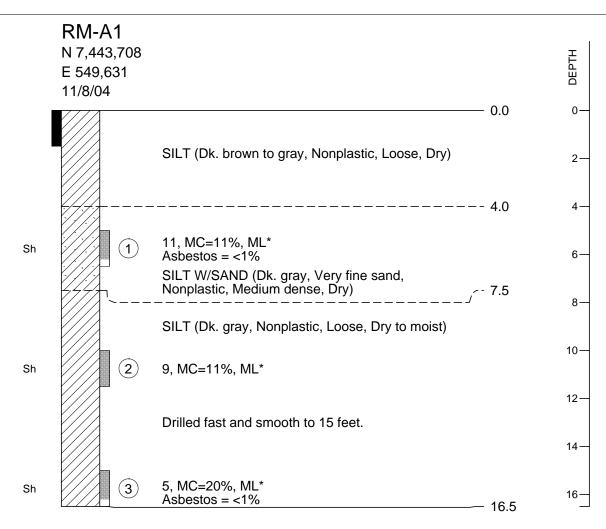
MATERIAL SITE EXPLORATION AMBLER, ALASKA LOG OF TEST BORING RM-A1

No groundwater was observed while drilling.

Coordinates are in UTM UPS Zone 4W (meters), WGS84 map datum.

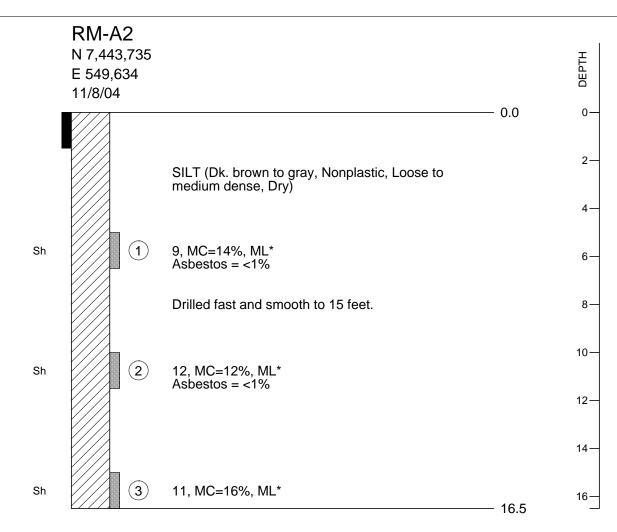
MATERIAL SITE EXPLORATION AMBLER, ALASKA LOG OF TEST BORING RM-A2

No groundwater was observed while drilling.

Coordinates are in UTM UPS Zone 4W (meters), WGS84 map datum.
