The Use of Geofibers and Synthetic Fluids Kwigillingok Airport

Prepared for the Alaska Department of Transportation

By: Rodney Collins and Billy Connor

February 2011

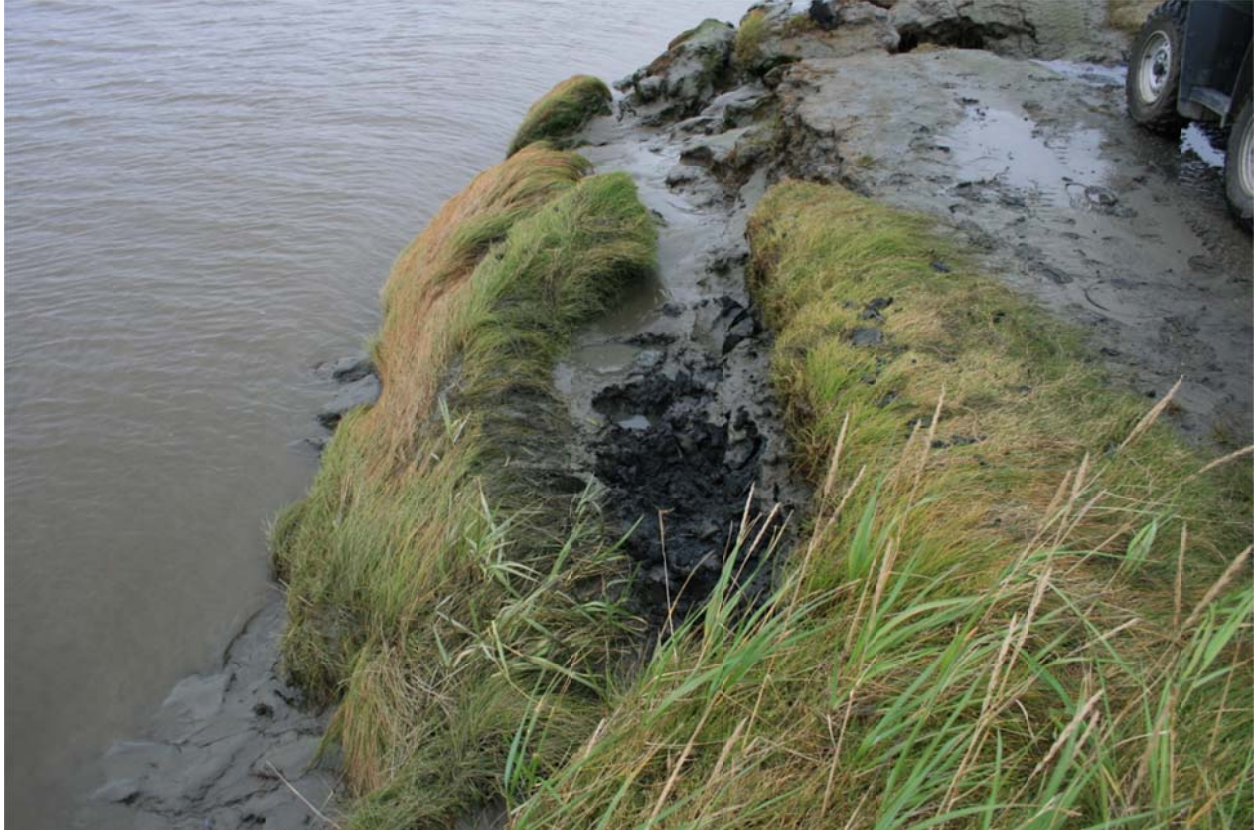
Figure 7: Area where clay was collected

Material was needed for use in laboratory testing. This will be treated with geofibers and synthetic fluid in an attempt to improve the strength and stability of the soil. The material collected is clay from the riverbank. This is representative of the soil found throughout Kwigillingok. A picture showing the site the clay was collected from is presented as [Fig.7](#). The site is also indicated by a star on [Fig.6](#).
