CADD	ECC	GEOLOGIC HAZARD SUMMARY ARRANGED BY 2012 SEIS STATIONING LYNN CANAL HIGHWAY PHASE 2 2012 SEIS ALIGNMENT HAZARD REVISIONS		
	DATE	9/10/12			
	CHECK	RGD			
	FILE No.	GEO_HAZ_SUMM.PPT			
PROJECT No.	113-95756	DATE	9/24/12	HDR / 2012 SEIS JUNEAU ACCESS / AK	G-2
		REV	1

TITLE
GEOLOGIC HAZARD SUMMARY
ARRANGED BY 2012 SEIS STATIONING
 LYNN CANAL HIGHWAY PHASE 2
 2012 SEIS ALIGNMENT HAZARD REVISIONS

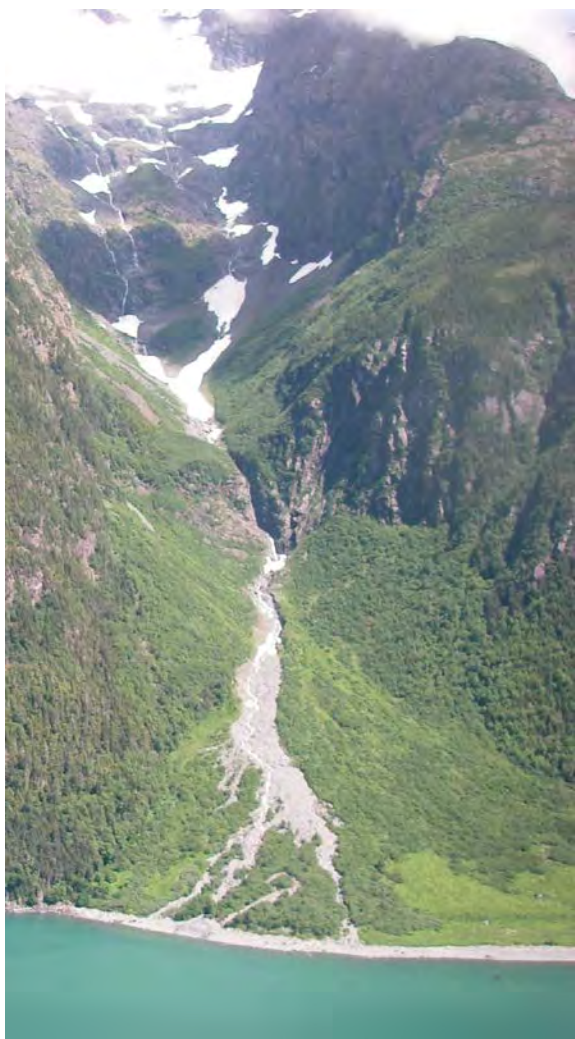
DF01. View east/upslope at alluvial fan with debris flow deposition zone (gray) and avalanche path.

Hazard ID #:	DF01
Hazard Type:	debris_flow
HIN:	225
Rating:	A
2012 SEIS Alignment Location:	1495
Frequency (yrs):	1-5
Predictability:	moderate
Material Volume (CY):	100-1000
Clast Size (ft):	1-2
Source Elev. (ft):	>1000
Centerline Slope:	fan
Alignment Location:	deposition_zone
Impact Alignment:	yes
Alignment Exposure (ft):	500+
Vegetation:	denuded
Deciduous Trees:	yes
2012 SEIS Alignment South Margin:	1492+00
2012 SEIS Alignment North Margin:	1498+00
Photo #:	4098, 4099, 5146

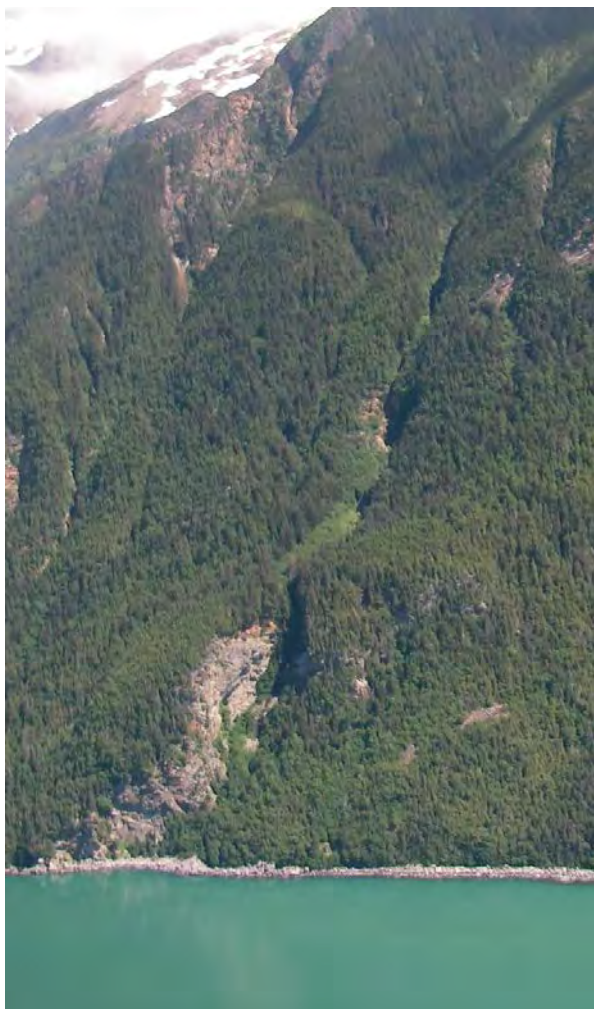
RF07. View east/upslope at rockfall hazard area.

Hazard ID #:	RF07
Hazard Type:	rockfall
HIN:	279
Rating:	A
2012 SEIS Alignment Location:	1738
Frequency (yrs):	0-1
Predictability:	unpredictable
Material Volume (CY):	10-100
Clast Size (ft):	4+
Source Elev. (ft):	500-1000
Centerline Slope:	open_bedrock_slope
Alignment Location:	deposition_zone
Impact Alignment:	yes
Alignment Exposure (ft):	>1000
Vegetation:	disturbed
Deciduous Trees:	yes
2012 SEIS Alignment South Margin:	1725+20
2012 SEIS Alignment North Margin:	1740+20
Photo #:	4674

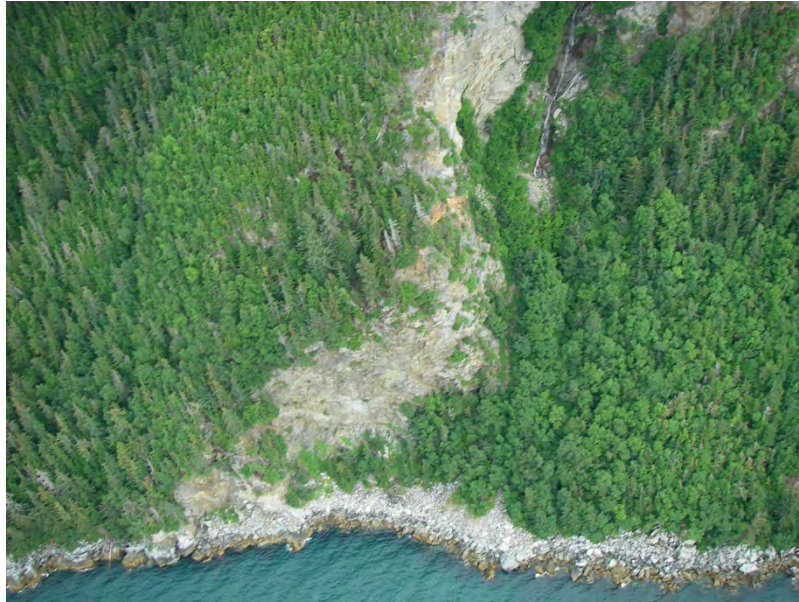
RF07. View east/upslope at 500 ft high gneiss cliffs with strong jointing and rockfall.

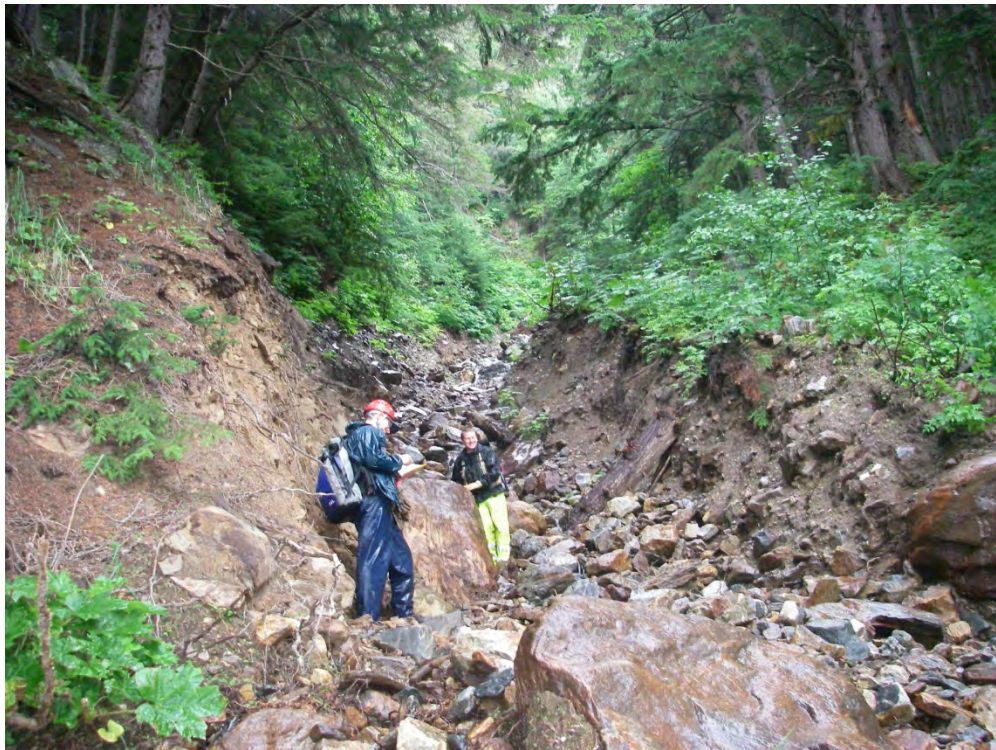
DF11. View east/upslope at debris flow channel and avalanche path.

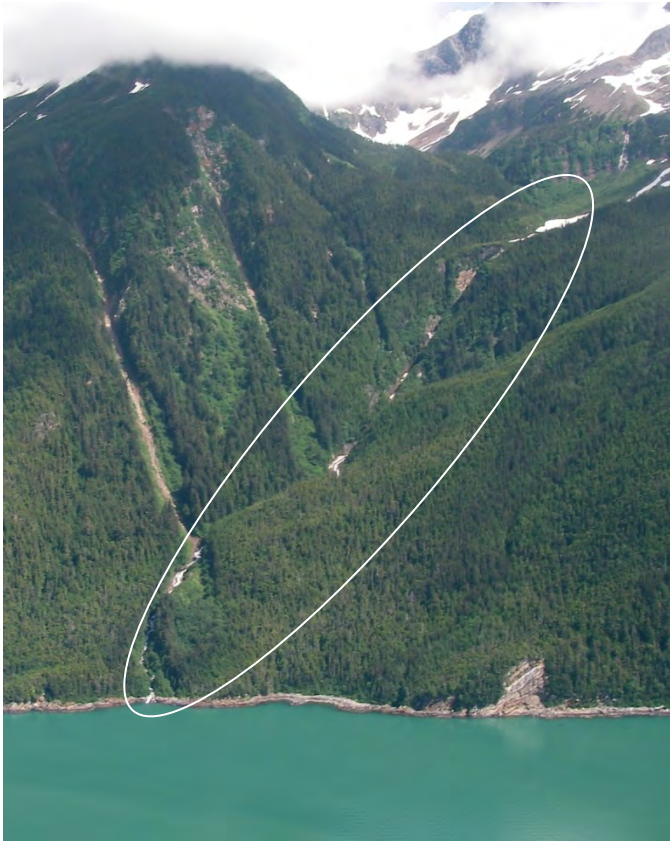
DF16. View east/upslope at debris flow channel and avalanche path.

Hazard ID #:	DF16
Hazard Type:	debris_flow
HIN:	207
Rating:	A
2012 SEIS Alignment Location:	1786
Frequency (yrs):	1-5
Predictability:	moderate
Material Volume (CY):	1000+
Clast Size (ft):	2-3
Source Elev. (ft):	>1000
Centerline Slope:	multi_channel
Alignment Location:	path
Impact Alignment:	yes
Alignment Exposure (ft):	50-200
Vegetation:	disturbed
Deciduous Trees:	yes
2012 SEIS Alignment South Margin:	1785+00
2012 SEIS Alignment North Margin:	1786+30
Photo #:	1141, 2091, 5158

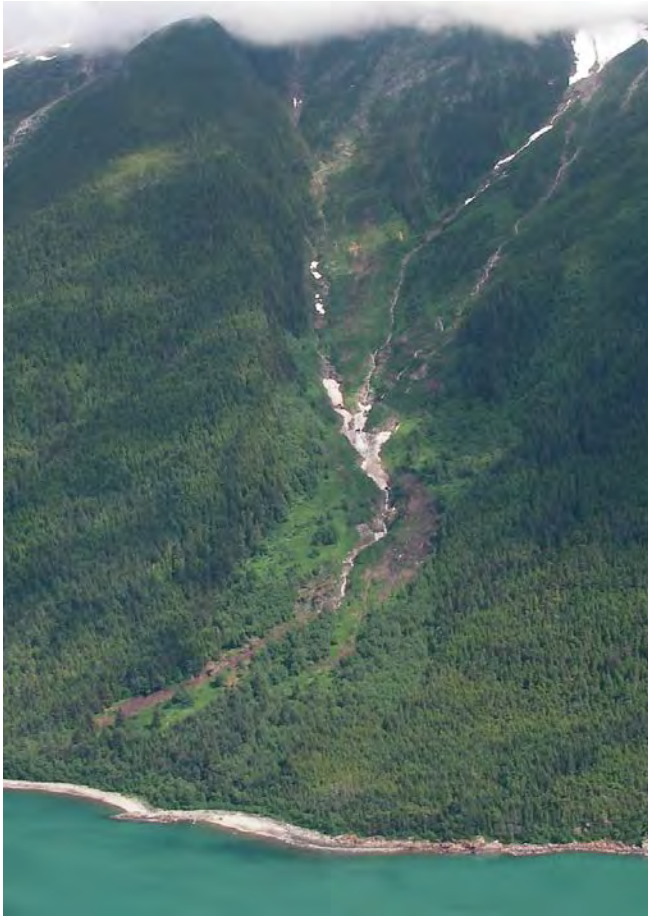
DF18. Debris flow and avalanche path.

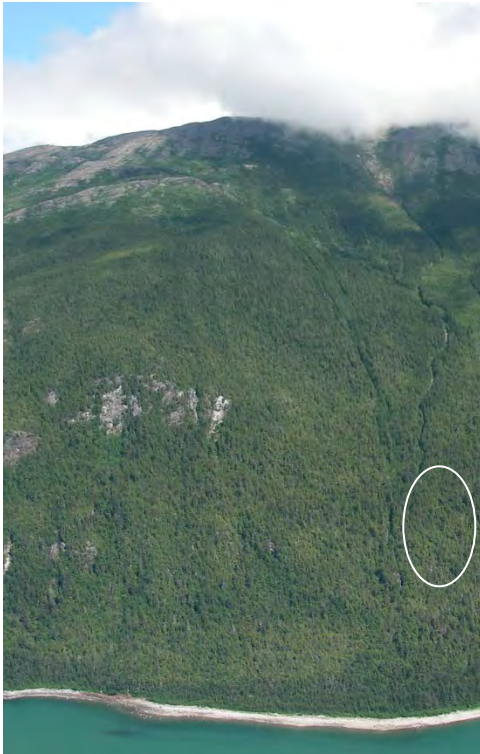
RF12. View east/upslope at rockfall area.

Hazard ID #:	RF12
Hazard Type:	rockfall
HIN:	105
Rating:	C
2012 SEIS Alignment Location:	1917
Frequency (yrs):	unknown (>25?)
Predictability:	unpredictable
Material Volume (CY):	<10
Clast Size (ft):	4+
Source Elev. (ft):	100-500
Centerline Slope:	-
Alignment Location:	below_deposition_zone
Impact Alignment:	no
Alignment Exposure (ft):	50-200
Vegetation:	disturbed
Deciduous Trees:	yes
2012 SEIS Alignment South Margin:	1916+10
2012 SEIS Alignment North Margin:	1917+30
Photo #:	5162

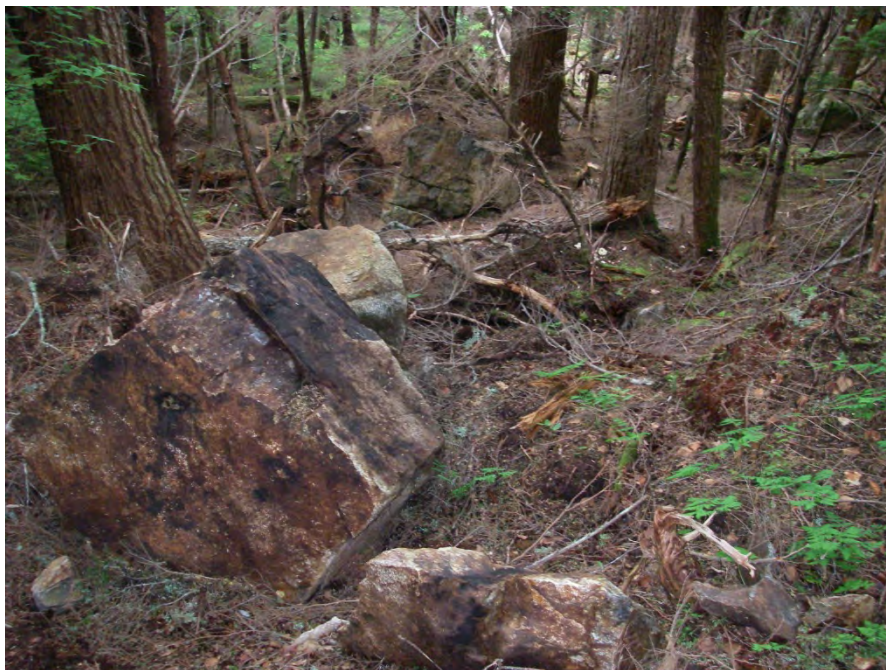
RF14. View west/downslope at fresh rockfall with 3-4 ft diameter boulders.

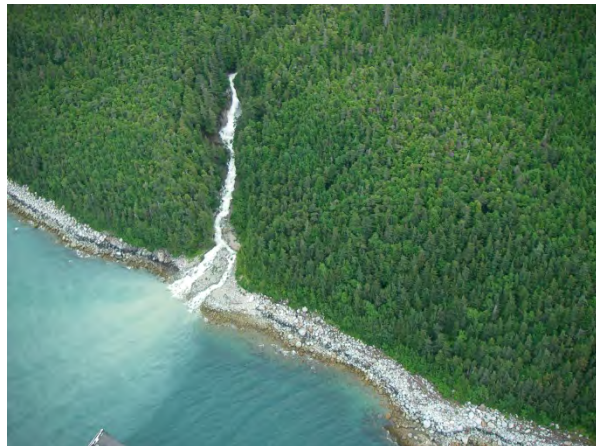
DF22. View east/upslope at debris flow channel.

Hazard ID #:	DF22
Hazard Type:	debris_flow
HIN:	129
Rating:	A
2012 SEIS Alignment Location:	1984
Frequency (yrs):	1-5
Predictability:	high
Material Volume (CY):	10-100
Clast Size (ft):	1-2
Source Elev. (ft):	2000-3000
Centerline Slope:	fan
Alignment Location:	deposition_zone
Impact Alignment:	yes
Alignment Exposure (ft):	50-200
Vegetation:	disturbed
Deciduous Trees:	no
2012 SEIS Alignment South Margin:	1983+50
2012 SEIS Alignment North Margin:	1985+00
Photo #:	5047, 5164, 5914

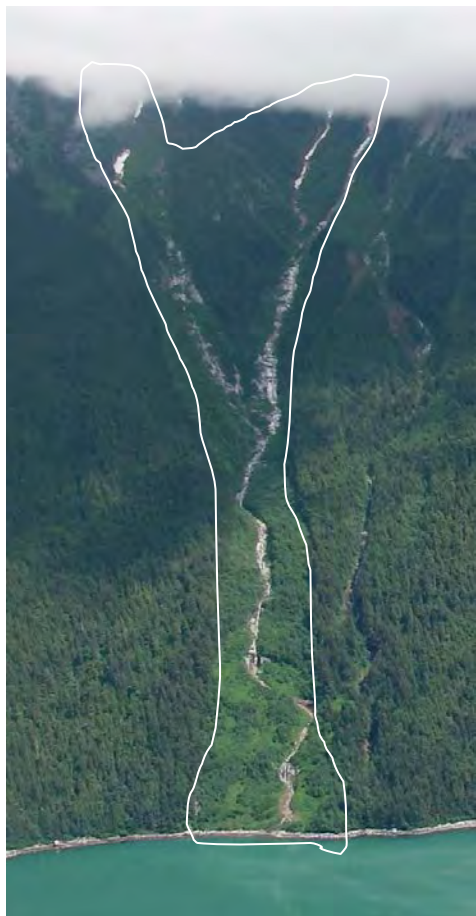
DF26. View east/upslope at debris flow channel and avalanche path.

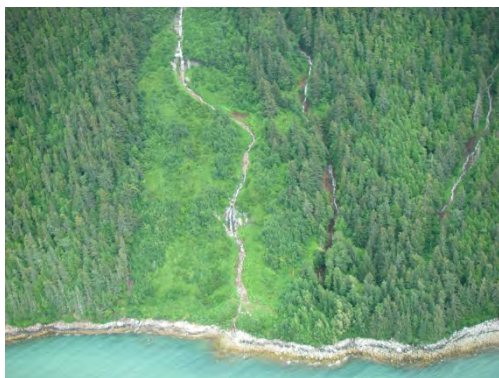
DF26. View east/upslope at debris flow channel and avalanche path (center).

Hazard ID #:	DF26
Hazard Type:	debris_flow
HIN:	129
Rating:	B
2012 SEIS Alignment Location:	2059
Frequency (yrs):	1-5
Predictability:	high
Material Volume (CY):	10-100
Clast Size (ft):	0-1
Source Elev. (ft):	3000+
Centerline Slope:	fan
Alignment Location:	deposition_zone
Impact Alignment:	yes
Alignment Exposure (ft):	50-200
Vegetation:	disturbed
Deciduous Trees:	yes
2012 SEIS Alignment South Margin:	2058+80
2012 SEIS Alignment North Margin:	2059+60
Photo #:	2241, 3470, 6195

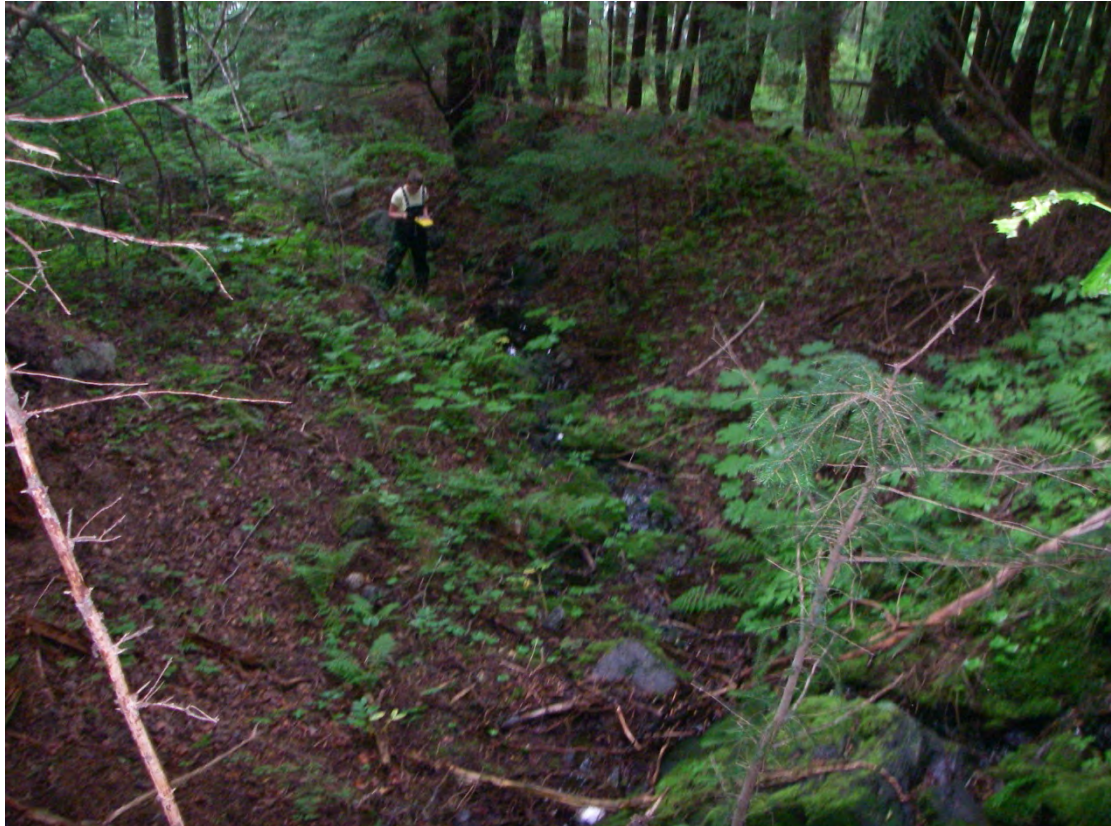
DF27. View east/upslope at debris flow channel and avalanche path.

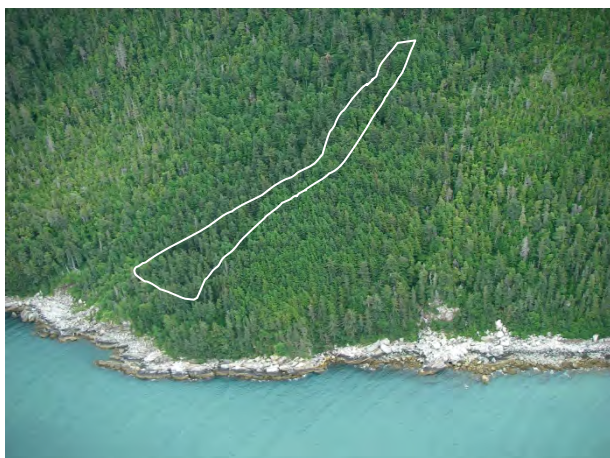
DF28. View east/upslope at debris flow channel.

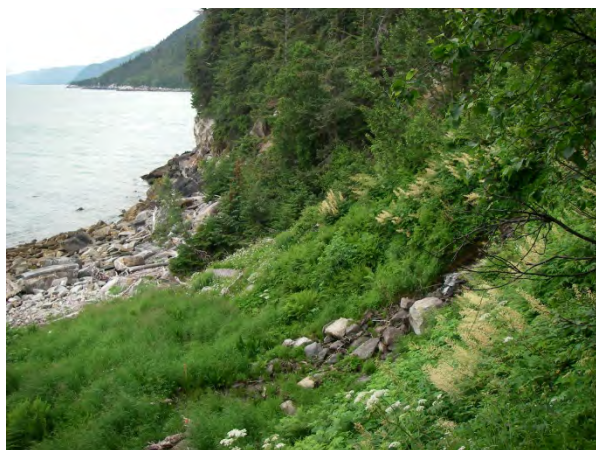
DF28. View northwest (up alignment and downslope) at deposition fan of debris flow.

Hazard ID #:	DF28
Hazard Type:	debris_flow
HIN:	183
Rating:	A
2012 SEIS Alignment Location:	2102
Frequency (yrs):	0-1
Predictability:	high
Material Volume (CY):	10-100
Clast Size (ft):	3-4
Source Elev. (ft):	3000+
Centerline Slope:	fan
Alignment Location:	deposition_zone
Impact Alignment:	yes
Alignment Exposure (ft):	50-200
Vegetation:	denuded
Deciduous Trees:	yes
2012 SEIS Alignment South Margin:	2101+40
2012 SEIS Alignment North Margin:	2102+30
Photo #:	3886, 5916

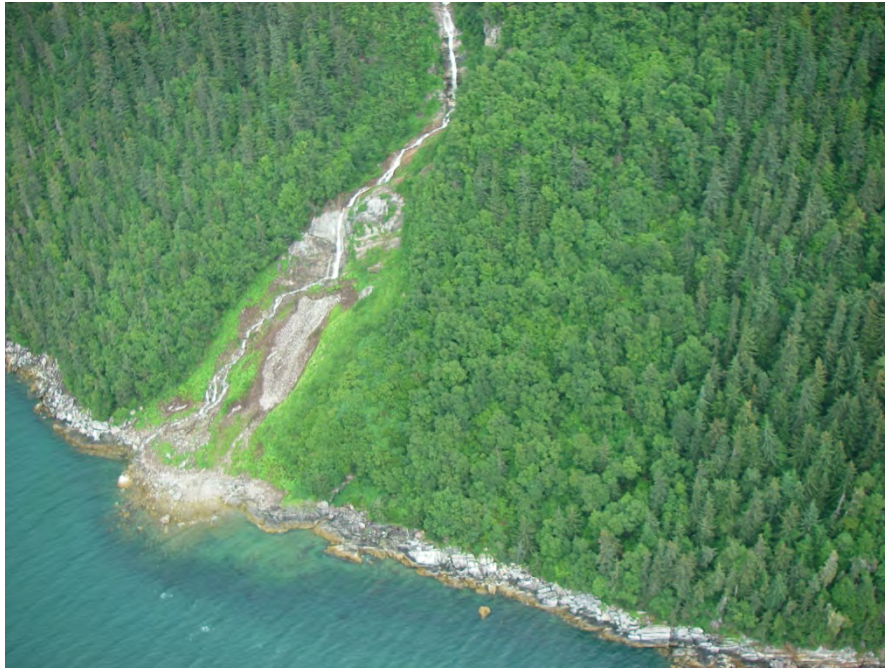
Hazard ID #:	DF29
Hazard Type:	debris_flow
HIN:	153
Rating:	A
2012 SEIS Alignment Location:	2115
Frequency (yrs):	1-5
Predictability:	moderate
Material Volume (CY):	10-100
Clast Size (ft):	1-2
Source Elev. (ft):	3000+
Centerline Slope:	fan
Alignment Location:	deposition_zone
Impact Alignment:	yes
Alignment Exposure (ft):	200-500
Vegetation:	denuded
Deciduous Trees:	yes
2012 SEIS Alignment South Margin:	2114+10
2012 SEIS Alignment North Margin:	2116+60
Photo #:	5125, 5926, 6248

DF29. View northeast (up alignment and upslope) at debris flow deposition zone and avalanche path.

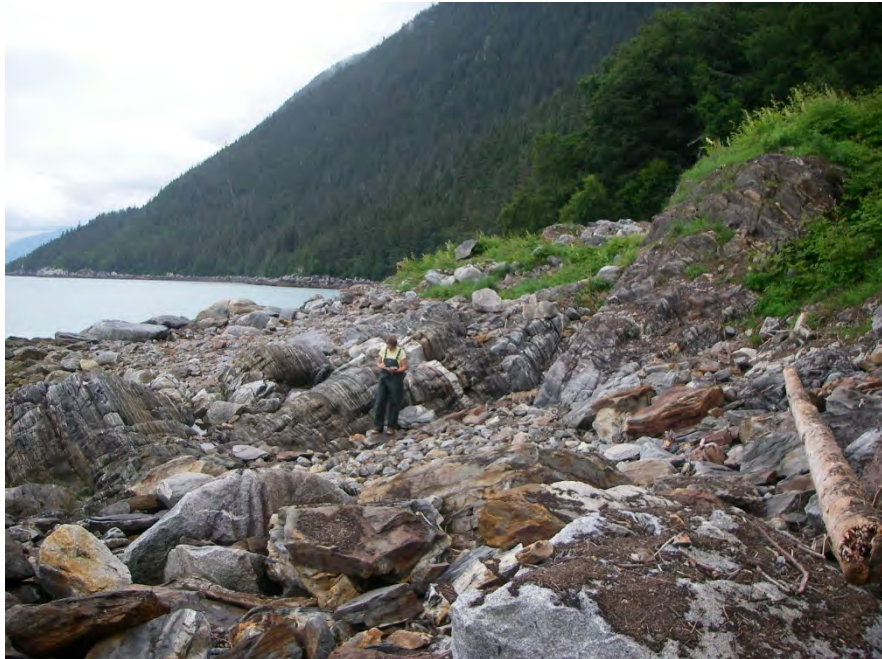
DF29. View north/up alignment across debris flow fan at base of avalanche path.

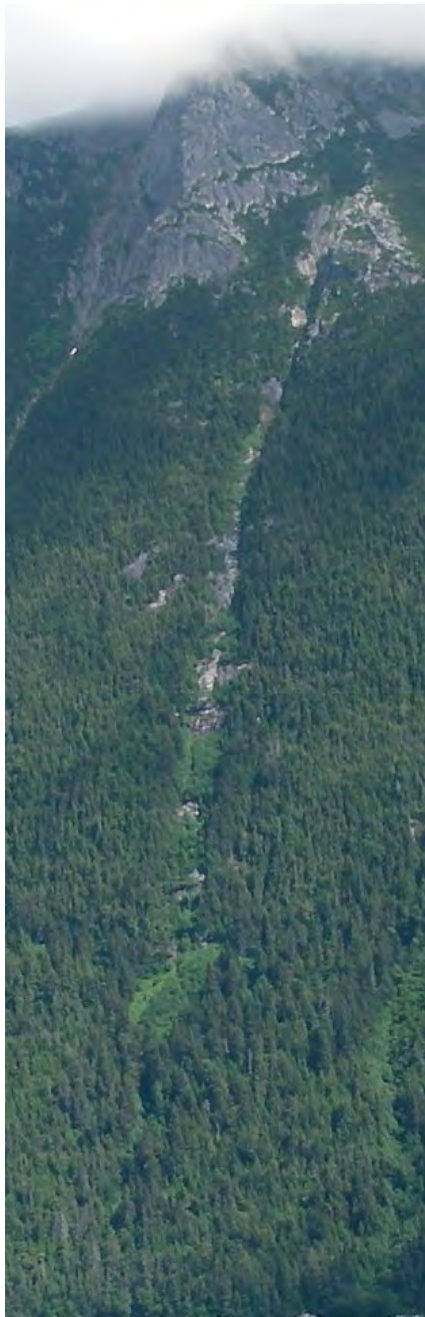
RF17. View east/upslope at rockfall hazard area.

Hazard ID #:	RF17
Hazard Type:	rockfall
HIN:	201
Rating:	A
2012 SEIS Alignment Location:	2128
Frequency (yrs):	1-5
Predictability:	unpredictable
Material Volume (CY):	<10
Clast Size (ft):	3-4
Source Elev. (ft):	1000-2000
Centerline Slope:	open_soil_slope
Alignment Location:	path
Impact Alignment:	yes
Alignment Exposure (ft):	50-200
Vegetation:	disturbed
Deciduous Trees:	yes
2012 SEIS Alignment South Margin:	2128+00
2012 SEIS Alignment North Margin:	2128+60
Photo #:	5928, 6251

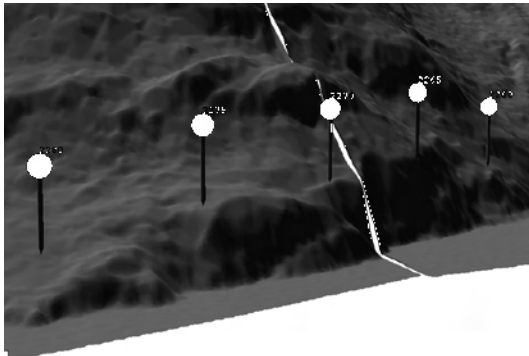
RF24. Bare earth LIDAR image of rockfall hazard. Station labels represent previous IRP 2006 alignment.

Hazard ID #:	RF24
Hazard Type:	rockfall
HIN:	141
Rating:	B
2012 SEIS Alignment Location:	2260
Frequency (yrs):	unknown (1-5?)
Predictability:	unpredictable
Material Volume (CY):	<10
Clast Size (ft):	4+
Source Elev. (ft):	<100
Centerline Slope:	-
Alignment Location:	deposition_zone
Impact Alignment:	yes
Alignment Exposure (ft):	200-500
Vegetation:	disturbed
Deciduous Trees:	yes
2012 SEIS Alignment South Margin:	2258+50
2012 SEIS Alignment North Margin:	2260+75
Photo #:	3507

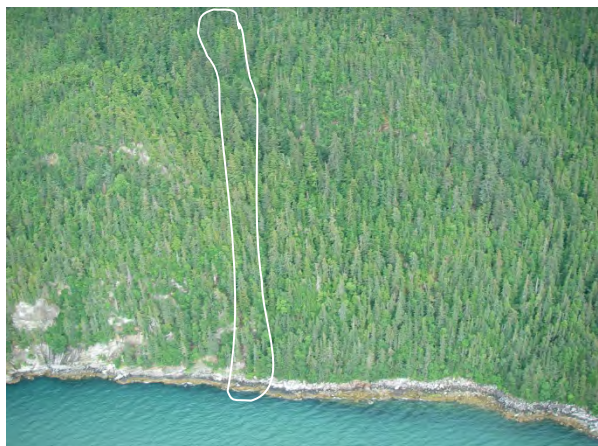
RS02. View east/upslope at rockfall hazard and rockslide.

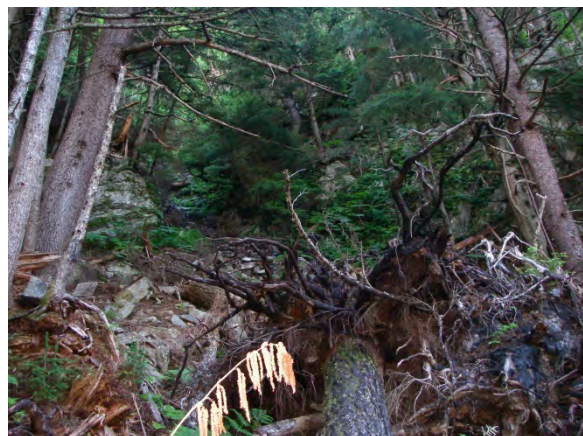
RS02. View east/upslope at rockslide path.

Hazard ID #:	RS02
Hazard Type:	rock_slide
HIN:	63
Rating:	A
2012 SEIS Alignment Location:	2261
Frequency (yrs):	1-5
Predictability:	moderate
Material Volume (CY):	10-100
Clast Size (ft):	1-2
Source Elev. (ft):	100-500
Centerline Slope:	single_channel
Alignment Location:	path
Impact Alignment:	yes
Alignment Exposure (ft):	50-200
Vegetation:	disturbed
Deciduous Trees:	no
2012 SEIS Alignment South Margin:	2260+75
2012 SEIS Alignment North Margin:	2261+35
Photo #:	3508, 3510, 3511

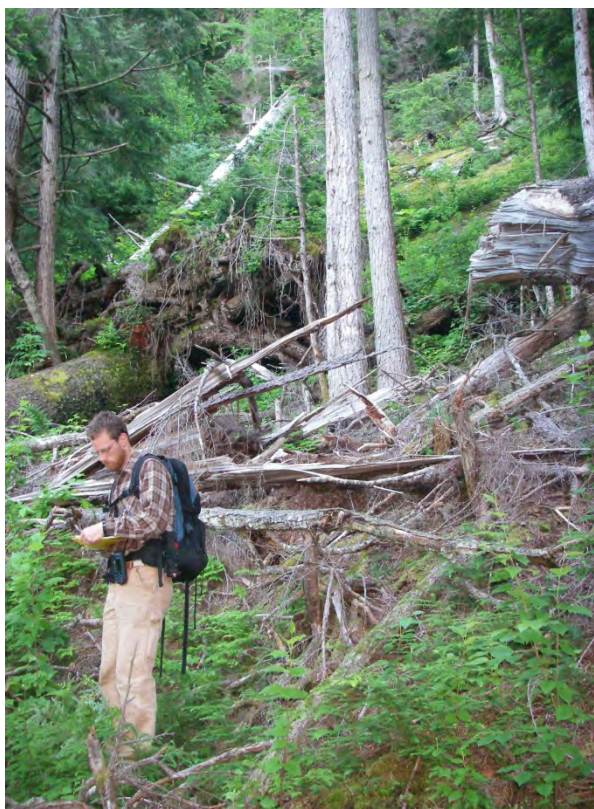
LS03. View north/up alignment at landslide.

Hazard ID #:	LS03
Hazard Type:	translational_slide
HIN:	105
Rating:	B
2012 SEIS Alignment Location:	2299
Frequency (yrs):	25+
Predictability:	unpredictable
Material Volume (CY):	10-100
Clast Size (ft):	1-2
Source Elev. (ft):	<100
Centerline Slope:	-
Alignment Location:	deposition_zone
Impact Alignment:	yes
Alignment Exposure (ft):	50-200
Vegetation:	disturbed
Deciduous Trees:	yes
2012 SEIS Alignment South Margin:	2298+50
2012 SEIS Alignment North Margin:	2299+10
Photo #:	5269, 5946

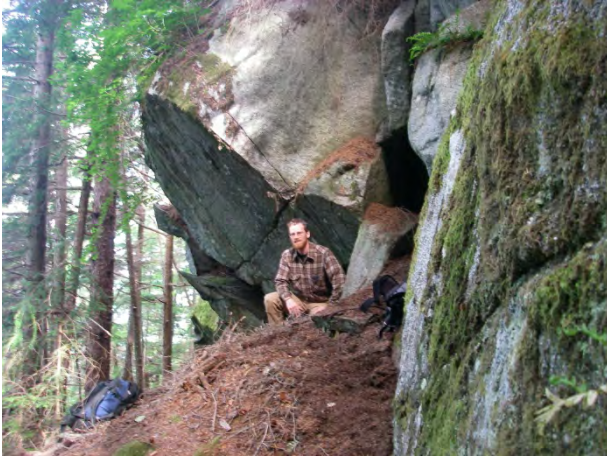
RF26. View north/up alignment at rockfall hazard.

Hazard ID #:	RF26
Hazard Type:	rockfall
HIN:	111
Rating:	B
2012 SEIS Alignment Location:	2300
Frequency (yrs):	unknown (5-25?)
Predictability:	unpredictable
Material Volume (CY):	10-100
Clast Size (ft):	4+
Source Elev. (ft):	<100
Centerline Slope:	-
Alignment Location:	path
Impact Alignment:	yes
Alignment Exposure (ft):	50-200
Vegetation:	undisturbed
Deciduous Trees:	no
2012 SEIS Alignment South Margin:	2299+60
2012 SEIS Alignment North Margin:	2300+70
Photo #:	3559, 3560, 5946

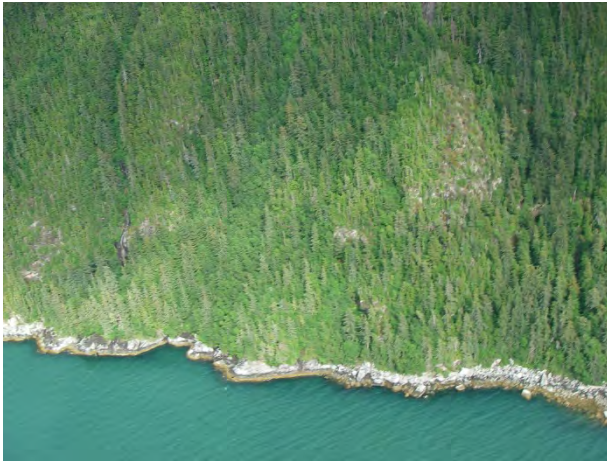
DF36. View east/upslope at debris flow channel.

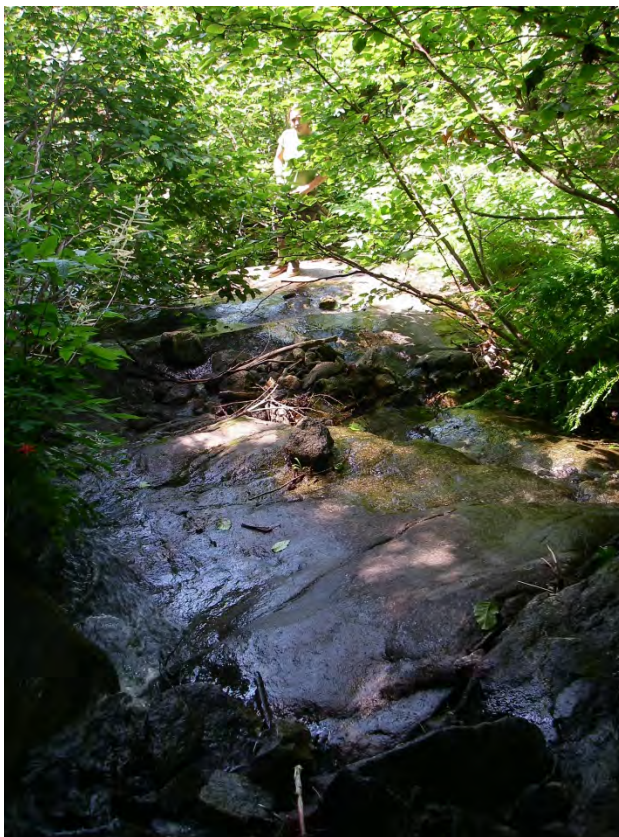
DF36. View west/downslope at debris flow channel scoured to gneiss bedrock.

Hazard ID #:	DF36
Hazard Type:	debris_flow
HIN:	123
Rating:	B
2012 SEIS Alignment Location:	2311
Frequency (yrs):	1-5
Predictability:	high
Material Volume (CY):	10-100
Clast Size (ft):	0-1
Source Elev. (ft):	1000-2000
Centerline Slope:	fan
Alignment Location:	path
Impact Alignment:	yes
Alignment Exposure (ft):	<50
Vegetation:	denuded
Deciduous Trees:	yes
2012 SEIS Alignment South Margin:	2310+65
2012 SEIS Alignment North Margin:	2311+15
Photo #:	3562

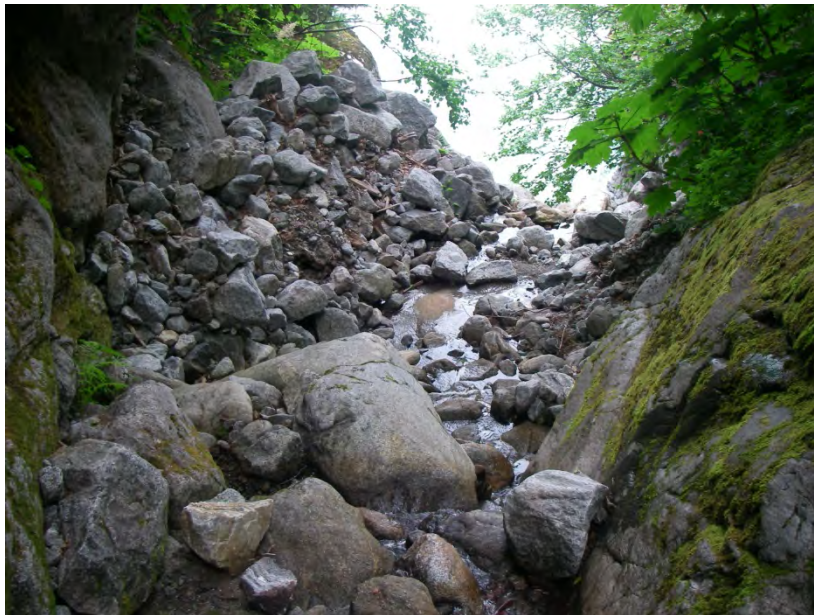
DF37. View east/downslope at boulders deposited by debris flow.

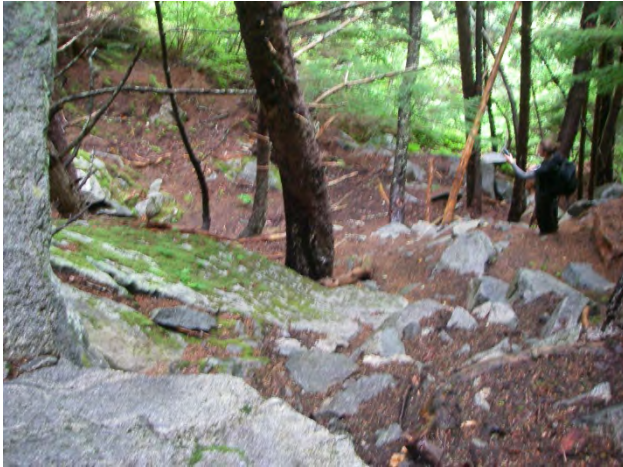
RF28. View east/downslope at rockfall hazard.

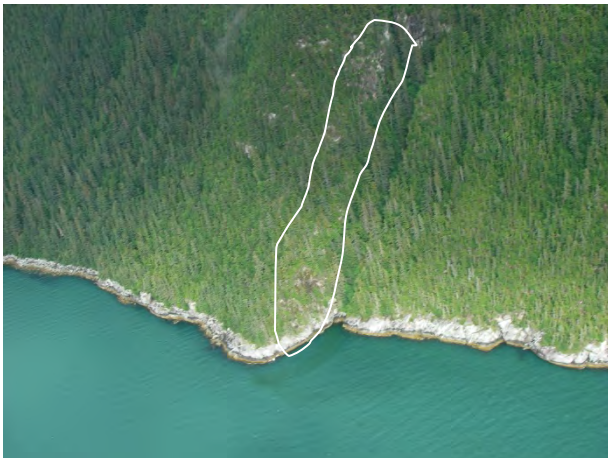
RF28. View east/downslope at rockfall hazard area.

Hazard ID #:	RF28
Hazard Type:	rockfall
HIN:	183
Rating:	A
2012 SEIS Alignment Location:	2322
Frequency (yrs):	0-1
Predictability:	unpredictable
Material Volume (CY):	<10
Clast Size (ft):	1-2
Source Elev. (ft):	100-500
Centerline Slope:	single_channel
Alignment Location:	path
Impact Alignment:	yes
Alignment Exposure (ft):	50-200
Vegetation:	disturbed
Deciduous Trees:	yes
2012 SEIS Alignment South Margin:	2321+60
2012 SEIS Alignment North Margin:	2322+25
Photo #:	3891, 5948, 6254

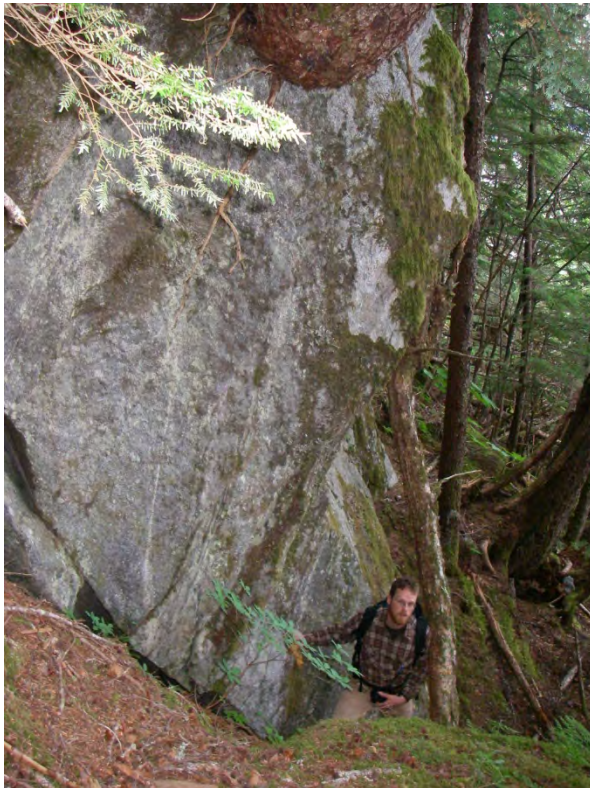
RF20. View west/downslope at rockfall hazard.

Hazard ID #:	RF29
Hazard Type:	rockfall
HIN:	99
Rating:	B
2012 SEIS Alignment Location:	2328
Frequency (yrs):	25+
Predictability:	unpredictable
Material Volume (CY):	<10
Clast Size (ft):	3-4
Source Elev. (ft):	<100
Centerline Slope:	open_soil_slope
Alignment Location:	path
Impact Alignment:	yes
Alignment Exposure (ft):	50-200
Vegetation:	disturbed
Deciduous Trees:	no
2012 SEIS Alignment South Margin:	2327+30
2012 SEIS Alignment North Margin:	2328+50
Photo #:	6140

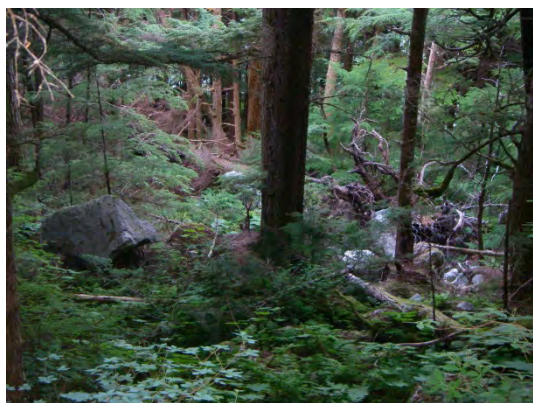
RF30. View west/downslope at rockfall hazard.

Hazard ID #:	RF30
Hazard Type:	rockfall
HIN:	135
Rating:	B
2012 SEIS Alignment Location:	2332
Frequency (yrs):	5-25
Predictability:	unpredictable
Material Volume (CY):	10-100
Clast Size (ft):	4+
Source Elev. (ft):	500-1000
Centerline Slope:	open_soil_slope
Alignment Location:	path
Impact Alignment:	yes
Alignment Exposure (ft):	50-200
Vegetation:	disturbed
Deciduous Trees:	no
2012 SEIS Alignment South Margin:	2331+00
2012 SEIS Alignment North Margin:	2332+20
Photo #:	6142, 6143

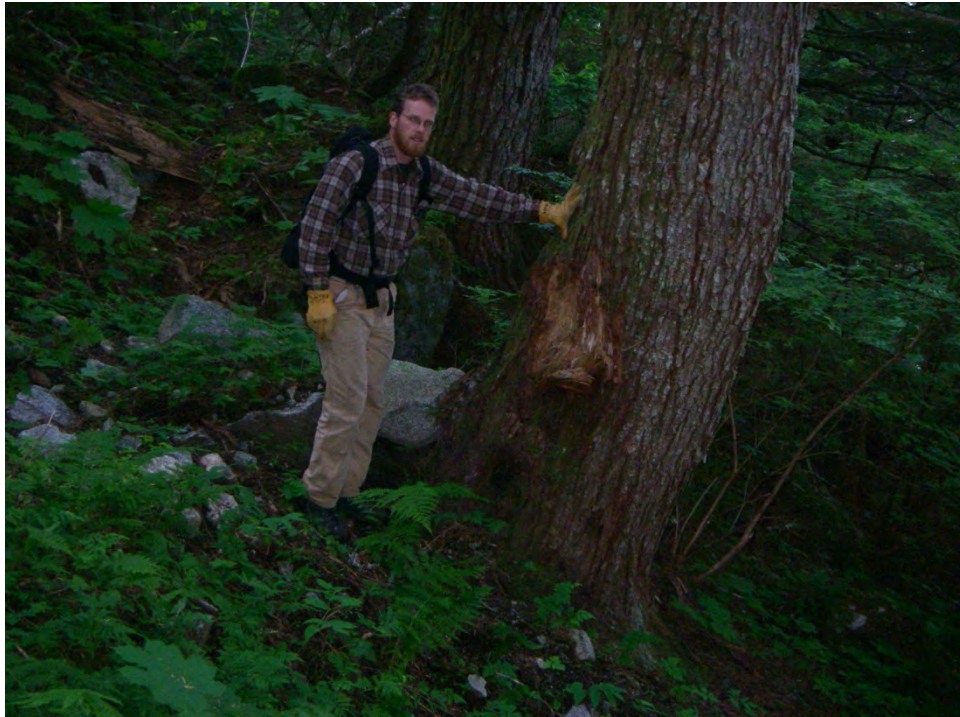
RF31. View south/down alignment at rockfall with freshly gouged trees.

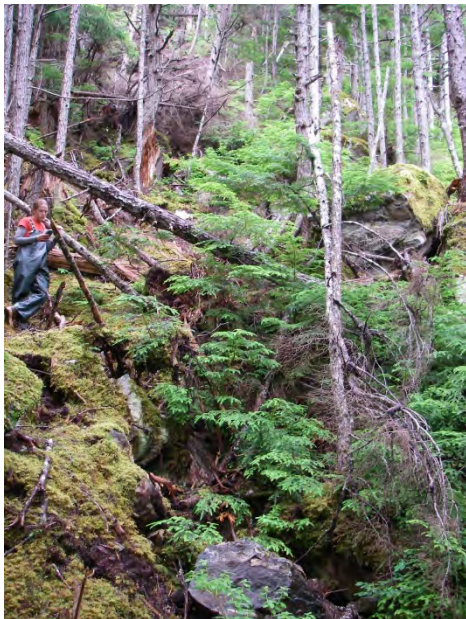
RF39. View east/upslope at rockfall.

Hazard ID #:	RF39
Hazard Type:	rockfall
HIN:	129
Rating:	B
2012 SEIS Alignment Location:	2488
Frequency (yrs):	1-5
Predictability:	unpredictable
Material Volume (CY):	<10
Clast Size (ft):	3-4
Source Elev. (ft):	100-500
Centerline Slope:	other
Alignment Location:	deposition_zone
Impact Alignment:	yes
Alignment Exposure (ft):	50-200
Vegetation:	disturbed
Deciduous Trees:	yes
2012 SEIS Alignment South Margin:	2488+00
2012 SEIS Alignment North Margin:	2489+00
Photo #:	6083, 6084

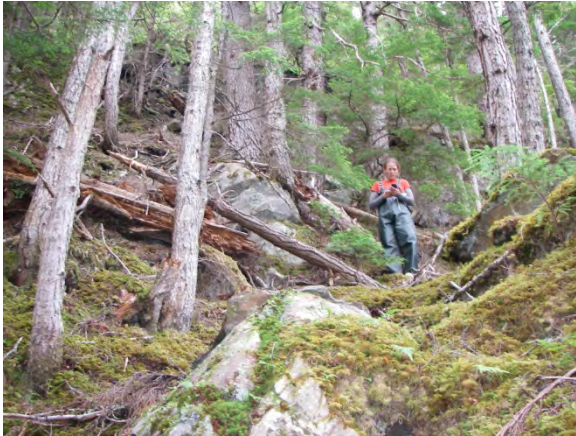
RF40. View west/upslope at rockfall hazard.

Hazard ID #:	RF40
Hazard Type:	rockfall
HIN:	147
Rating:	B
2012 SEIS Alignment Location:	2494
Frequency (yrs):	1-5
Predictability:	unpredictable
Material Volume (CY):	<10
Clast Size (ft):	3-4
Source Elev. (ft):	100-500
Centerline Slope:	-
Alignment Location:	deposition_zone
Impact Alignment:	yes
Alignment Exposure (ft):	200-500
Vegetation:	disturbed
Deciduous Trees:	no
2012 SEIS Alignment South Margin:	2491+60
2012 SEIS Alignment North Margin:	2496+20
Photo #:	5182, 5964, 6085

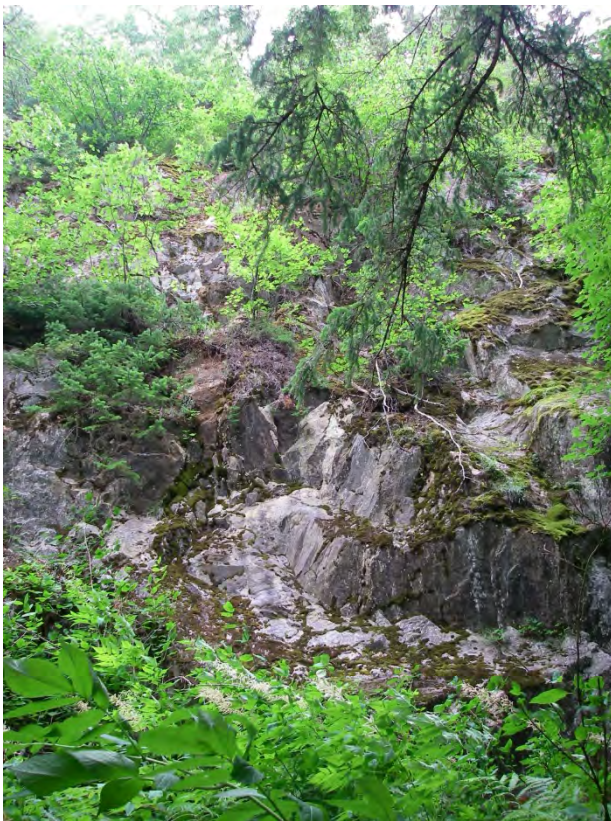
RF42. View east/upslope at rockfall hazard.

Hazard ID #:	RF42
Hazard Type:	rockfall
HIN:	111
Rating:	B
2012 SEIS Alignment Location:	2507
Frequency (yrs):	unknown (5-25?)
Predictability:	moderate
Material Volume (CY):	<10
Clast Size (ft):	0-1
Source Elev. (ft):	100-500
Centerline Slope:	deciduous_trees
Alignment Location:	path
Impact Alignment:	yes
Alignment Exposure (ft):	500+
Vegetation:	denuded
Deciduous Trees:	yes
2012 SEIS Alignment South Margin:	2502+50
2012 SEIS Alignment North Margin:	2512+40
Photo #:	6094, 6095

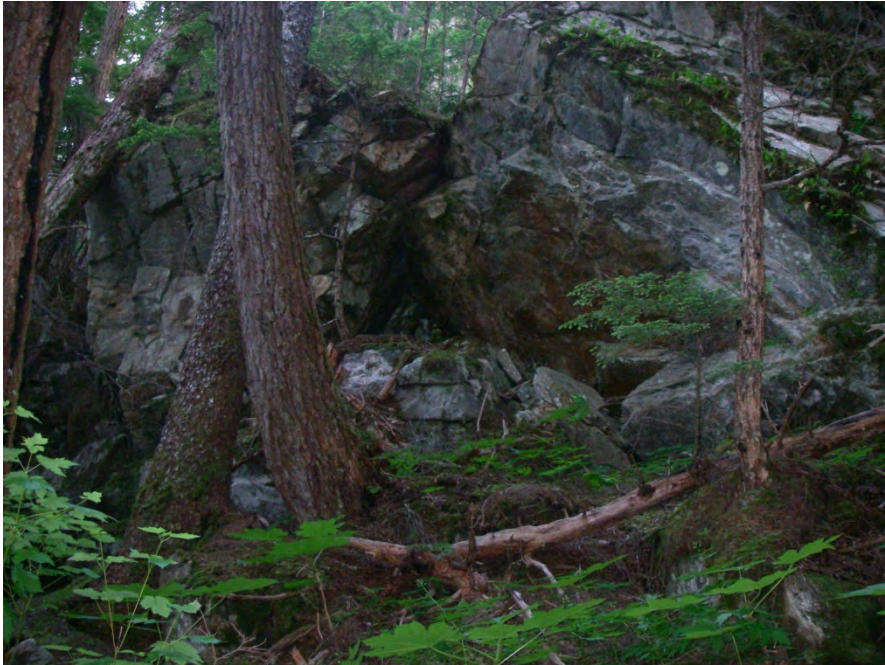
Hazard ID #:	HR03
Hazard Type:	hazard_rocks
HIN:	105
Rating:	C
2012 SEIS Alignment Location:	2525
Frequency (yrs):	unknown (>25?)
Predictability:	unpredictable
Material Volume (CY):	<10
Clast Size (ft):	4+
Source Elev. (ft):	100-500
Centerline Slope:	-
Alignment Location:	below_deposition_zone
Impact Alignment:	yes
Alignment Exposure (ft):	50-200
Vegetation:	-
Deciduous Trees:	no
2012 SEIS Alignment South Margin:	2524+45
2012 SEIS Alignment North Margin:	2525+10
Photo #:	5311, 5312

HR03. View east/upslope at hazard rock.

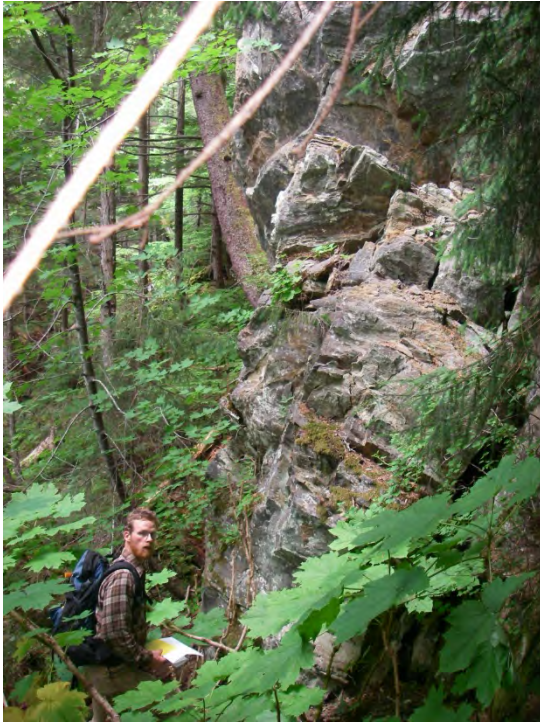
RF46. View north/up alignment at rockfall hazard cliffs.

Hazard ID #:	RF46
Hazard Type:	rockfall
HIN:	111
Rating:	B
2012 SEIS Alignment Location:	2556
Frequency (yrs):	5-25
Predictability:	unpredictable
Material Volume (CY):	<10
Clast Size (ft):	2-3
Source Elev. (ft):	100-500
Centerline Slope:	open_soil_slope
Alignment Location:	below_deposition_zone
Impact Alignment:	no
Alignment Exposure (ft):	50-200
Vegetation:	disturbed
Deciduous Trees:	yes
2012 SEIS Alignment South Margin:	2555+50
2012 SEIS Alignment North Margin:	2557+10
Photo #:	5338, 5339

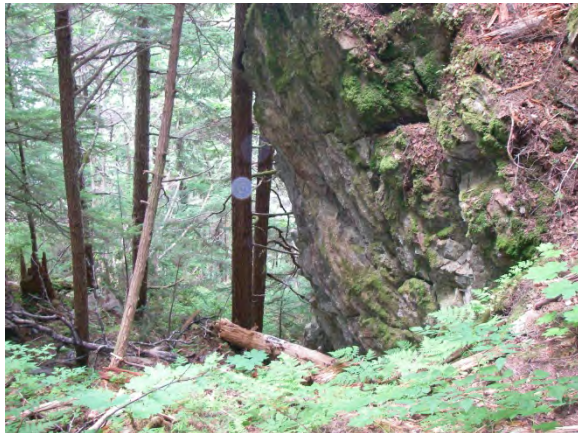
RF46. View northwest (up alignment and downslope) at rockfall hazard area.

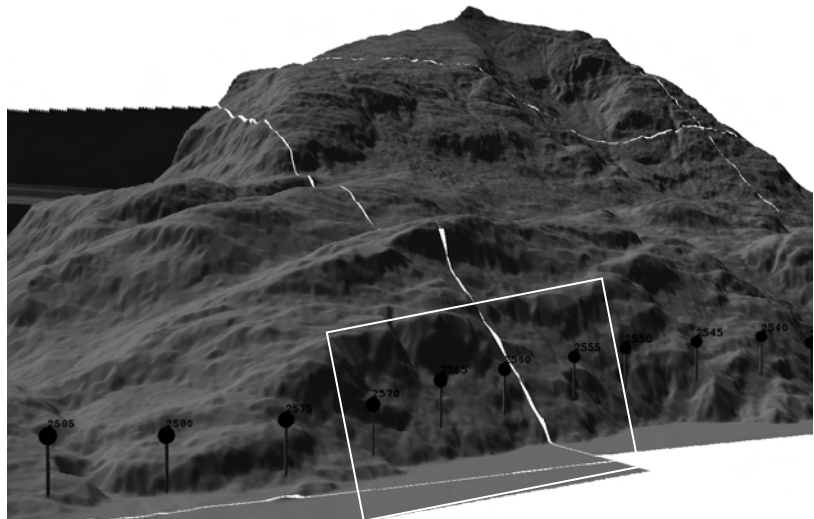
LIDAR bare earth image highlighting the regional photo above. Station labels represent previous IRP 2006 alignment.

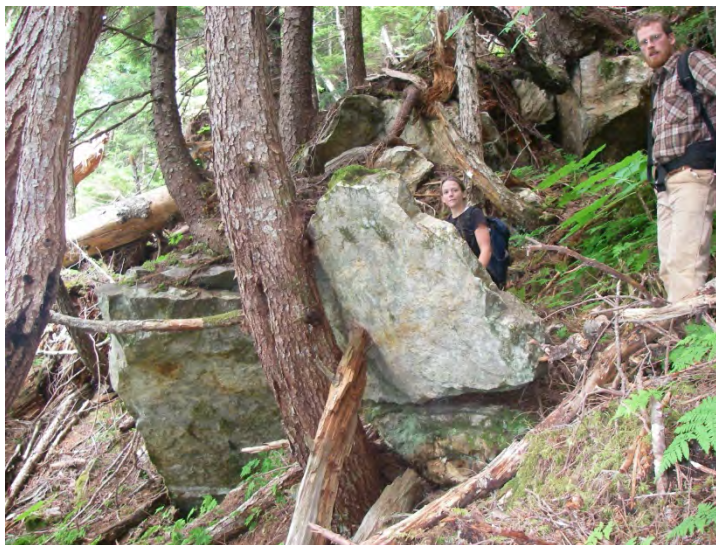
RF47. View north/up alignment at rockfall stopped by tree trunk.

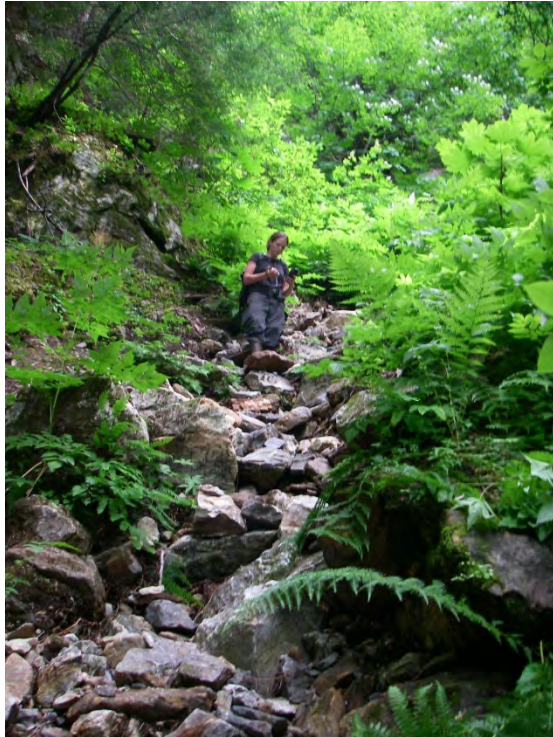
DF43. View north/upslope at debris flow channel.

Hazard ID #:	DF43
Hazard Type:	debris_flow
HIN:	117
Rating:	A
2012 SEIS Alignment Location:	2573
Frequency (yrs):	5-25
Predictability:	moderate
Material Volume (CY):	10-100
Clast Size (ft):	1-2
Source Elevation (ft):	>1000
Centerline Slope:	single_channel
Alignment Location:	below_deposition_zone
Impact Alignment:	no
Alignment Exposure (ft):	50-200
Vegetation:	denuded
Deciduous Trees:	yes
2012 SEIS Alignment South Margin:	2572+50
2012 SEIS Alignment North Margin:	2573+50
Photo #:	5356

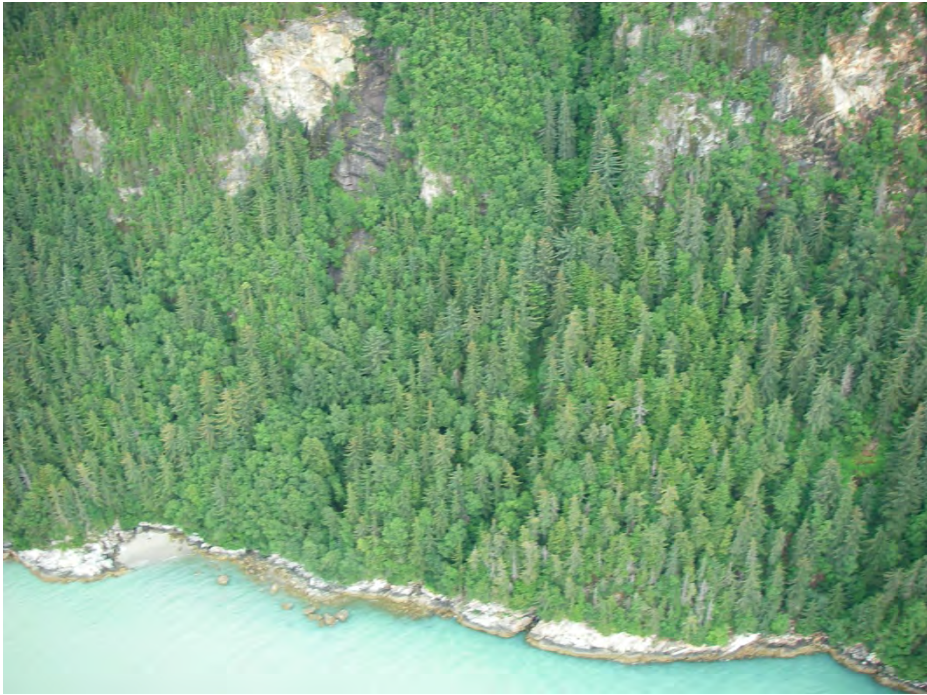
DF43. View east/upslope at debris flow channel.

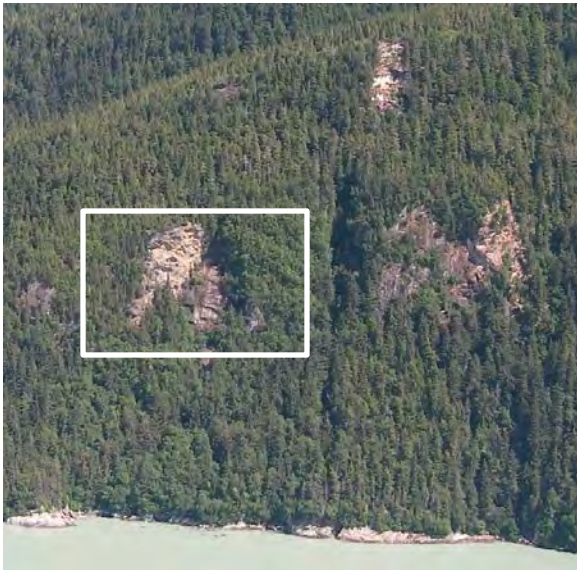
RF53. View east/upslope at rockfall hazard outlined in photo. Hazard characteristics based on RF49 characteristics.

Hazard ID #:	RF53
Hazard Type:	rockfall
HIN:	147
Rating:	C
2012 SEIS Alignment Location:	2575
Frequency (yrs):	1-5
Predictability:	unpredictable
Material Volume (CY):	<10
Clast Size (ft):	2-3
Source Elevation (ft):	100-500
Centerline Slope:	open_soil_slope
Alignment Location:	below_deposition_zone
Impact Alignment:	-
Alignment Exposure (ft):	200-500
Vegetation:	disturbed
Deciduous Trees:	-
2012 SEIS Alignment South Margin:	2572+90
2012 SEIS Alignment North Margin:	2577+00
Photo #:	-

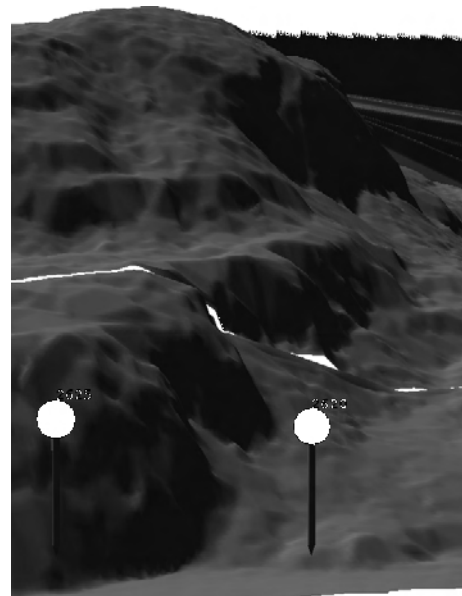
RF54. Bare earth LIDAR image of local topography surrounding rockfall hazard. Station labels represent previous IRP 2006 alignment.
