*GENERAL LAYOUT
PRINCE RUPERT*

Prince Rupert Ferry Terminal

Terminal Description: Prince Rupert Ferry Terminal is a stern-loading facility consisting of a timber transfer bridge, supported by a timber framed lift tower and counterweight system at the seaward end, with two timber stern dolphins, and three timber breasting dolphins connected by timber catwalks. Uplands include a terminal building built in 1992, with US & Canadian customs stations, paved parking and overhead lighting. The facility was originally constructed in 1963 to service AMHS vessels. Terminal is owned by the Prince Rupert Port Authority (PRPA). The City of Prince Rupert also had interest in the terminal building. As of April, 2013, AMHS now leases the entire facility under a fifty-year term for exclusive AMHS operations. AMHS is now responsible for all operation and maintenance of the marine and upland structures.

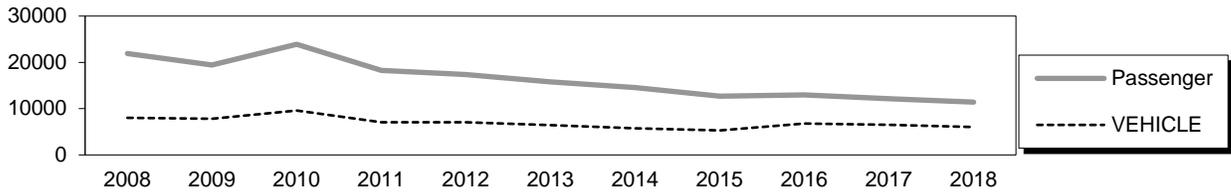
The past 10 years of total passenger and vehicle traffic counts for Prince Rupert are shown below.
