AKUTAN HARBOR

Akutan City Dock

Owner: Aleutians East Borough
Terminal Manager: 907-381-1366 – Brett Willis, Harbormaster

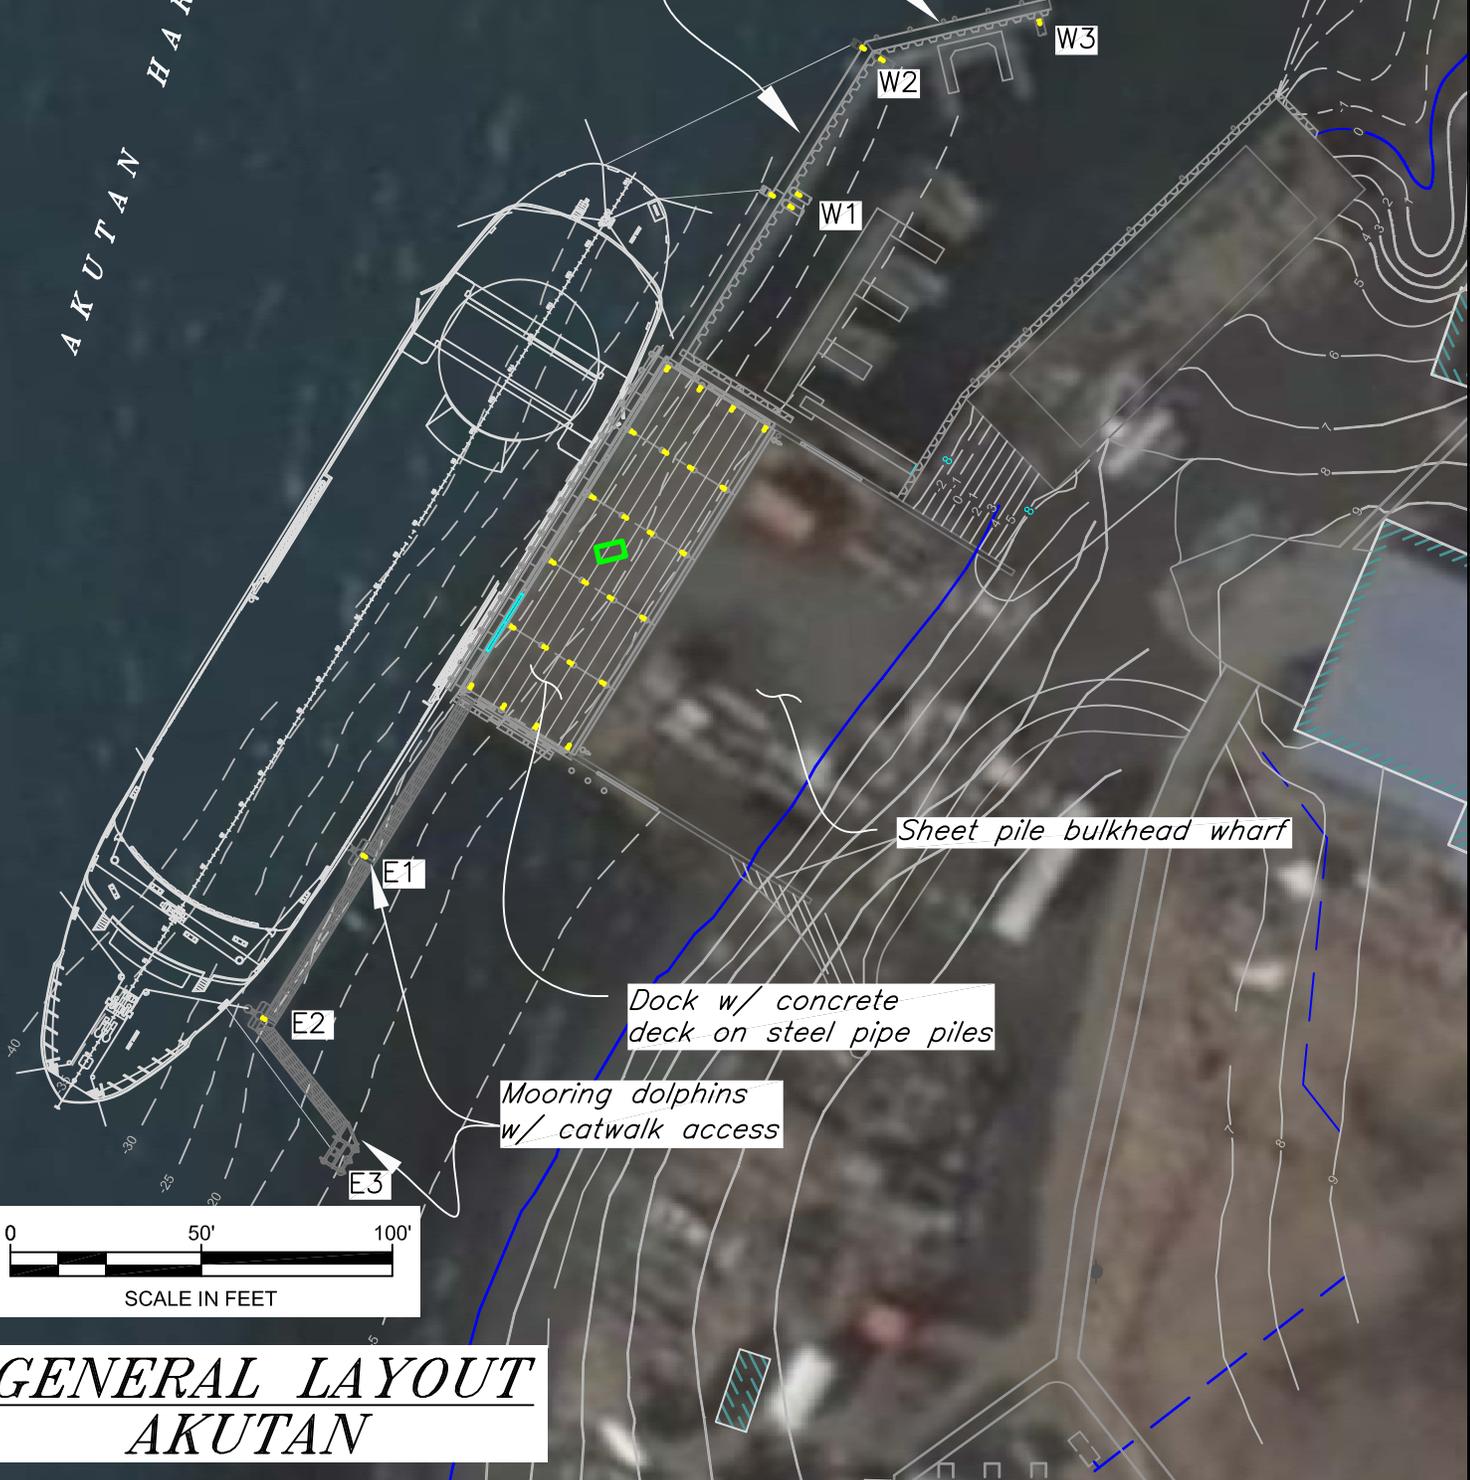
GENERAL LAYOUT
AKUTAN

Sheet pile wave barrier with catwalk

Sheet pile bulkhead wharf

Dock w/ concrete deck on steel pipe piles

Mooring dolphins w/ catwalk access

City Dock - #1946	
Type:	35' x 100' Concrete Panels
Year Built:	1982
Support:	16" dia Steel Pipe Piles
Coating:	Coal Tar Epoxy
Fenders:	(21) - 16" dia Steel Pipe Piles
Fender Face:	UHMW wear strips
Anodes:	Yes
Lighting:	Light poles, east and west ends of dock
Condition:	Fair
Load Posting Sign:	Single Axle 7 Tons; Tandem 12 Tons

Sheet Pile Bulkheads							
Section	Length	Type	Coating	Anodes	Built	Cond.	Notes
1	90'	Z-Section	None	Yes	2002	Good	
2	100'	Z-Section	None	Yes	2005	Good

Dolphins							
Dolphin	Dolphin Piles	Fender Support	Fender Face	Anodes	Built	Cond.	Notes
W3	1B, 1V	-	-	No	2005	Good	
W2	1B, 1V	2V	Plastic Rub Strip	No	2002	Good	
W1	2B, 2V	2V	Plastic Rub Strip	No	2002	Good	Rubber Fenders & steel wale are severely damaged.
E1	3B	1H	Rubber donut, vertically mounted	Yes	1993/2015	Fair	Fender re-built in '15
E2	3B	1H	Rubber donut, vertically mounted	Yes	1993/2015	Fair	Fender re-built in '15; Red Navlight
E3	5B	-	-	Yes	2015	New
