Juneau Access Improvements Project Draft Supplemental Environmental Impact Statement

2014 Update to Appendix R Bald Eagle Technical Report

State Project Number: 71100 Federal Project Number: STP-000S(131)

May 2014

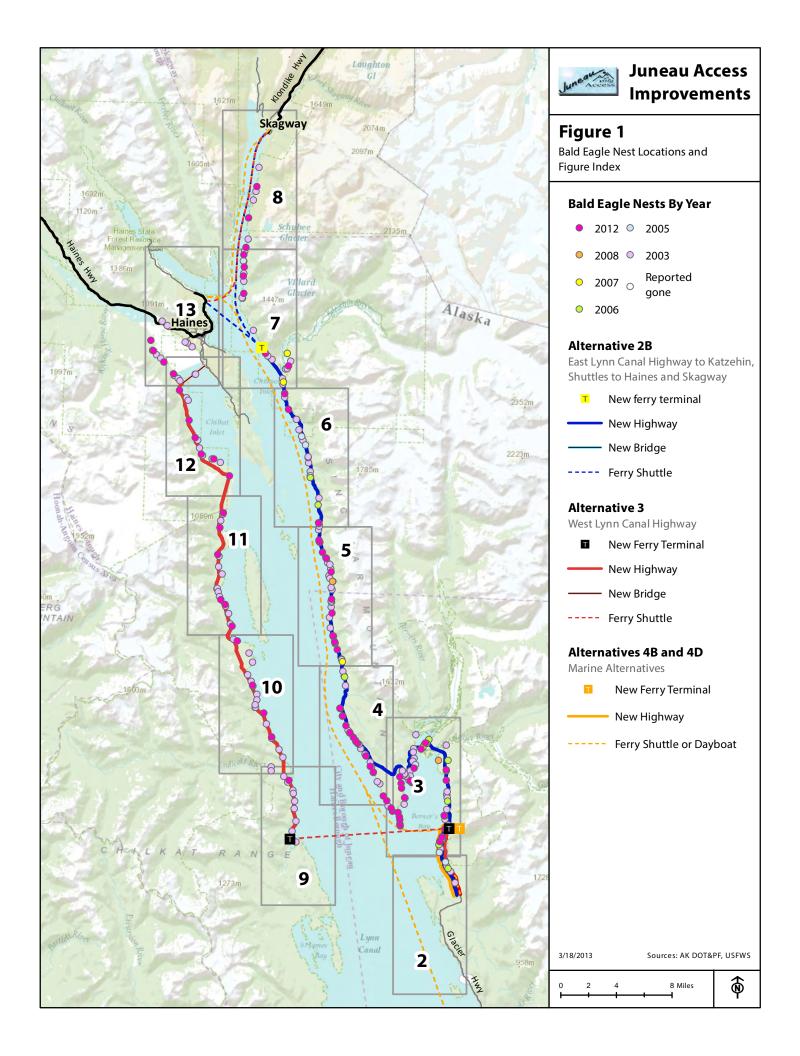
Figure 1	Bald Eagle Nest Locations and Figure Index
Figure 2	Bald Eagle Nests Echo Cove Vicinity East Lynn Canal
Figure 3	Bald Eagle Nests Berners Bay Vicinity East Lynn Canal
Figure 4	Bald Eagle Nests Sherman Rock Vicinity East Lynn Canal
Figure 5	Bald Eagle Nests Eldred Rock Vicinity East Lynn Canal
Figure 6	Bald Eagle Nests Yeldagalga Creek East Lynn Canal
Figure 7	Bald Eagle Nests Katzehin River East Lynn Canal
Figure 8	Bald Eagle Nests Taiya Inlet East Lynn Canal
Figure 9	Bald Eagle Nests William Henry Bay West Lynn Canal
Figure 10	Bald Eagle Nests Endicott River West Lynn Canal
Figure 11	Bald Eagle Nests Sullivan Island West Lynn Canal
Figure 12	Bald Eagle Nests Chilkat Inlet West Lynn Canal
Figure 13	Bald Eagle Nests Chilkat Inlet – Haines

There are 268 bald eagle nests located within the JAI study area (see Figures 1–13, and Tables B-1 and B-2 in Attachment A). For this 2014 update, Tables B-1 and B-2 from Attachment B of the 2004 *Bald Eagle Technical Report* have been updated to provide the distance from the work limits of the highway alignments to nests that fall within 0.5 mile of the work limits.
